Appendix A: Community Input

Focus Group Summary Report

Quincy Park District ***Quincy, Illinois***

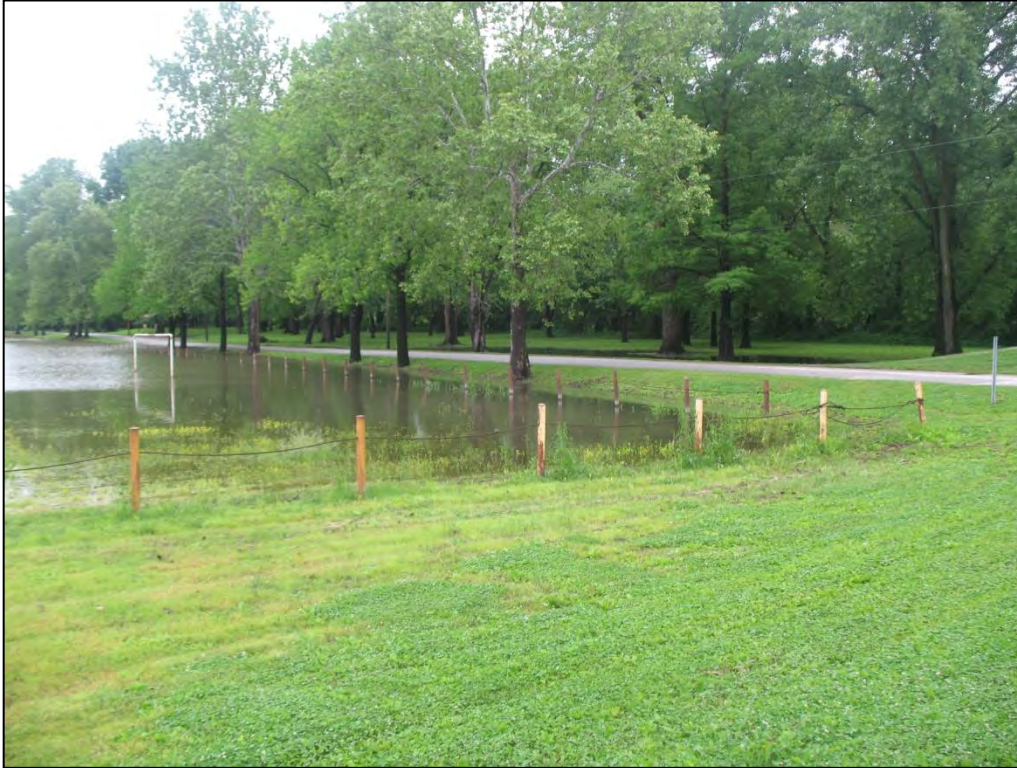
Photo 1:

The park is continually wet or flooded inhibiting recreational use for the majority of the year. Replacing existing turf with a wetland and mesic prairie seed mix would provide natural water retention and an educational experience for the public.

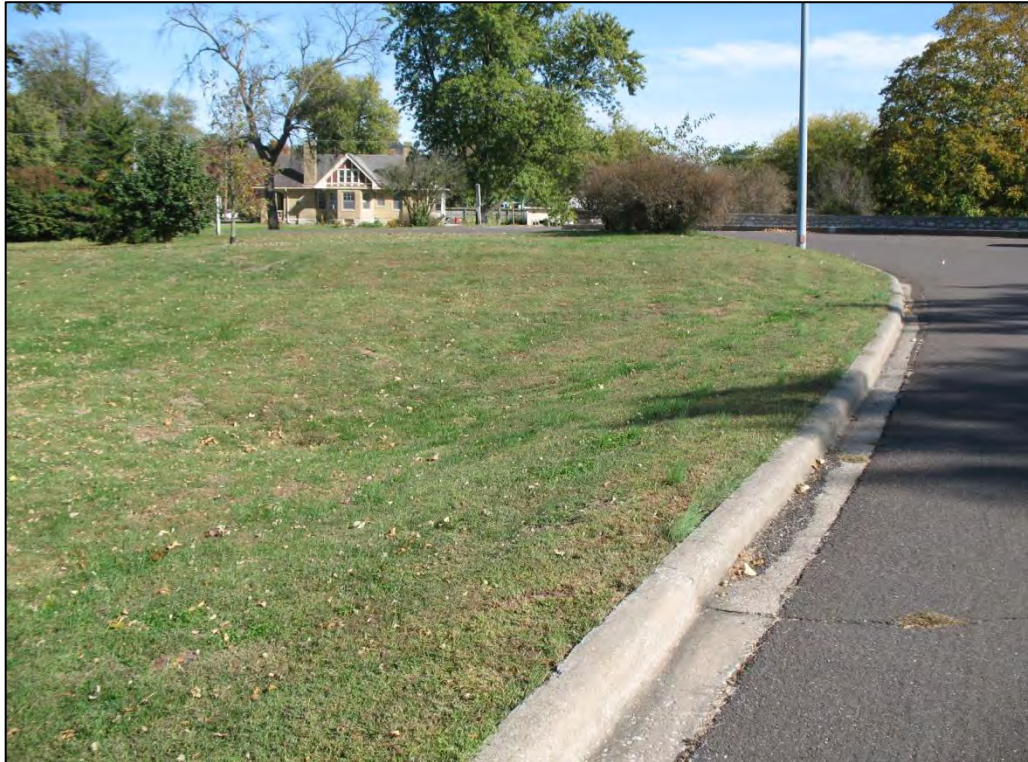
Photo 3:

Expansive turf should be replaced with a natural area to cut down maintenance and chemical use. Natural areas along roads would have a buffer of low mow fescue or buffalo grass for safety concerns.

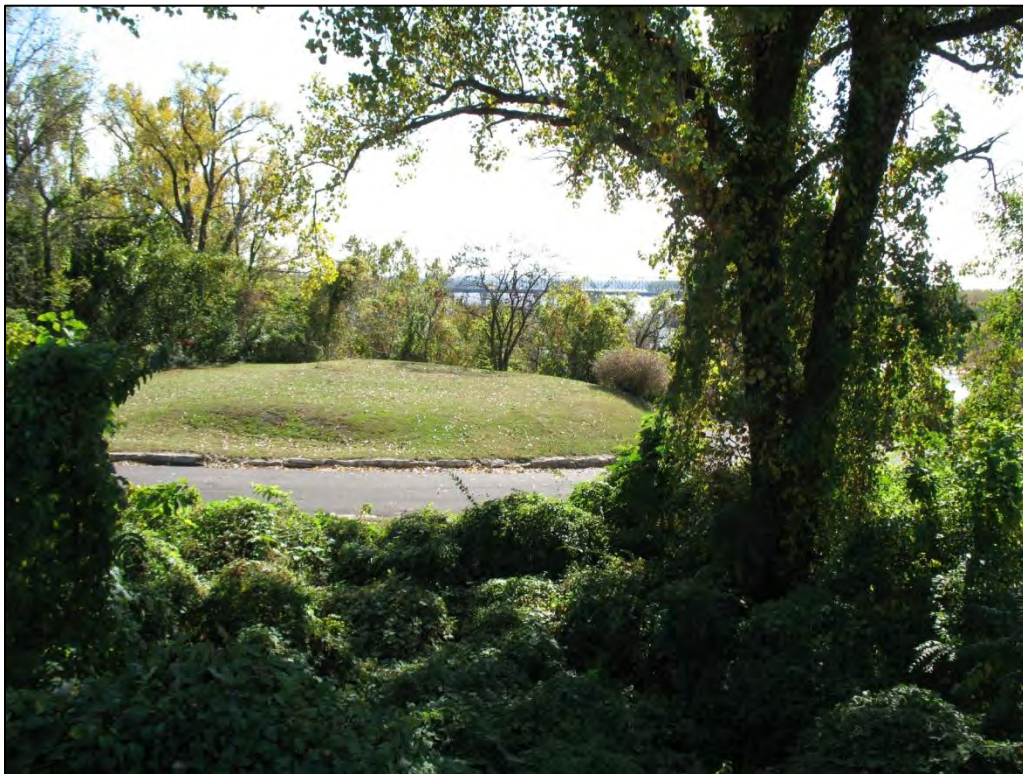
Photo 8:

The amazing views of the river are inhibited by invasive woody understory. Once cleared the remnant canopy tree species will frame the river view with a colorful carpet of prairie that should replace high maintenance turf. Invasive Riverbank Grape, as seen in the foreground, should be eradicated from the site.

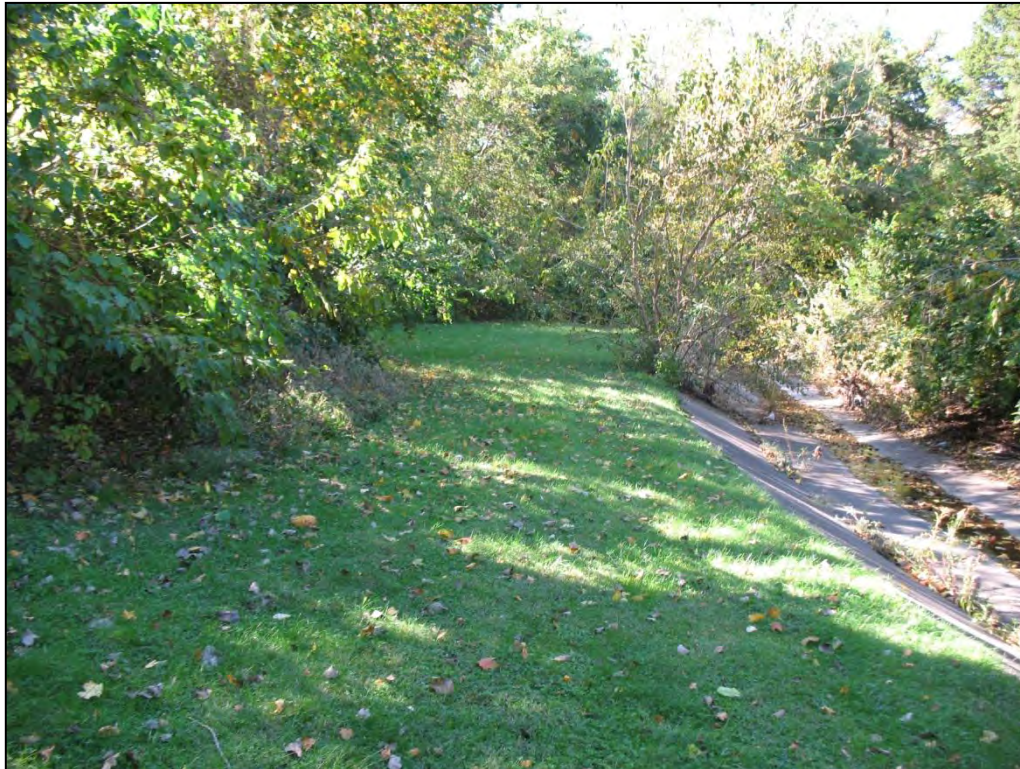
Photo 12:

Turf in an under-utilized pedestrian corridor should be replaced with native prairie. Best Management Practices can be implemented in the drainage swale to allow water percolation and filtration.

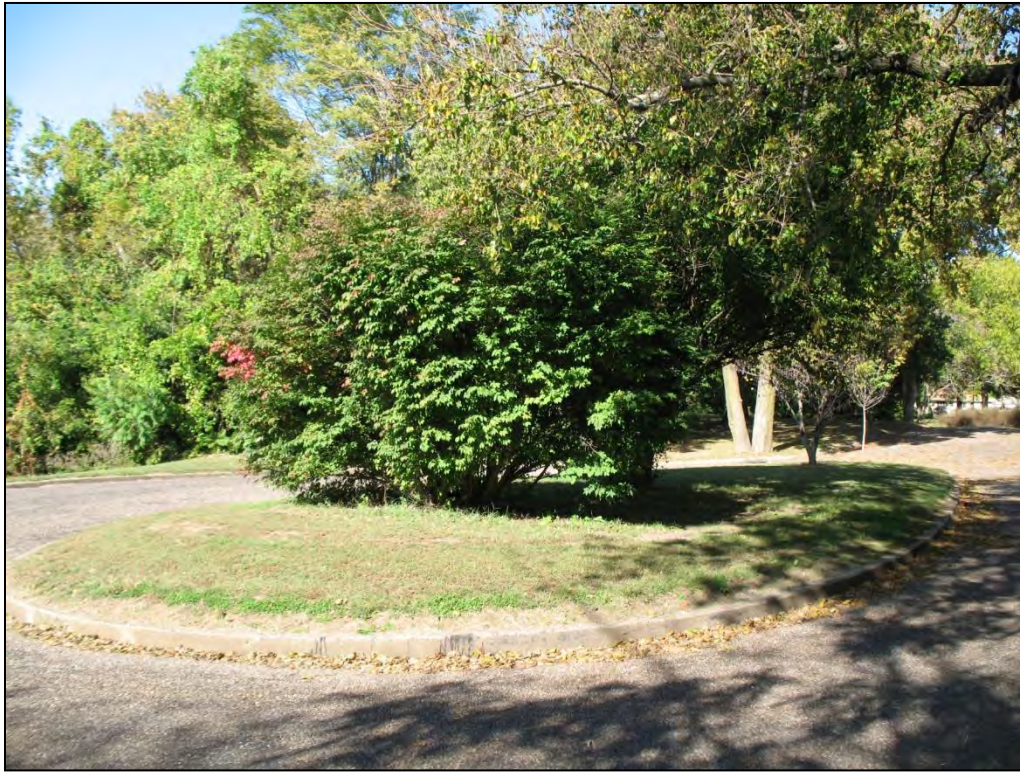
Photo 15:

The turf and Burning-bush Viburnum should be removed and replaced with native prairie to eliminate unnecessary landscape maintenance and restore the native vegetation of the site.

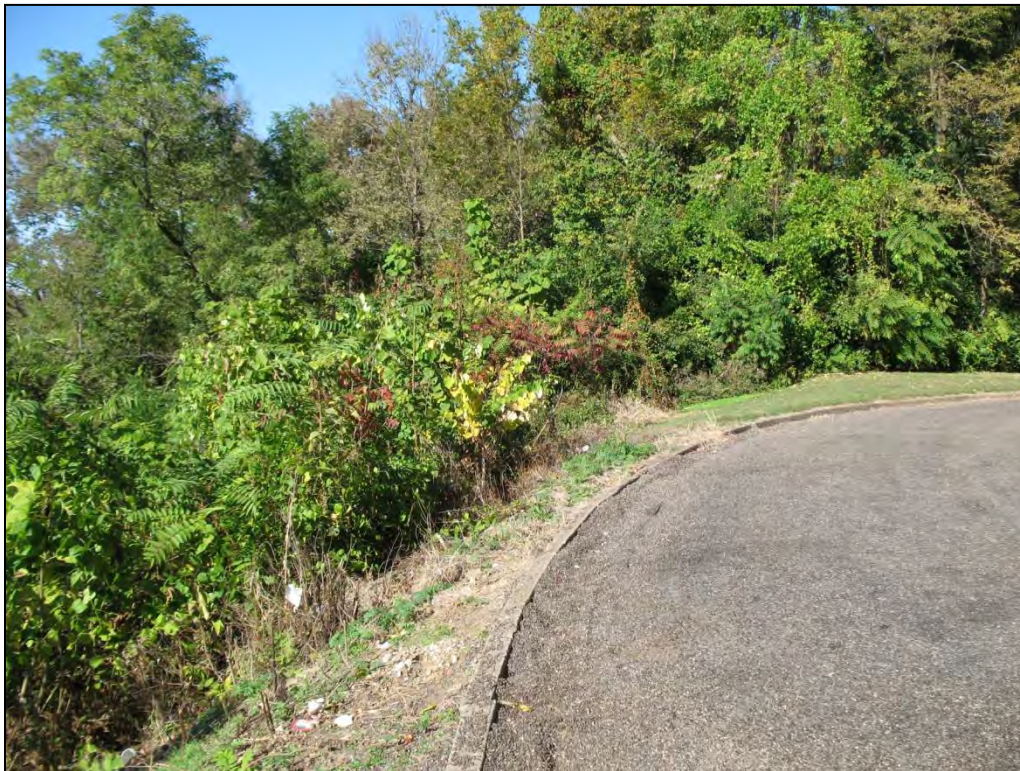
Photo 16:

Once the invasive and exotic species are cleared from this portion of Sunset Park, and replaced with native hill prairie erosion should be controlled and river views restored.

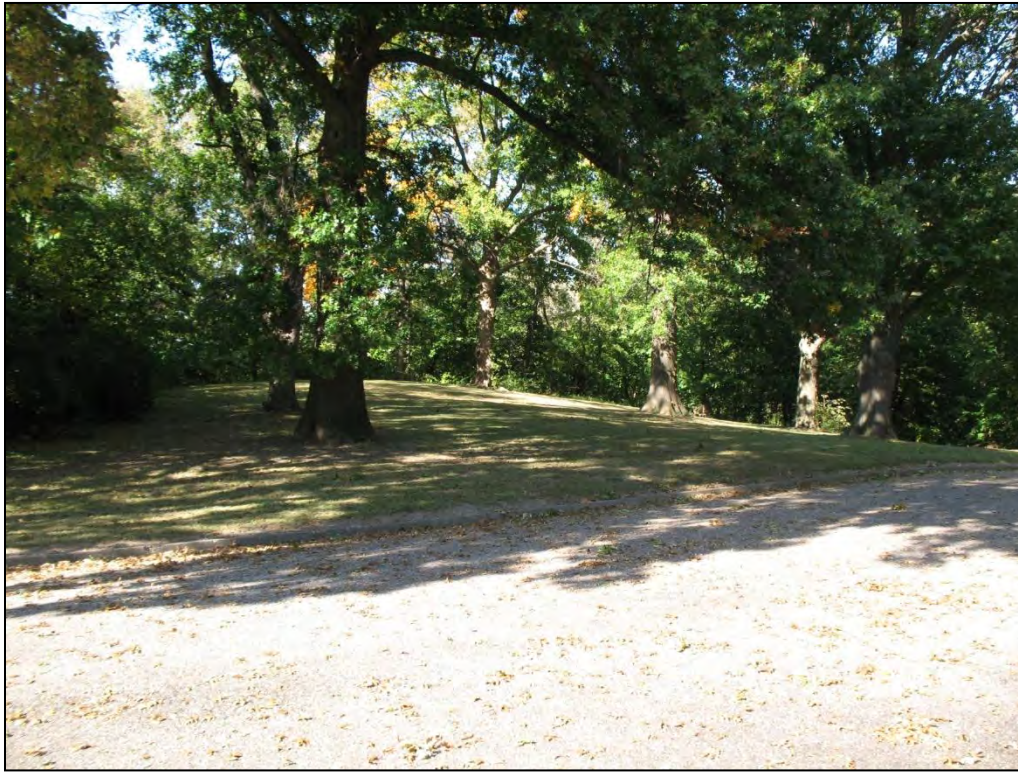
Photo 17:

These old growth oaks set along the highpoints of Sunset Park should be restored into Oak Savanna.

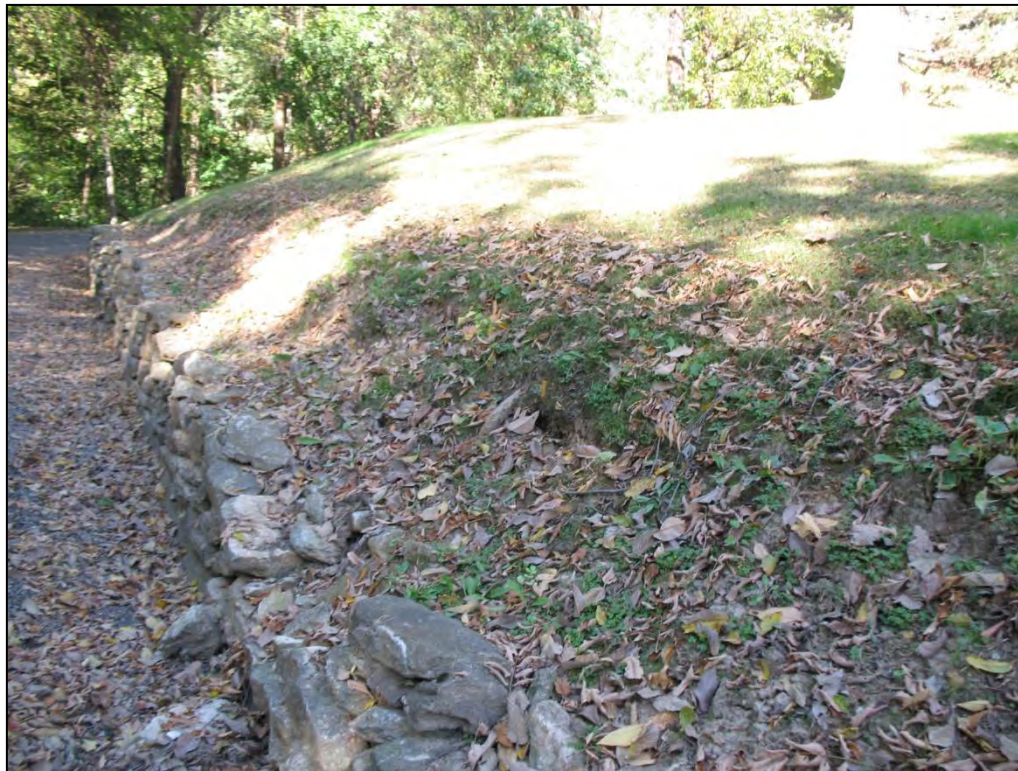
Photo 18:

This retaining wall located in the northern section of Sunset Park is in need of repair among other retaining walls in Sunset/Gardner Park. Replacing the turf hill with native prairie will eliminate erosion from the site as seen along the back of the wall.

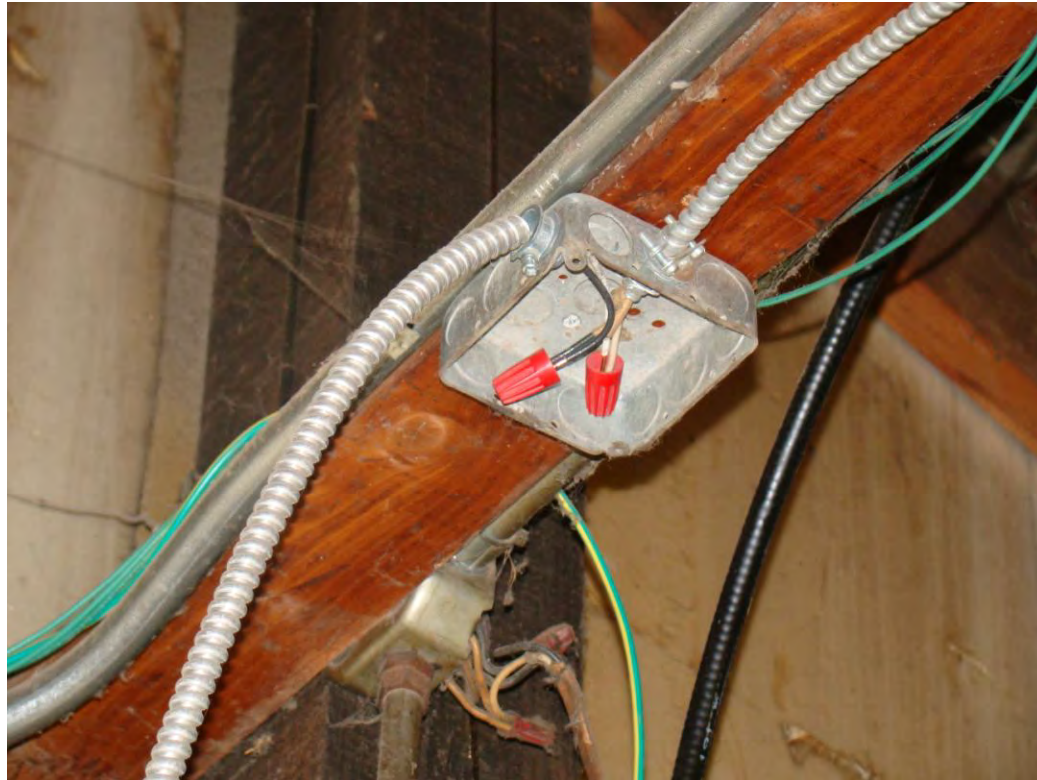
Electrical Boxes had missing covers

OSHA Standard Subpart S Electrical 1910.305 (b) Cabinets, boxes or fittings

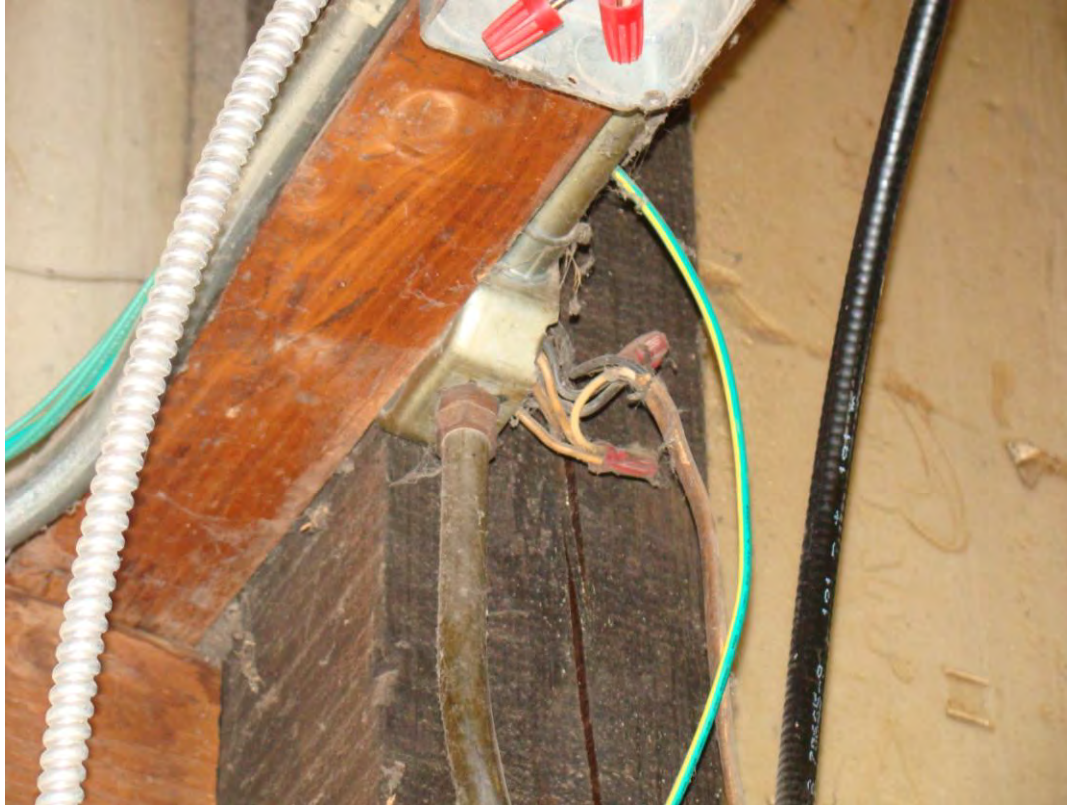
Electrical Boxes had missing covers

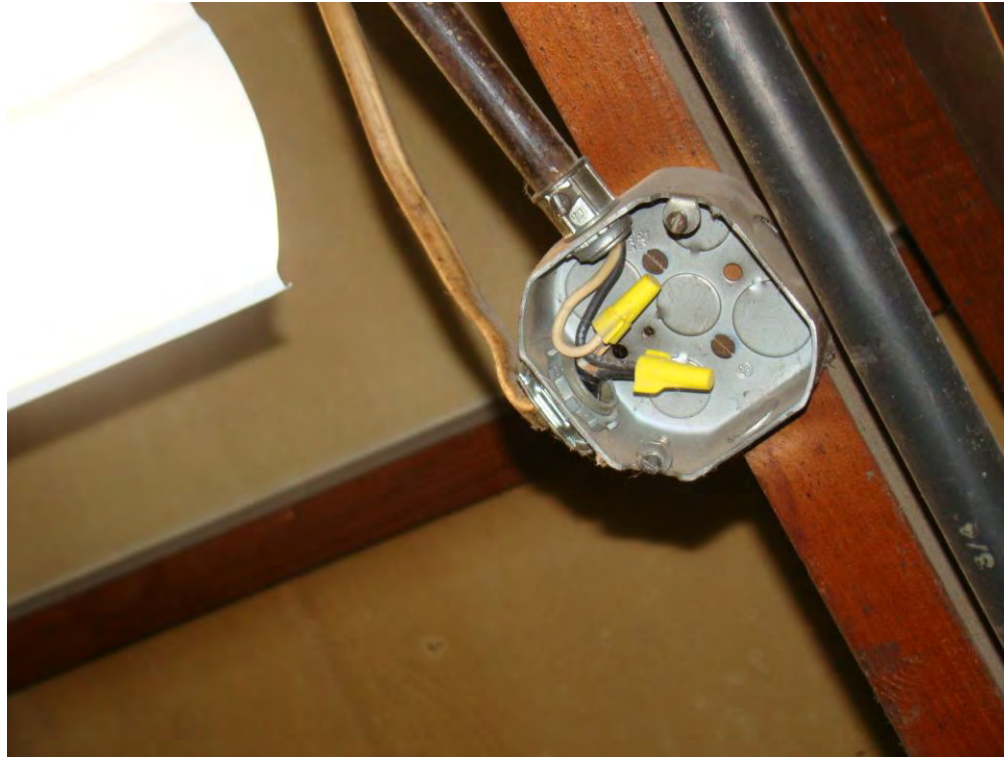
Cover missing on electrical box

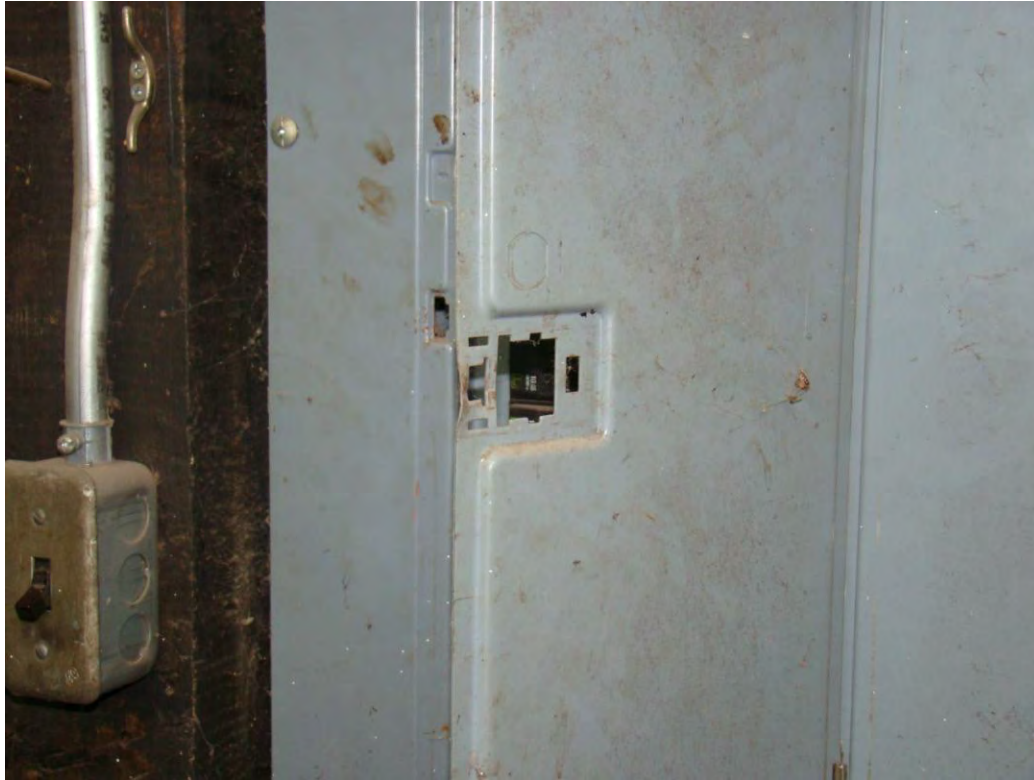
Latch missing on electrical main building panel

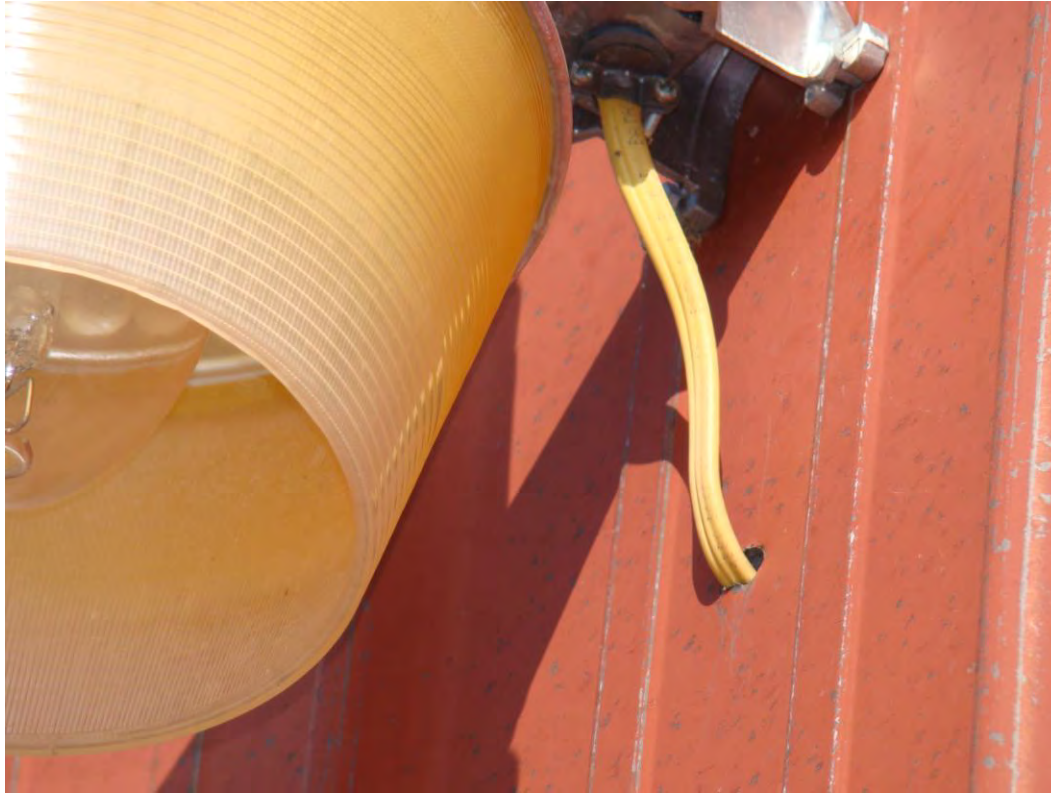
Close-up photo of previous violation.

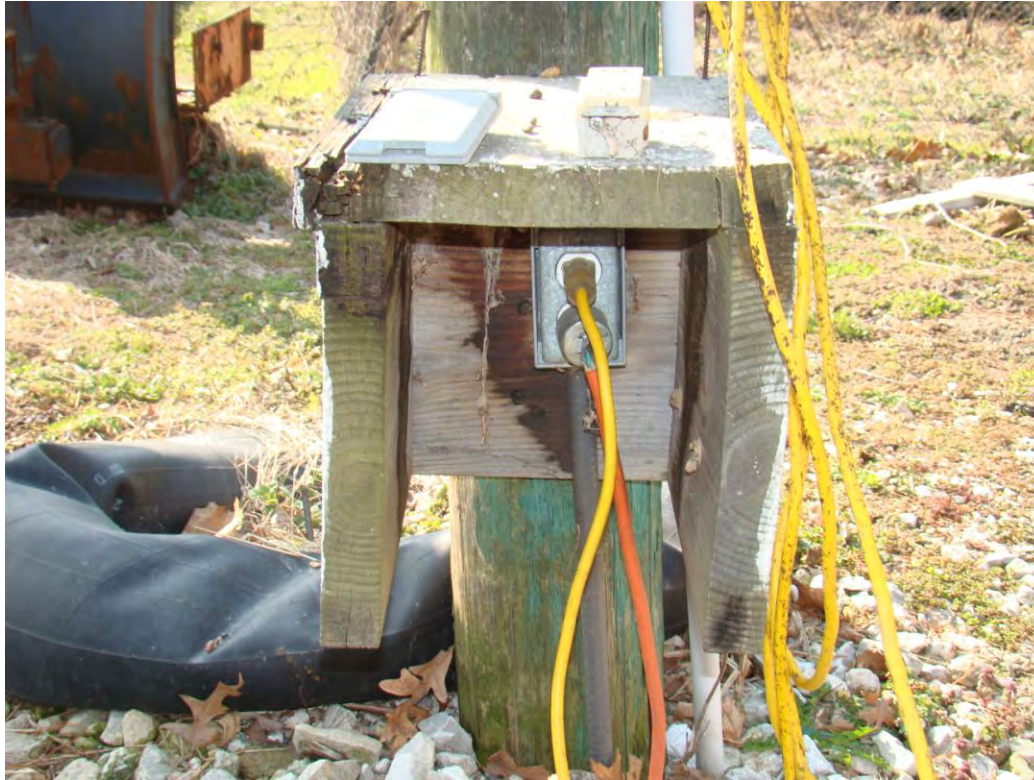
Outside receptacles without GFCI protection

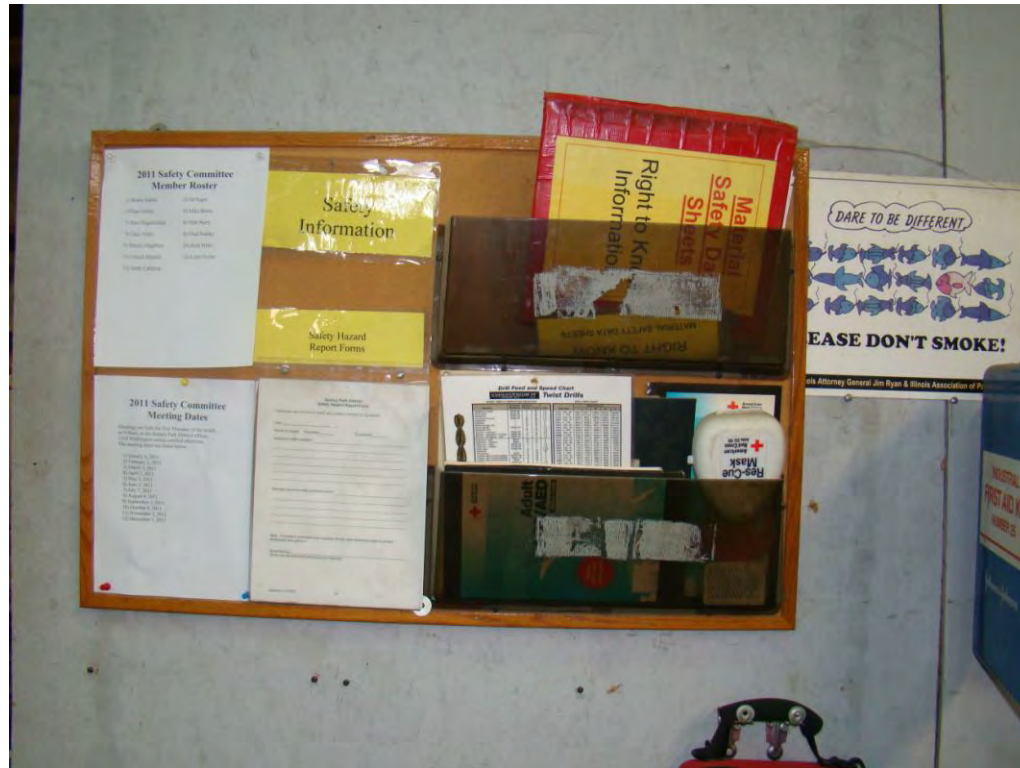
MSDS Book Outdated and incomplete

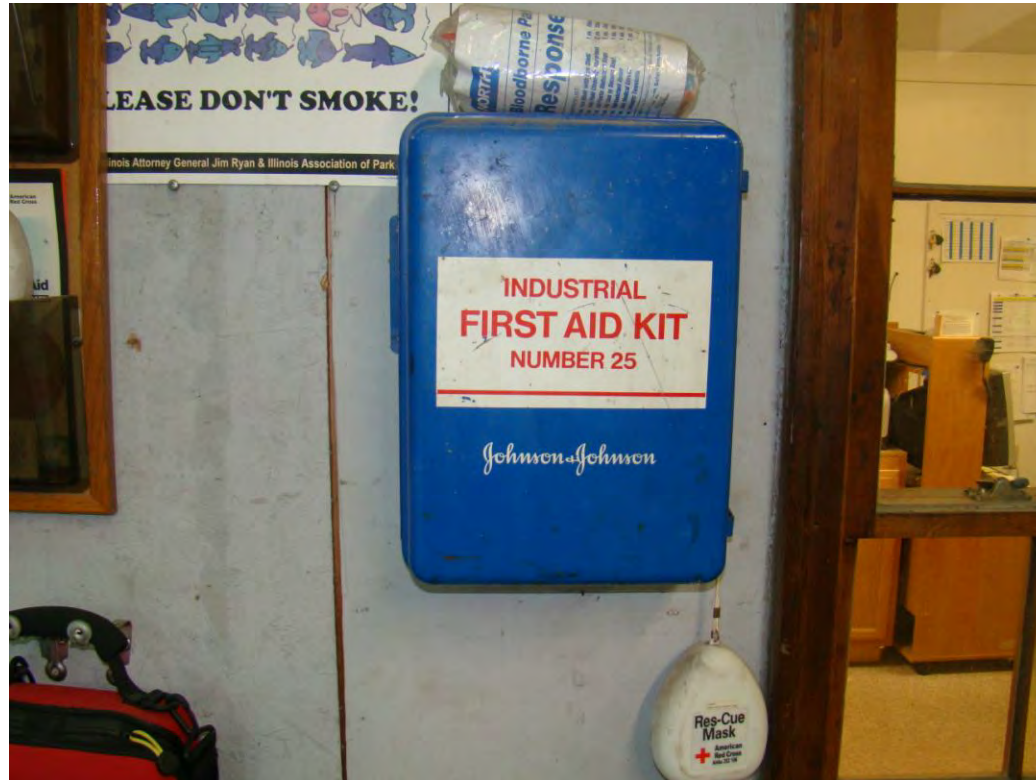
First Aid Kit very old and missing many items; not inspected

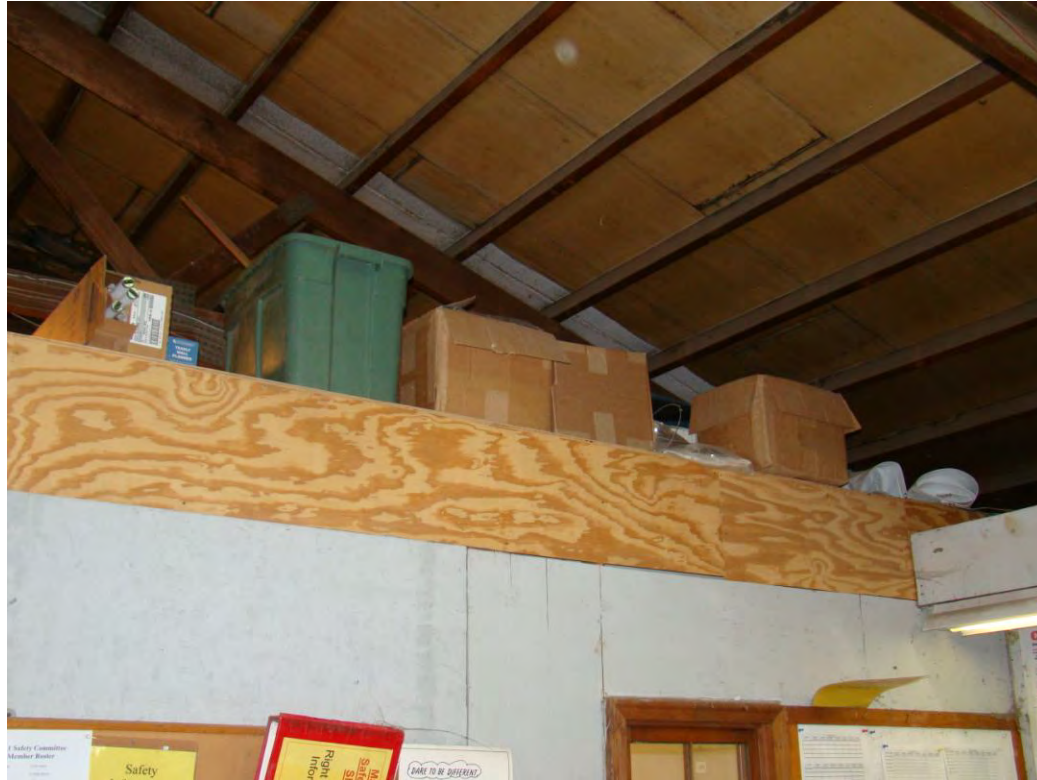
**Missing signs for load capacity of load bearing
Messene area**

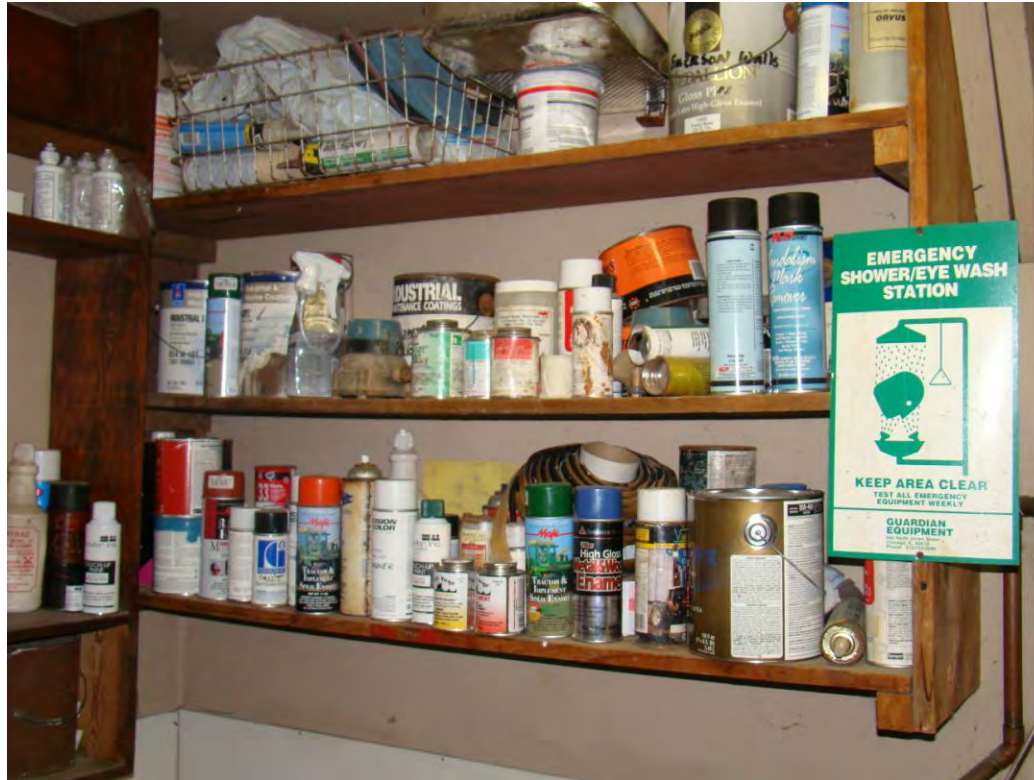
**Photo of many different types of paint and spray paint
all flammable should be in cabinet not in a bath room**

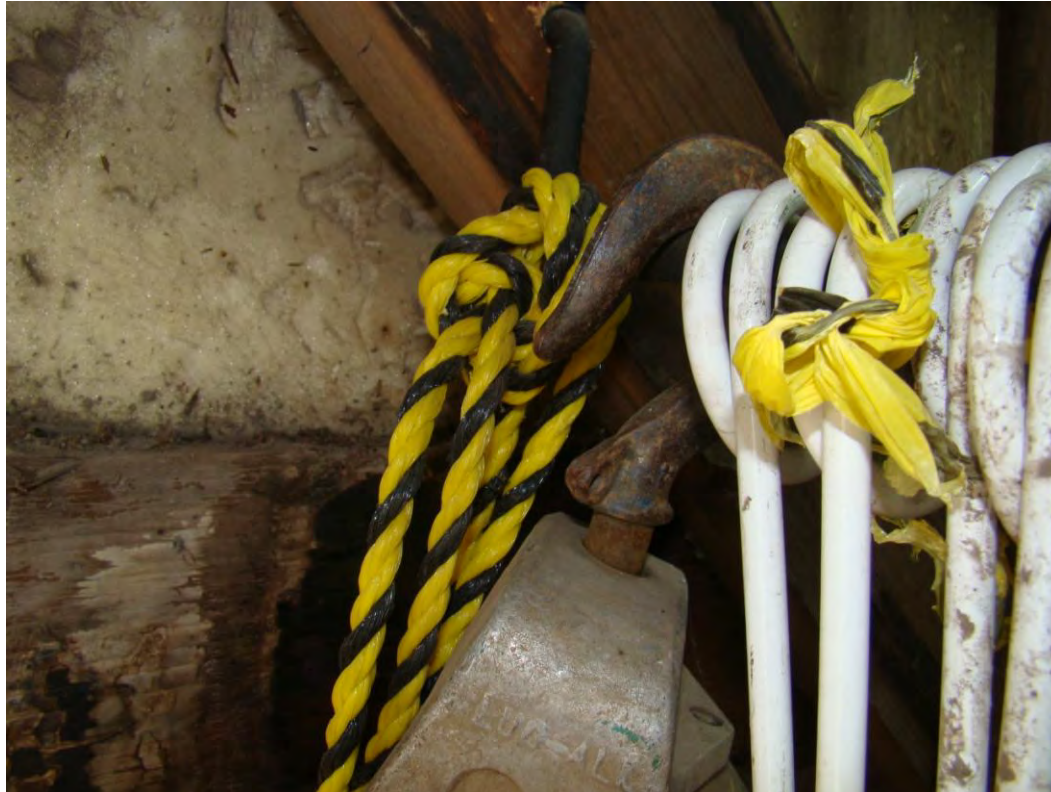
Safety catch missing on chain come-a-long

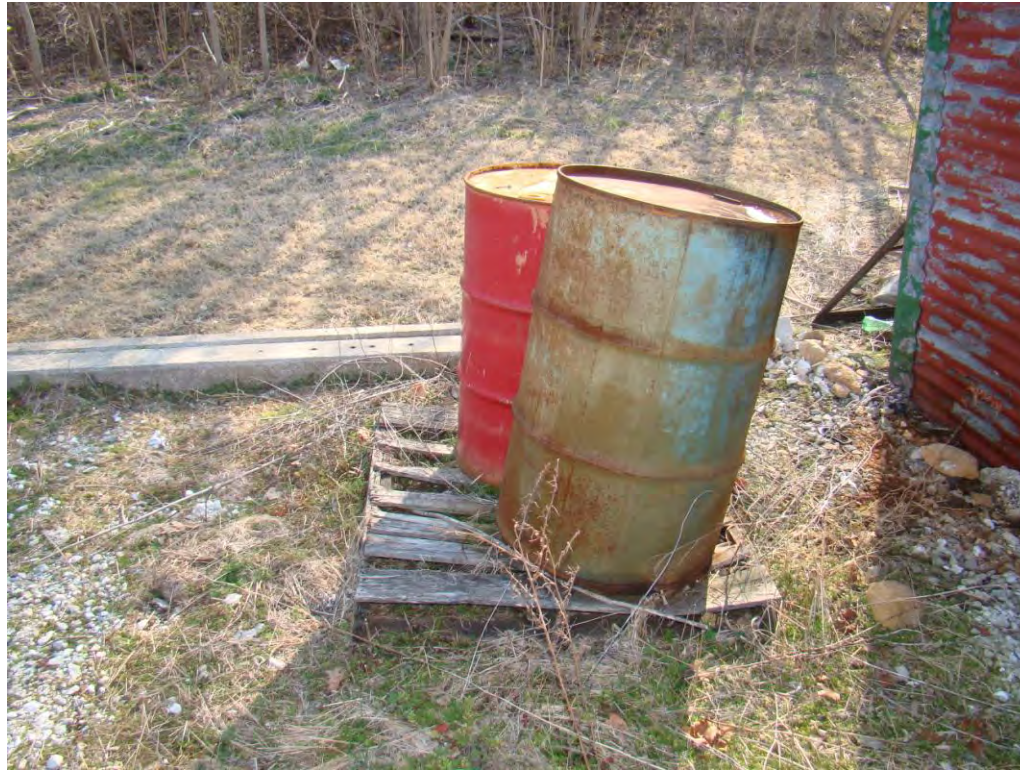
Misc. Drum full of unknown product no labels or markings, also unprotected from spills

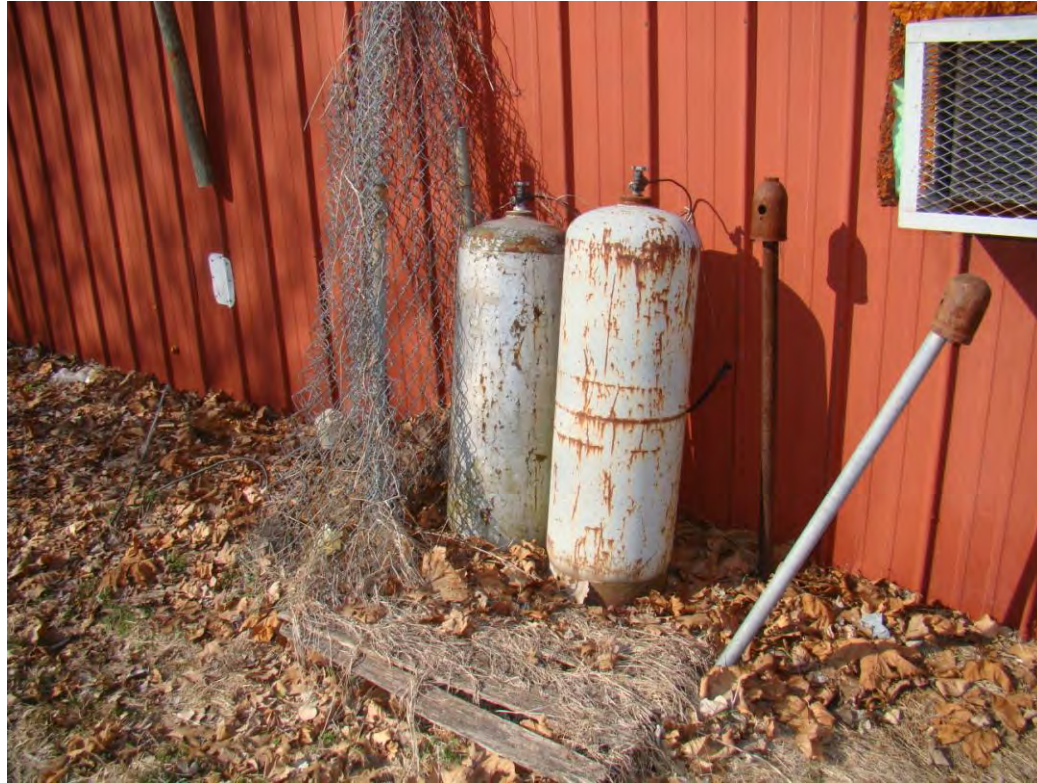
2 LP tanks with no labeling or markings

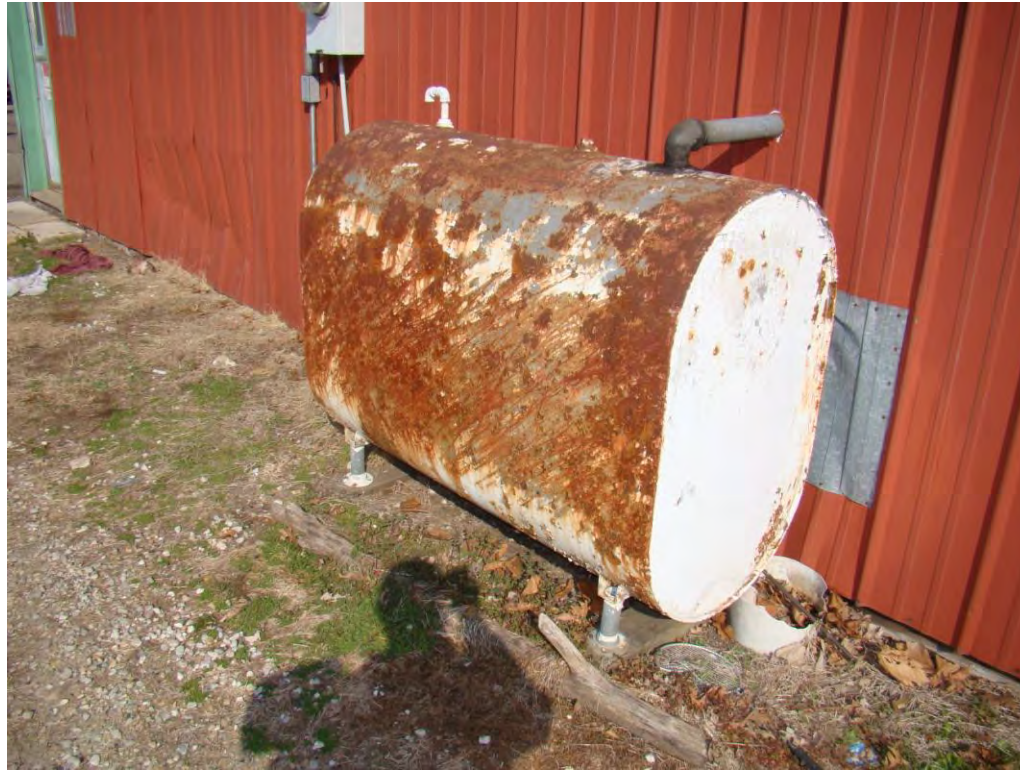
Waste Oil that has no marking or labeling and no containment

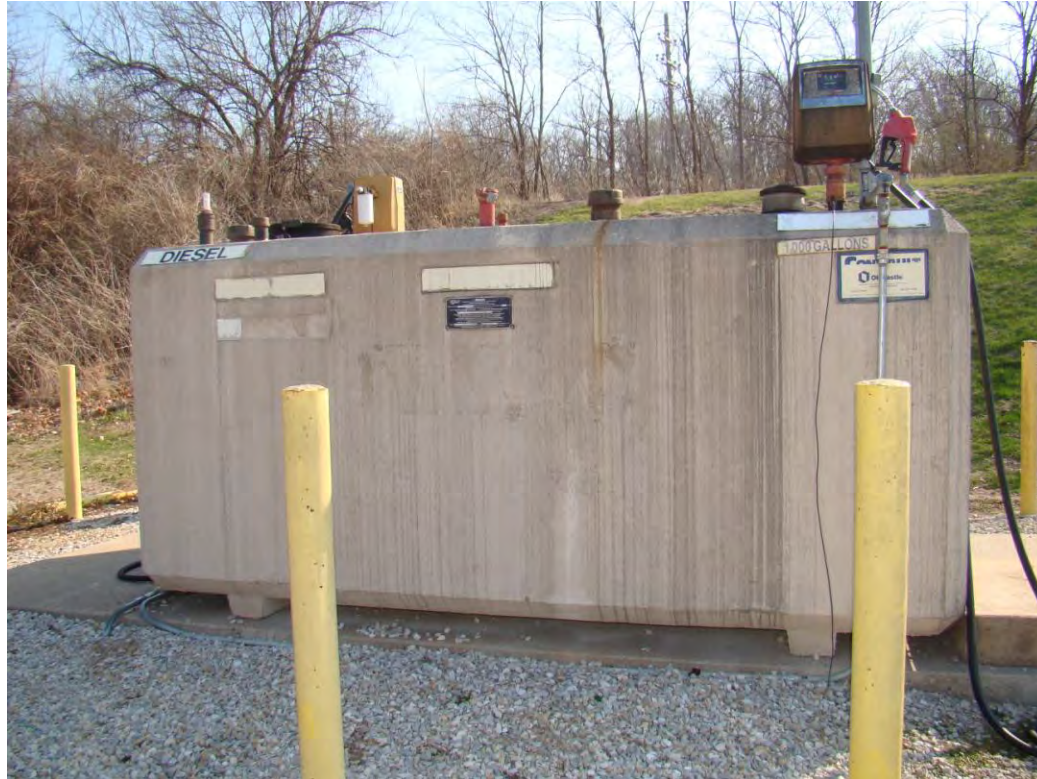
Double walled Gasoline and Diesel Fuel above ground storage tanks have missing labeling or markings.

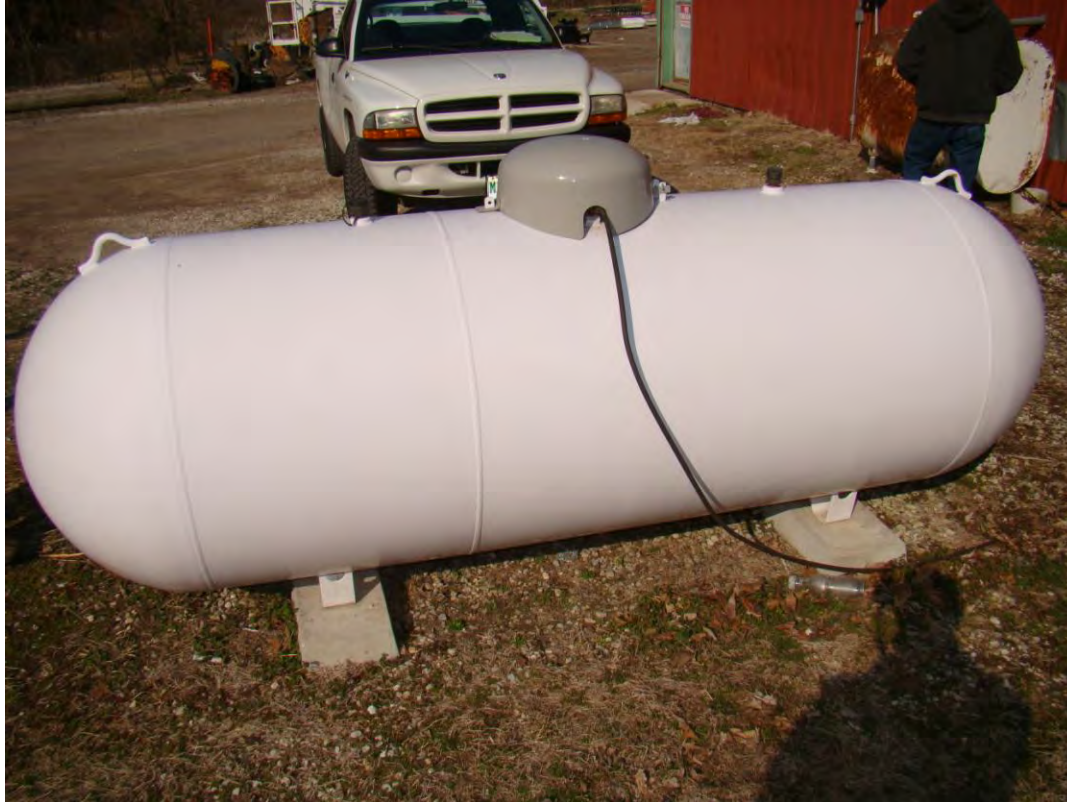
Unmarked LP above ground tank

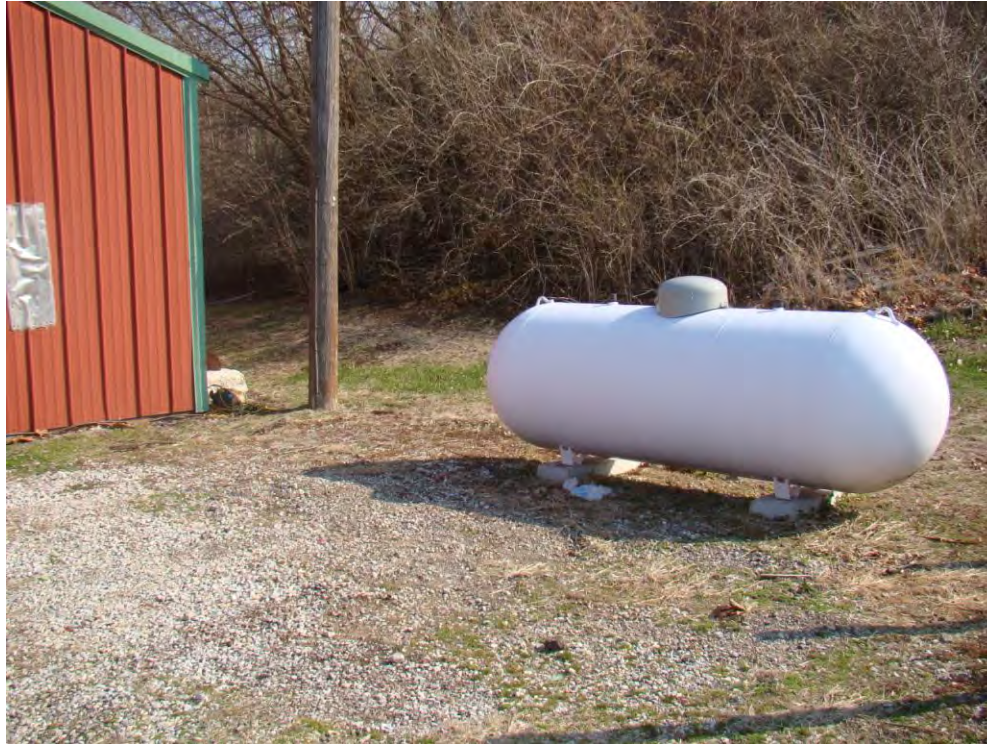
LP tank has 40 foot of copper line unprotected on the ground into building

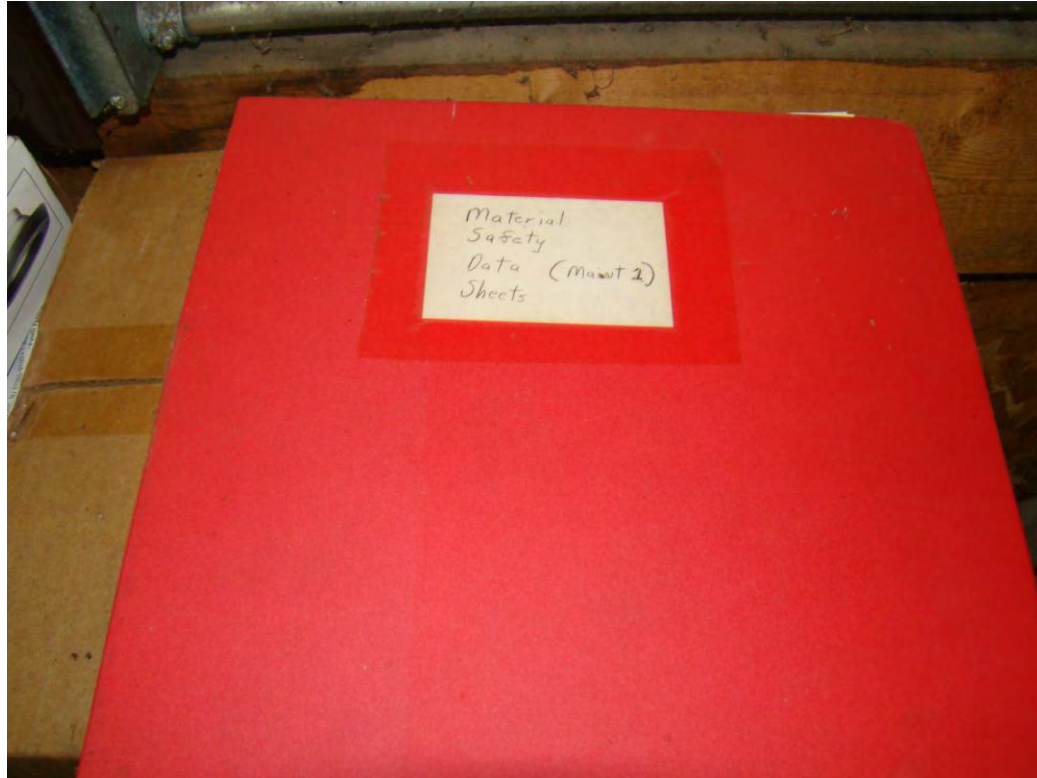
MSDS Book Out dated and not organized properly

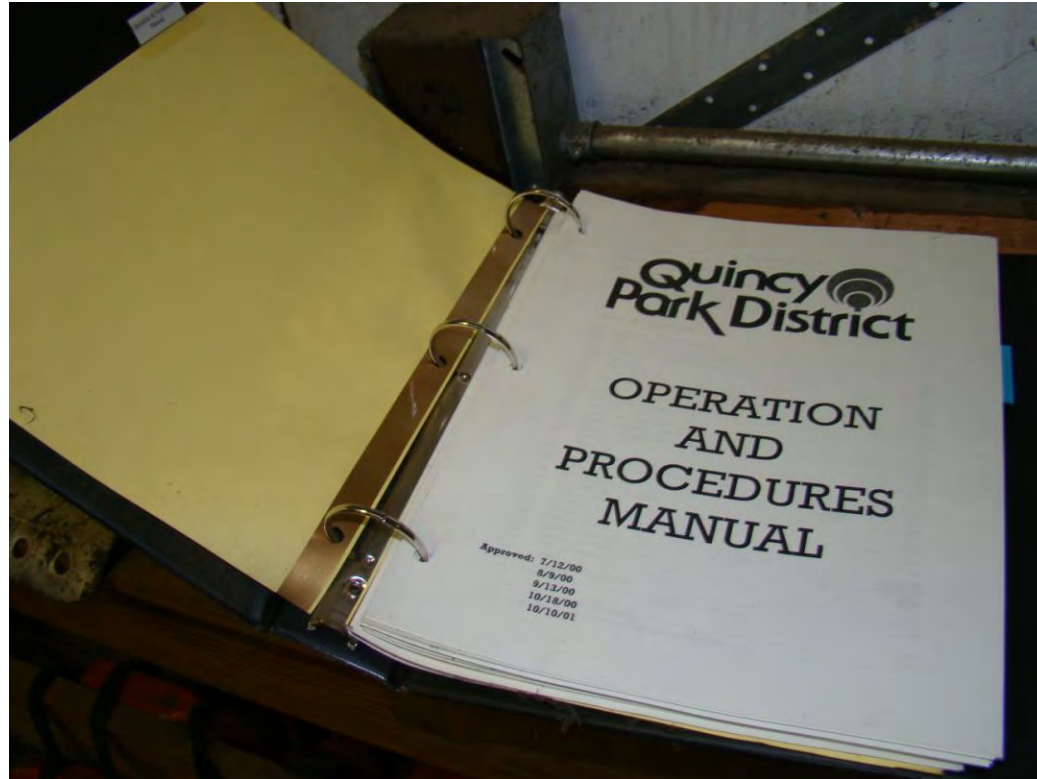
Safety Manual outdated should be reviewed annually

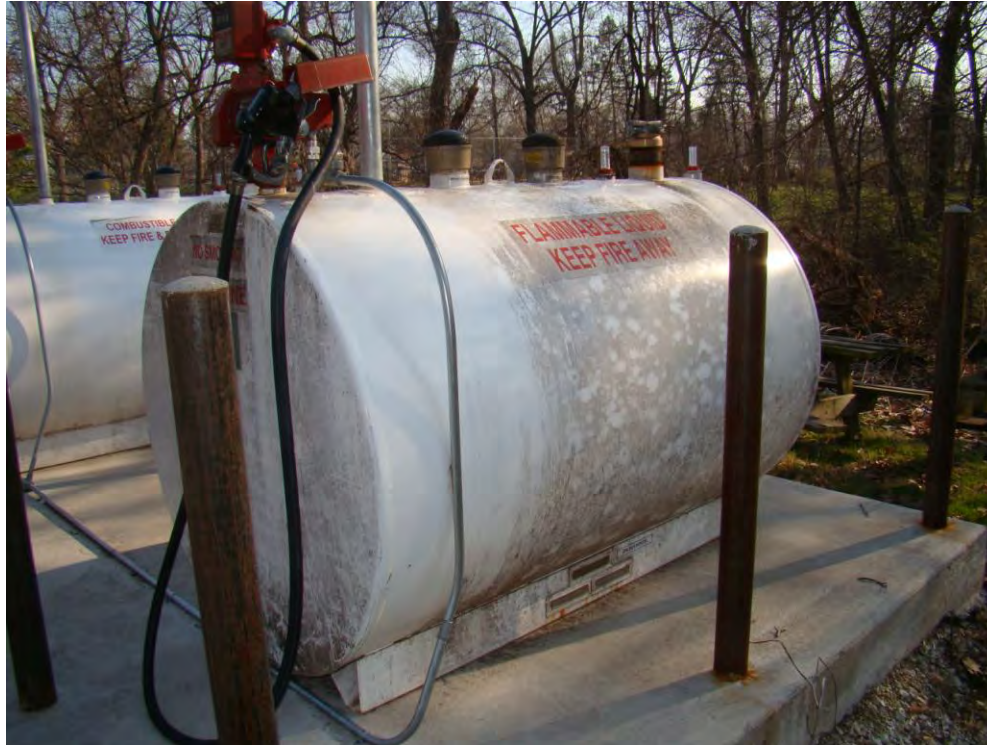
NFPA label missing on New Gasoline Fuel Above ground tank
