Appendix A: Community Input

Focus Group Summary Report

Quincy Park District ***Quincy, Illinois***

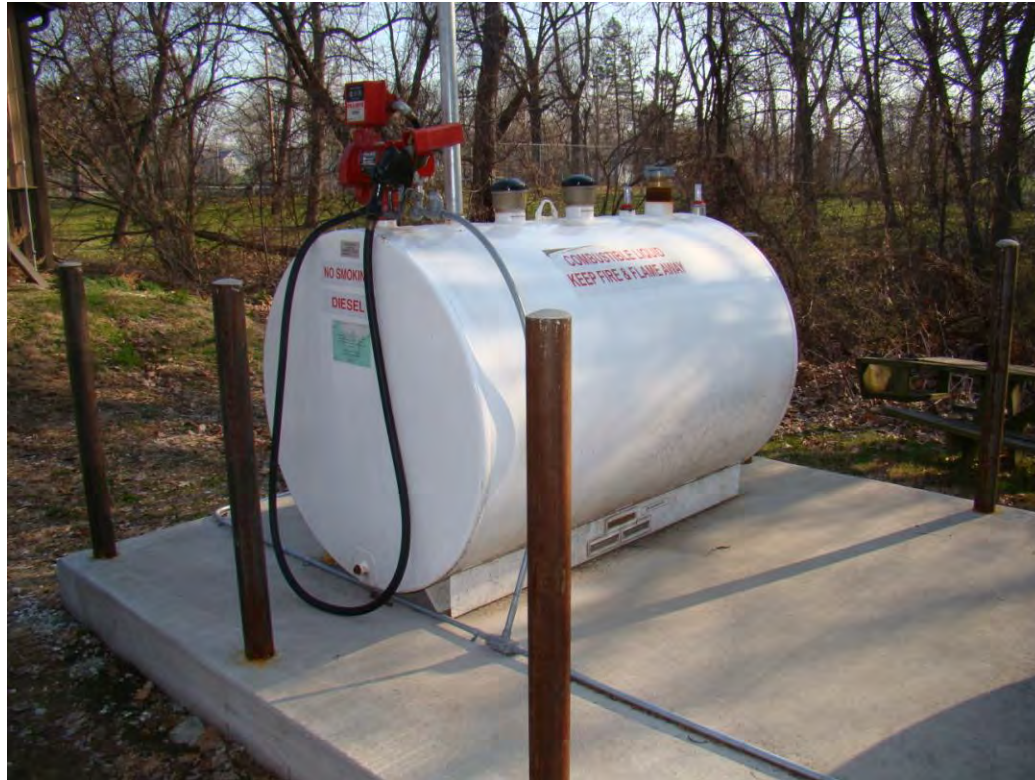
NFPA label missing on New Diesel Fuel above ground tank

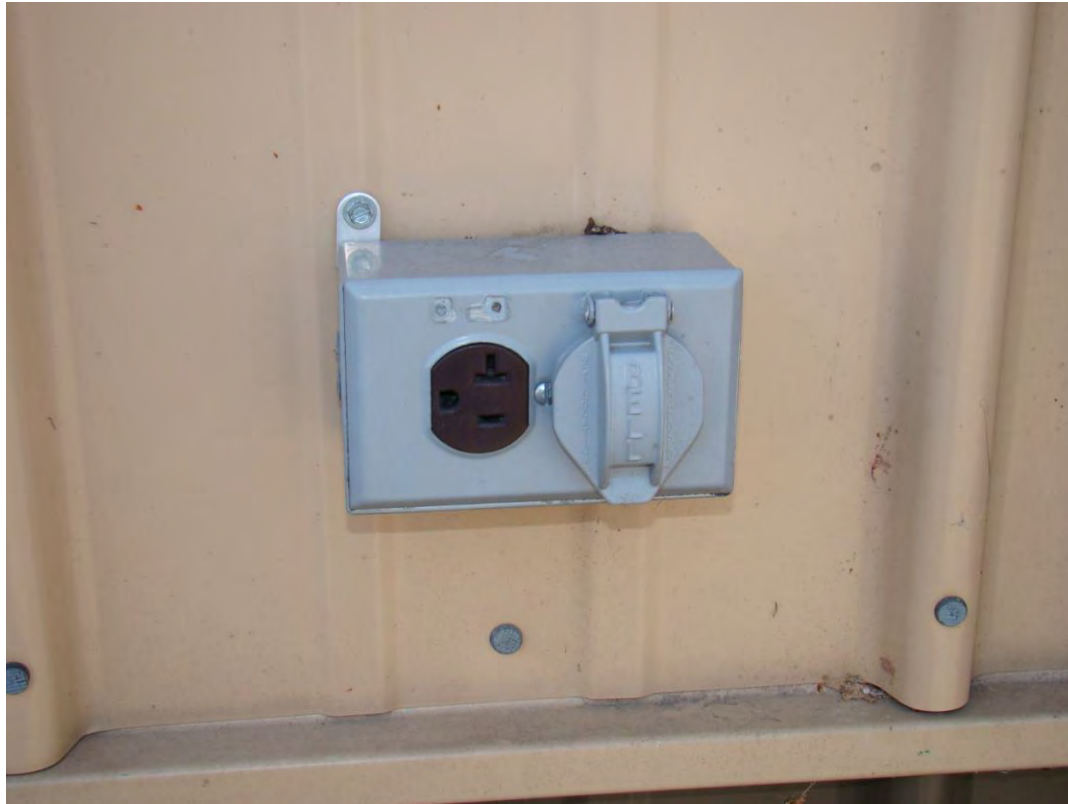
Outlet covers missing around the outside of the building

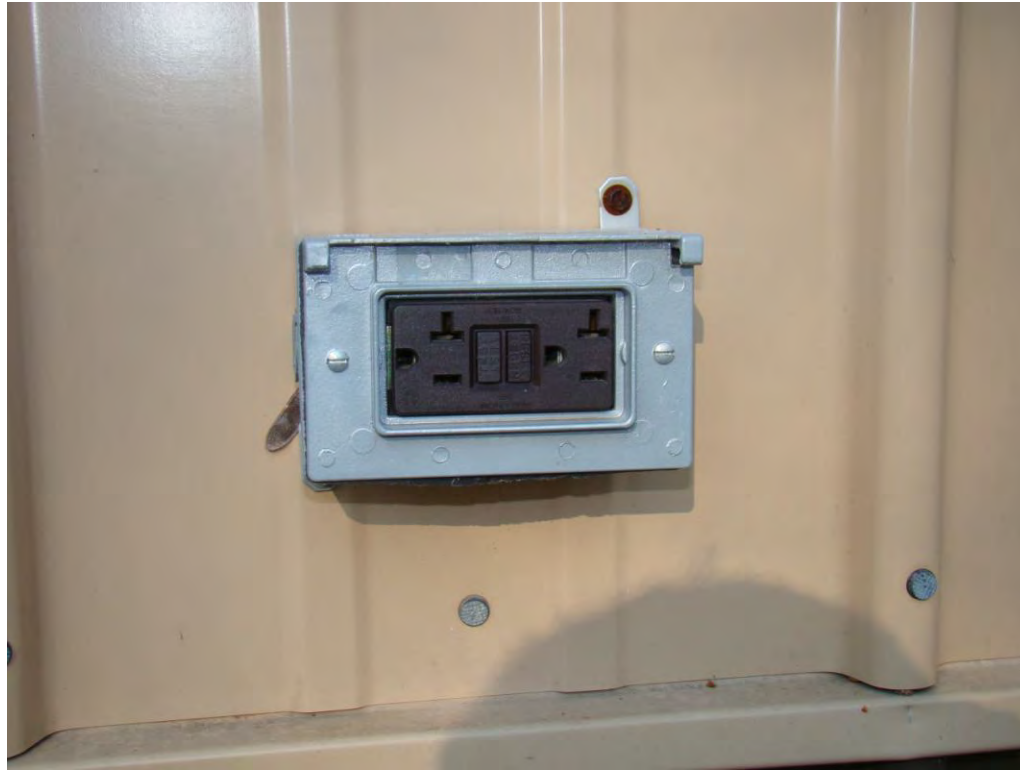
Outside electrical outlet missing cover

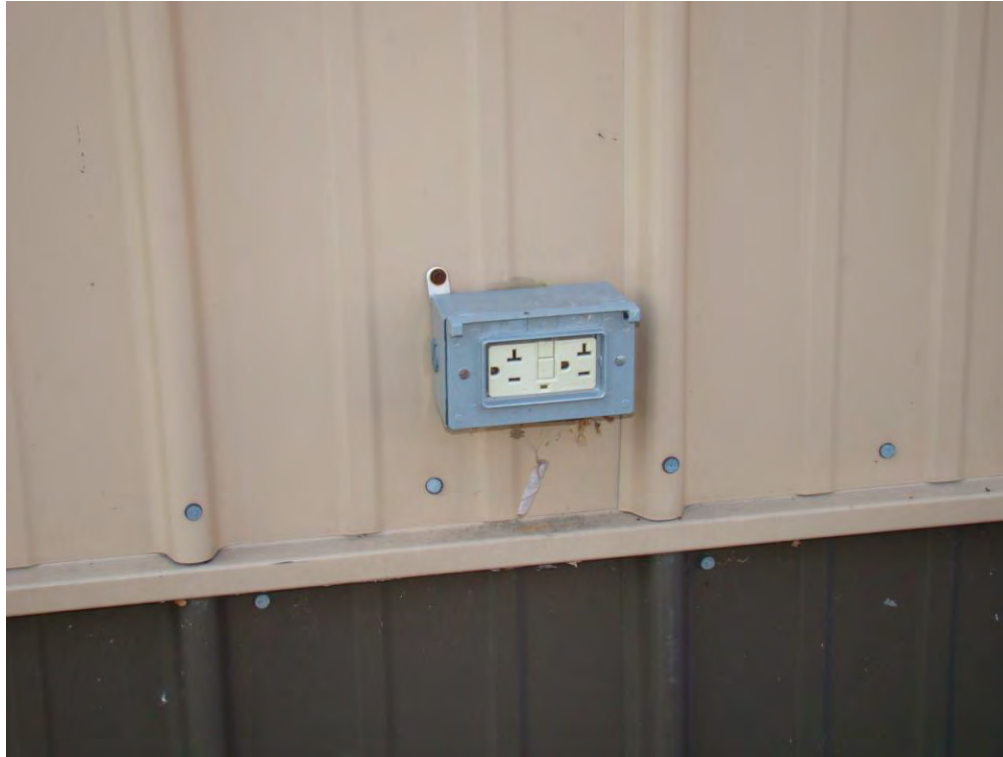
Outside electrical outlet missing cover

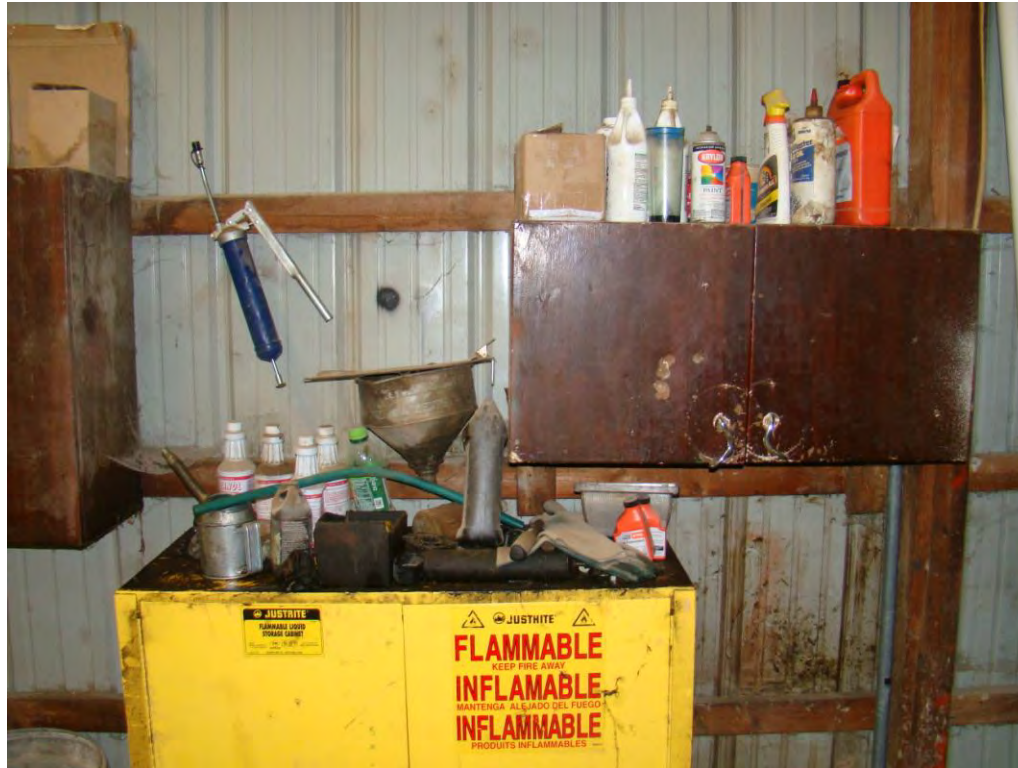
Chemical not stored in flammable cabinets

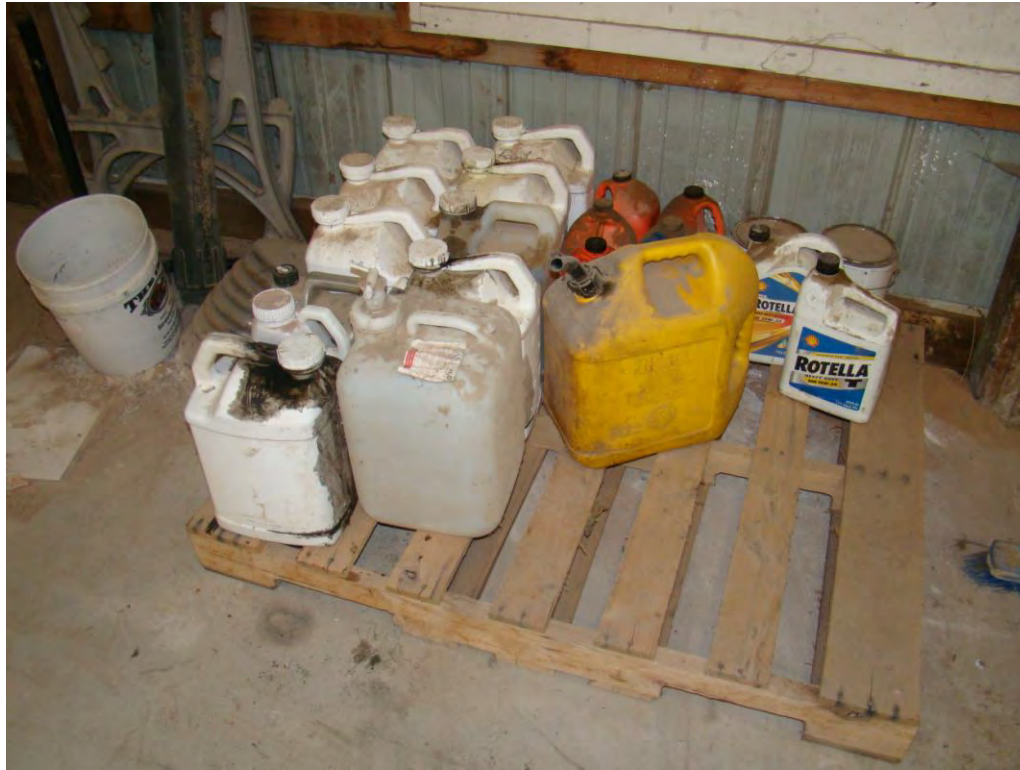
Unmarked plastic container of chemicals and storage of containers

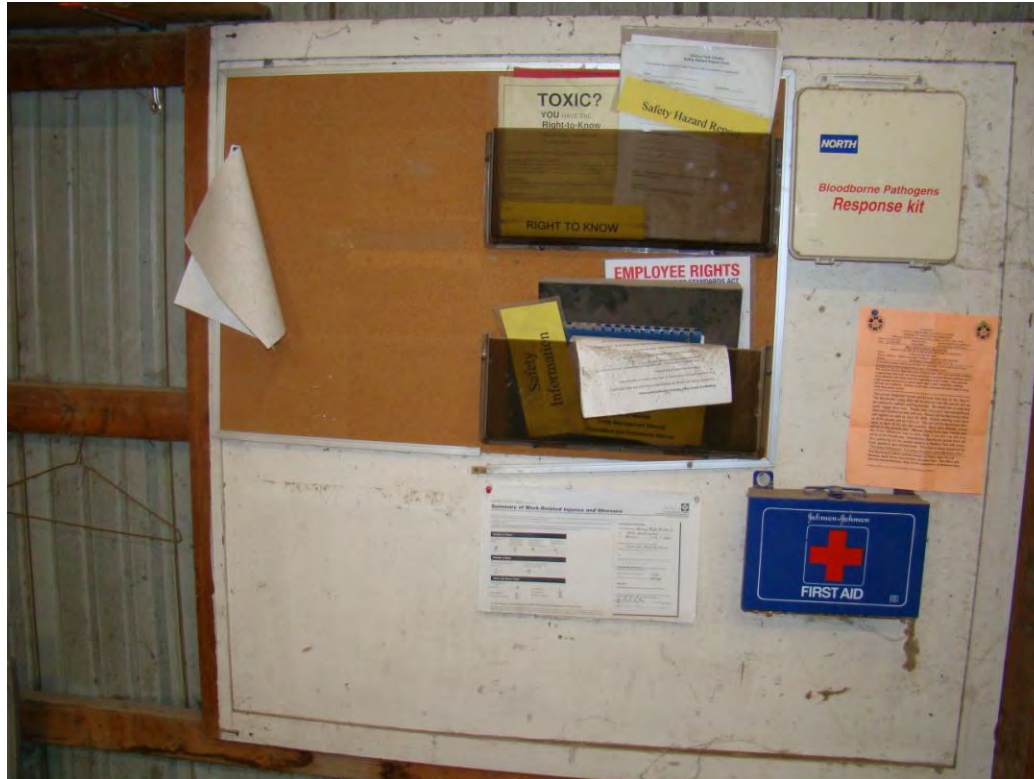
MSDS Book out dated and not organized properly
OSHA Standard 1910.1200 Hazard Communication

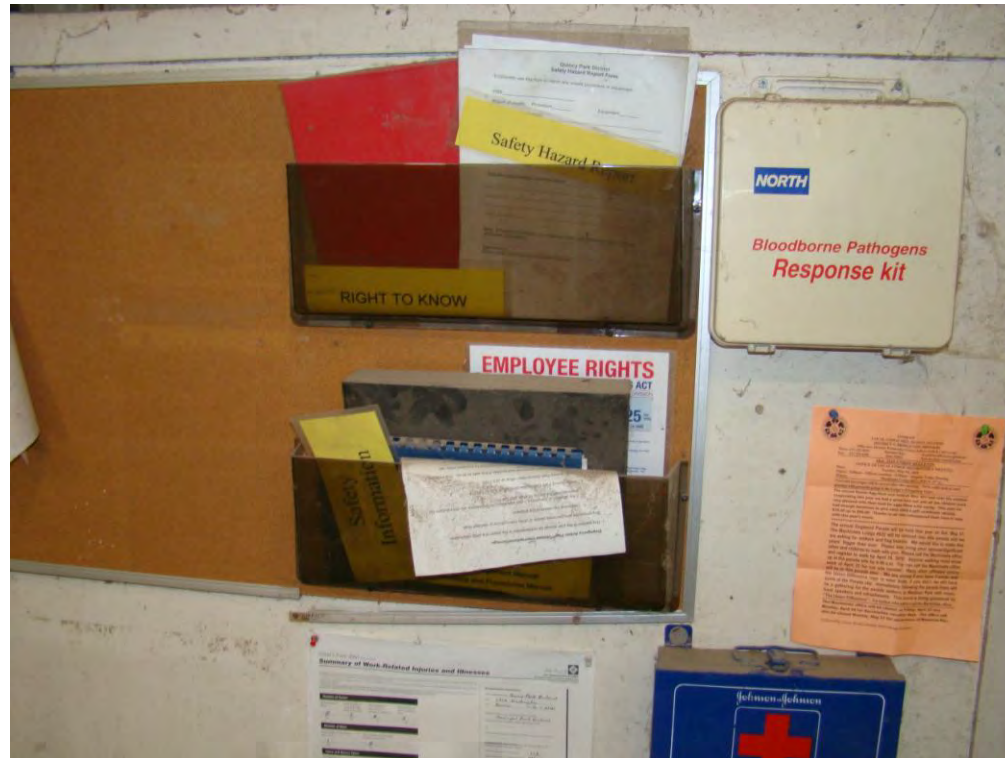
Safety Manual outdated should be reviewed annually

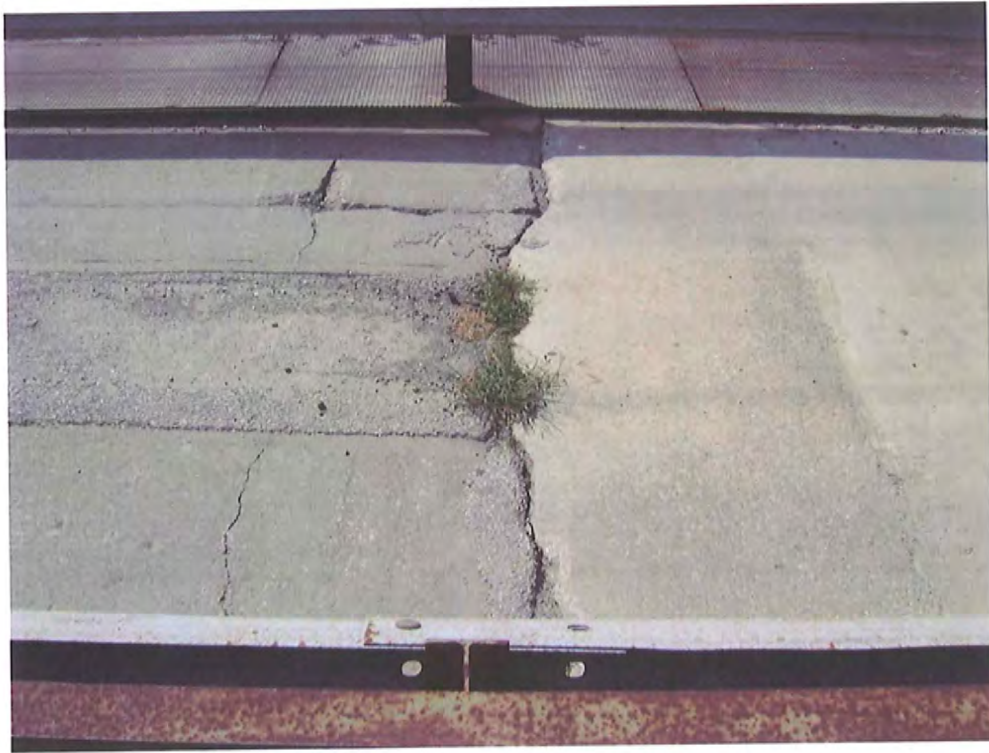
Photo No. 17
Looking south at west abutment joint above stone arch.

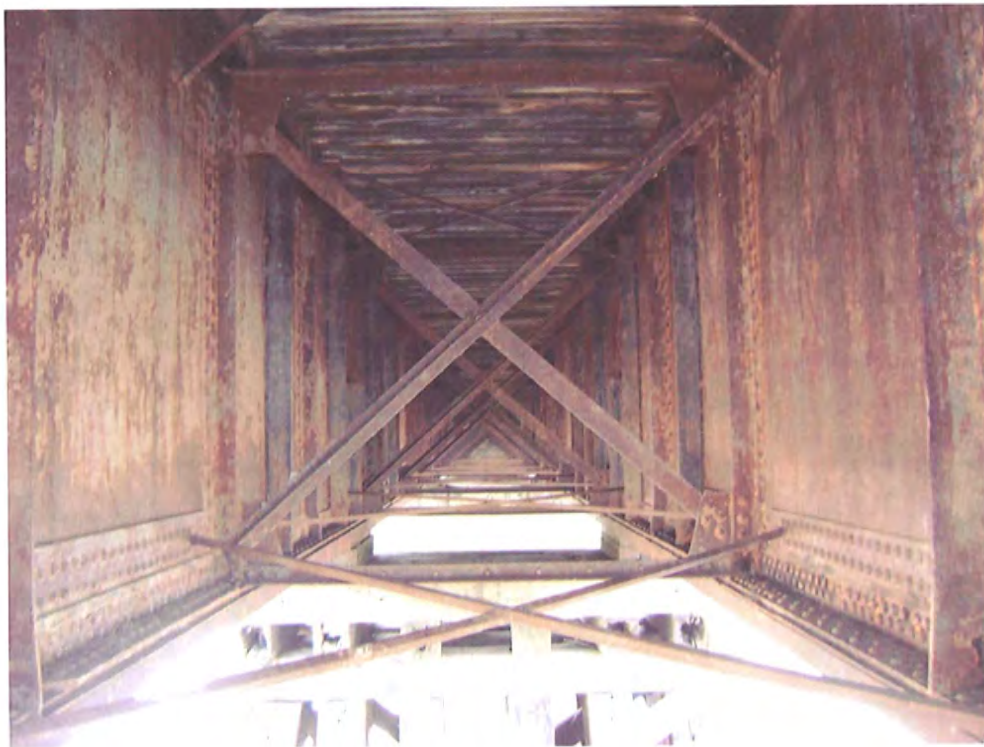
Photo No. 54
Looking west through girders, span 4.

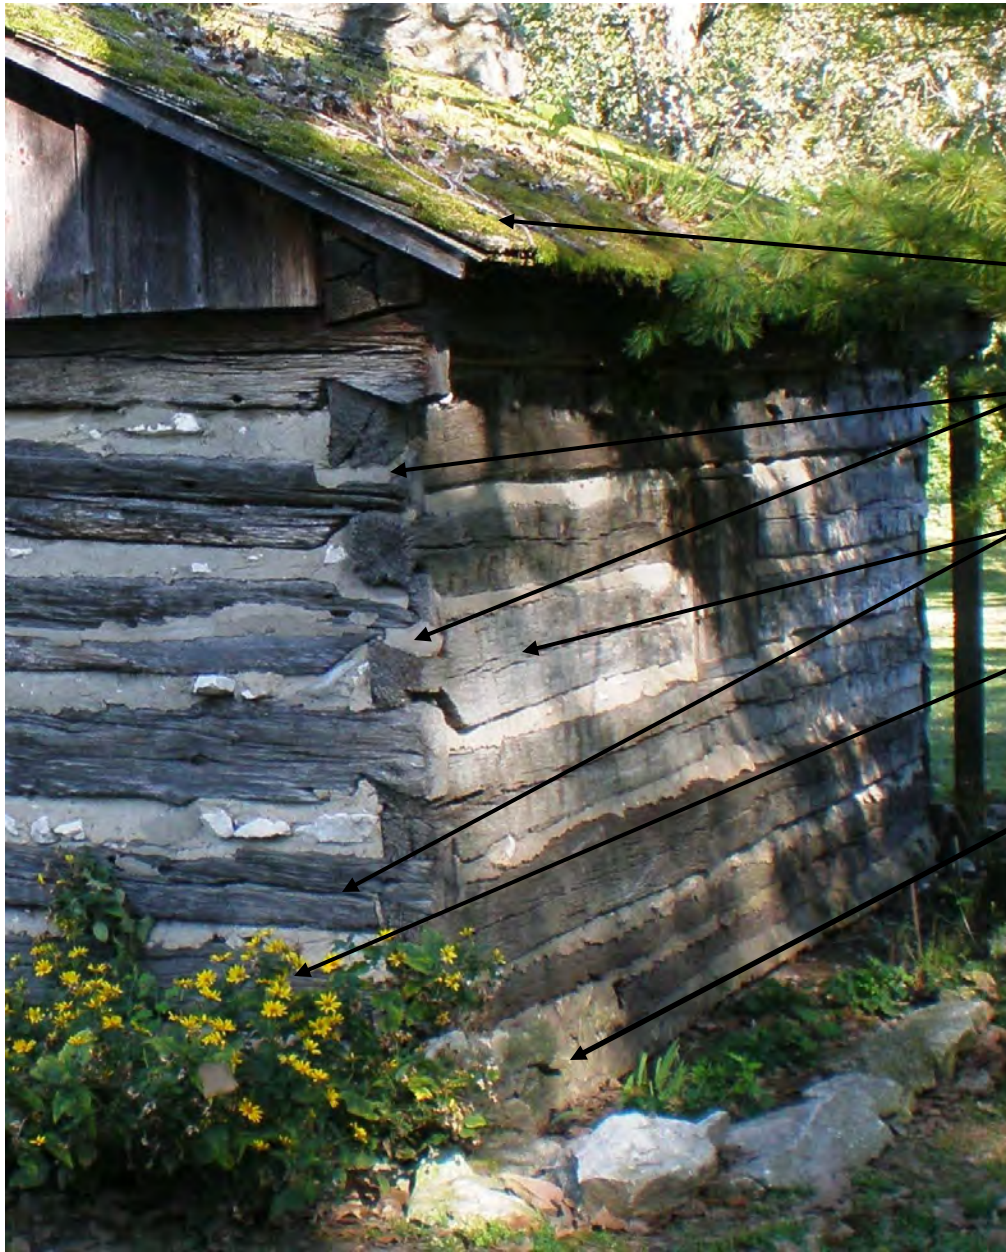
Figure 2. D.A. Hull Cabin.

This Hull cabin is overall in fair condition in that it is unlikely to collapse any time soon although it does need attention within 2-4 years to ensure that deterioration does not accelerate. The tables that follow provide more detail on the overall state of the cabin.

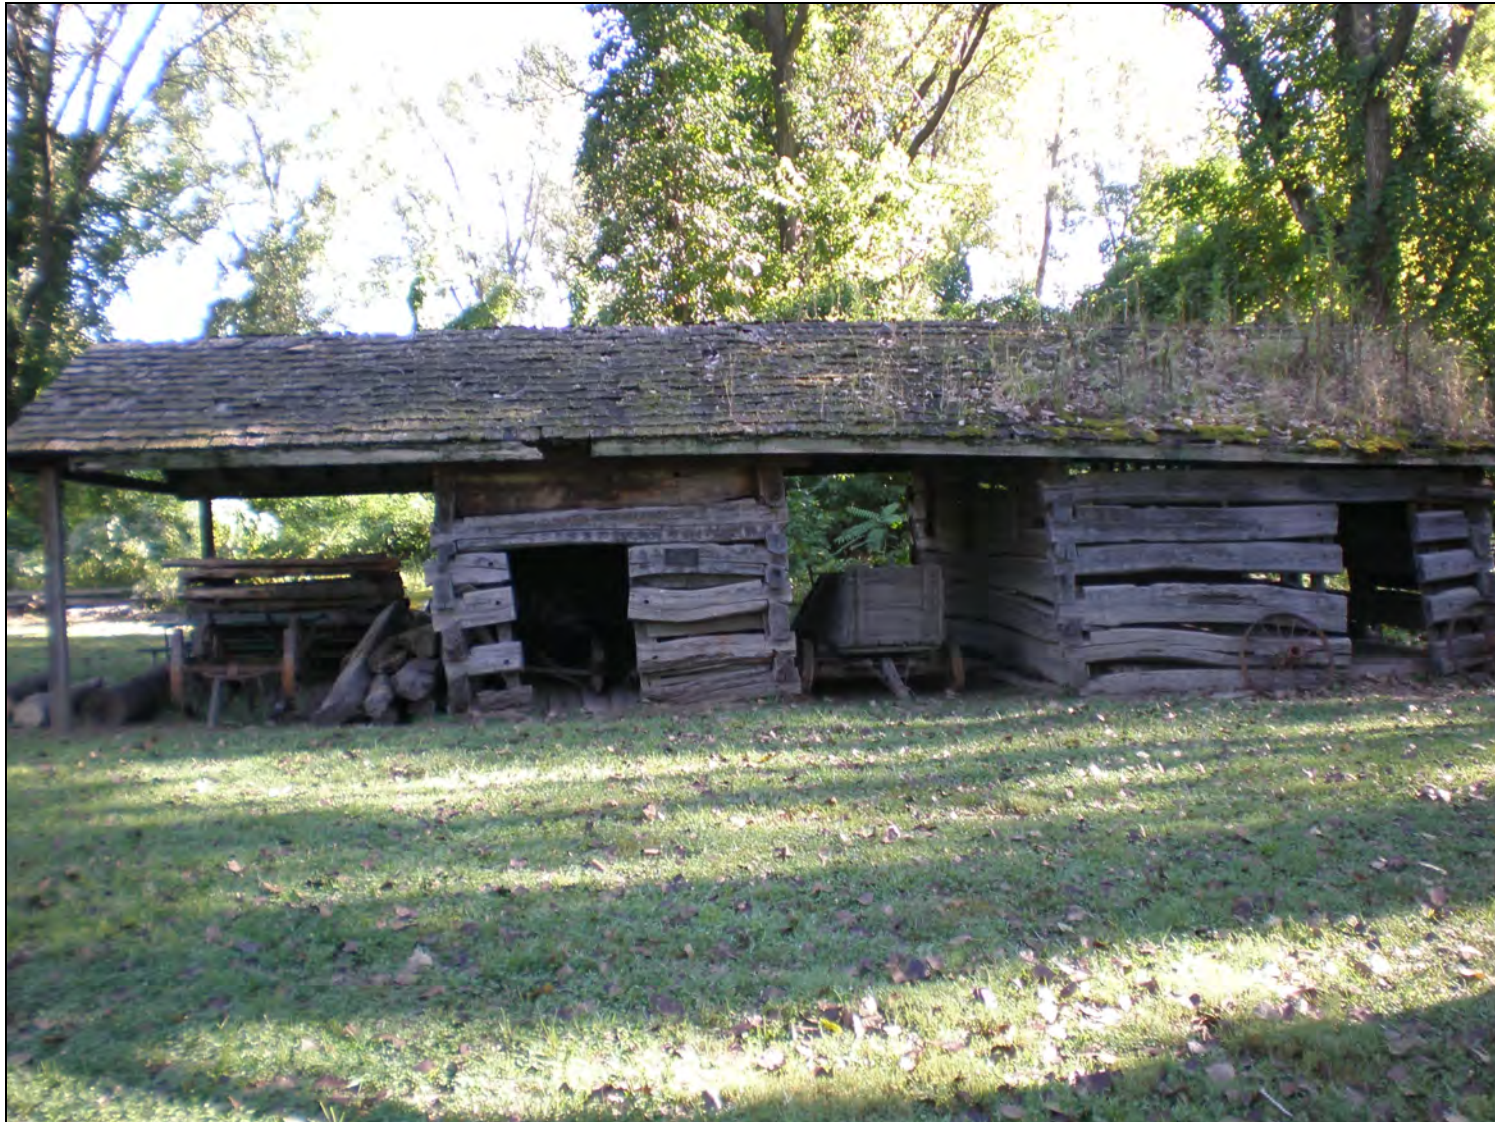
Figure 10. Corn Crib. This image shows the 2 pens as they lean to the north. The roof has exceeded its useful life, and two pens contain material that should be disposed of appropriately.

The corn crib has been used as a storage location for both historic artifacts and fencing materials. The contents of the cabins need to be examined, assessed, determined it is important for the history of Quincy and donated to whoever can best manage these historic items. These are not items that will lessen the burden of managing the cabins in the village unless they can be converted into cash or good will. There is also considerable debris around the cabin. This should be cleared away and all materials that has been placed along side of, or under the gable taken to the dump, burned or given away. The building is heavily shaded and to the extent possible the surrounding brush and overhanging limbs pruned back. Sun-light and air will help keep the repaired/restored corn crib in better condition.

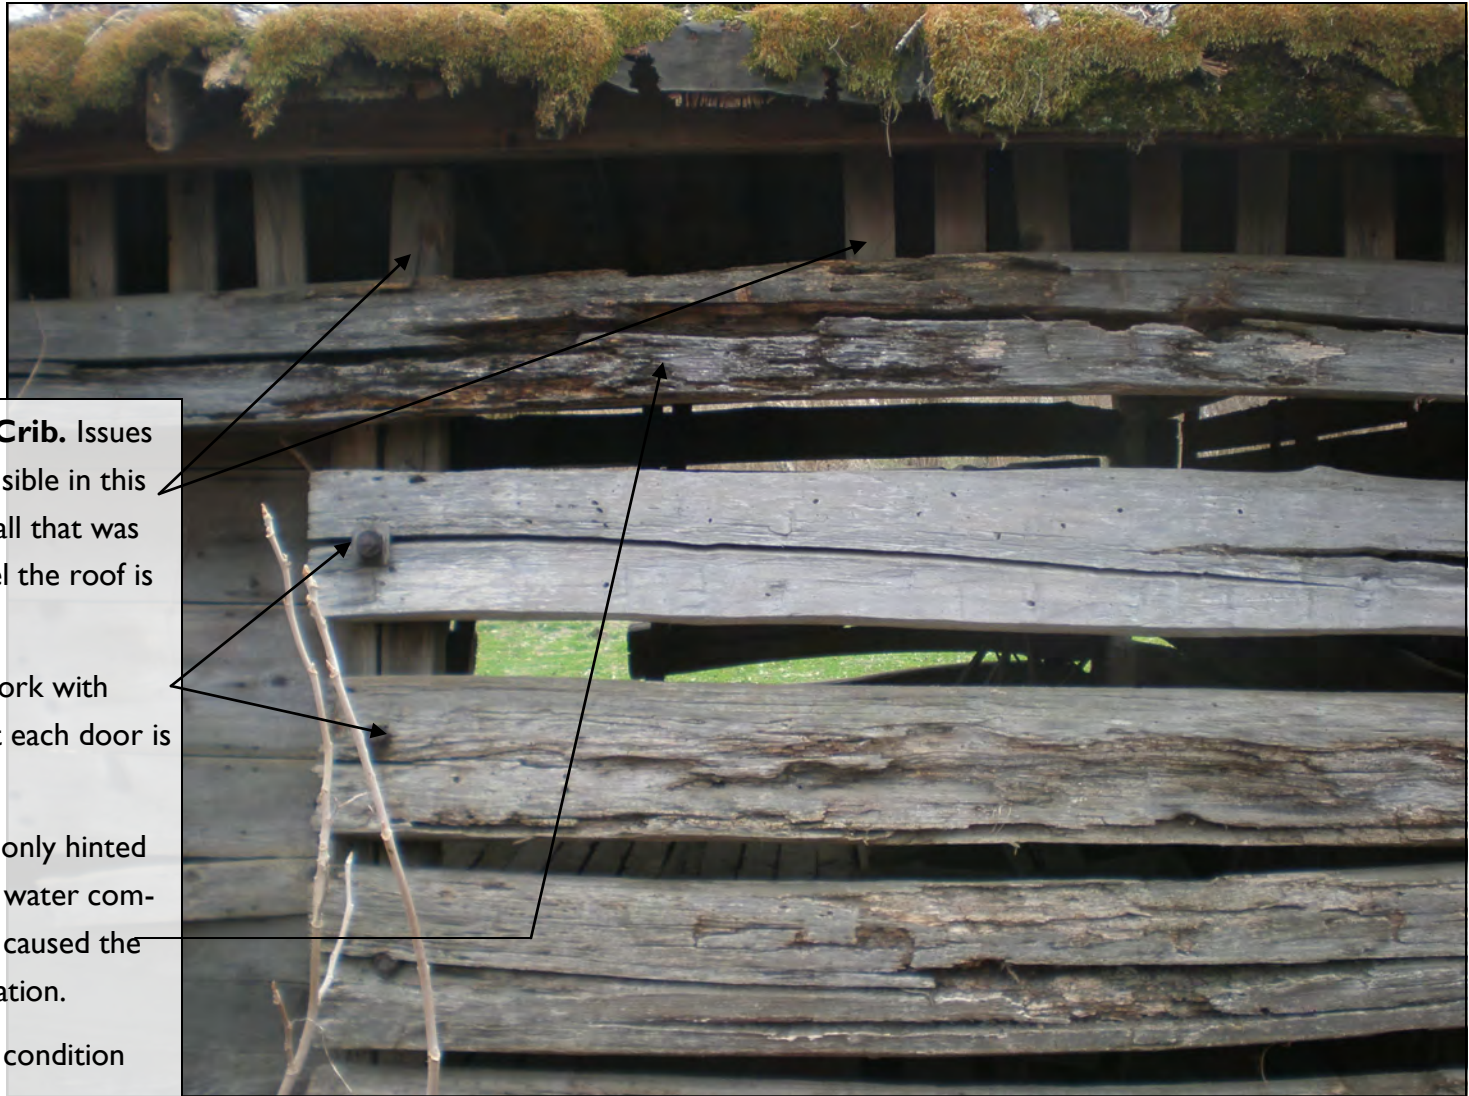
Figure 12. Corn Crib. Issues with the roof are visible in this image. The pony wall that was constructed to level the roof is visible here.

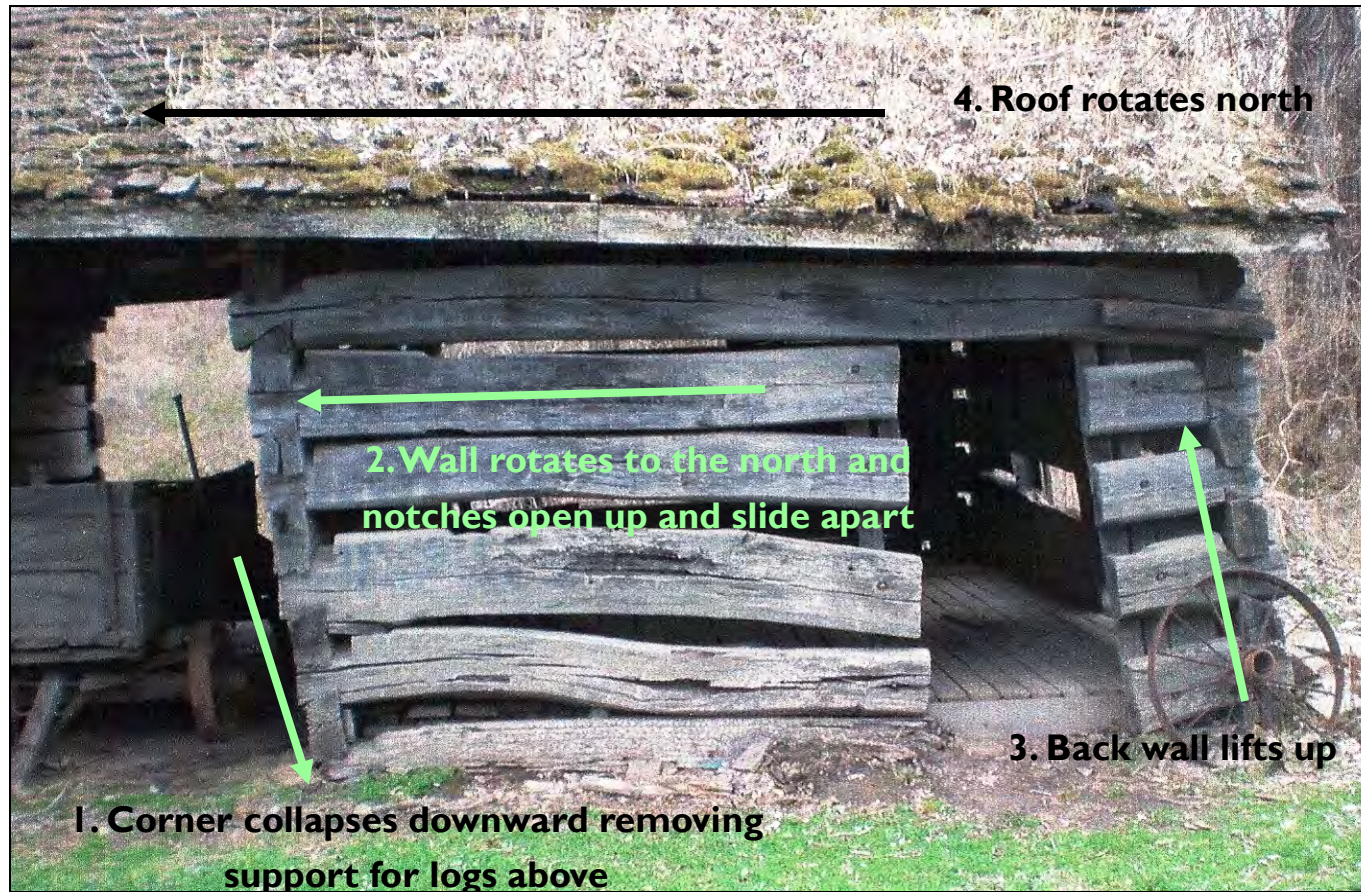
Figure 13. Corn Crib. As the sill log decays and no longer supports the logs above it, the building starts to pull itself apart.

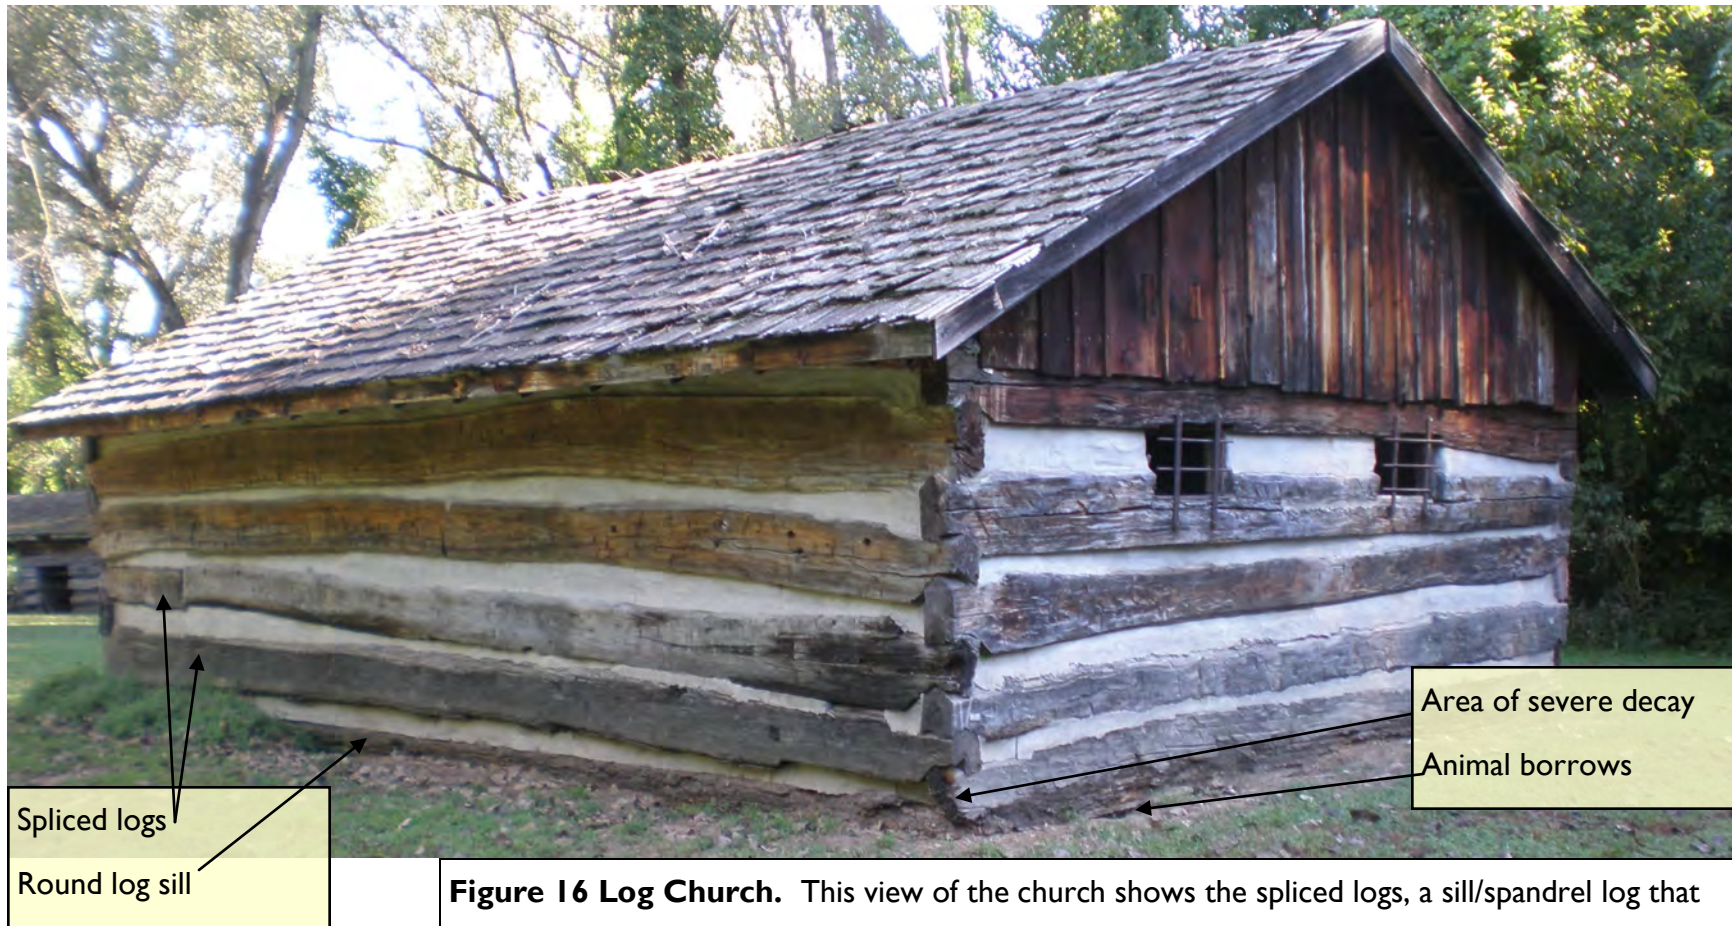
Figure 16 Log Church. This view of the church shows the spliced logs, a sill/spandrel log that is not hewn, and animal access points along the building's perimeter.

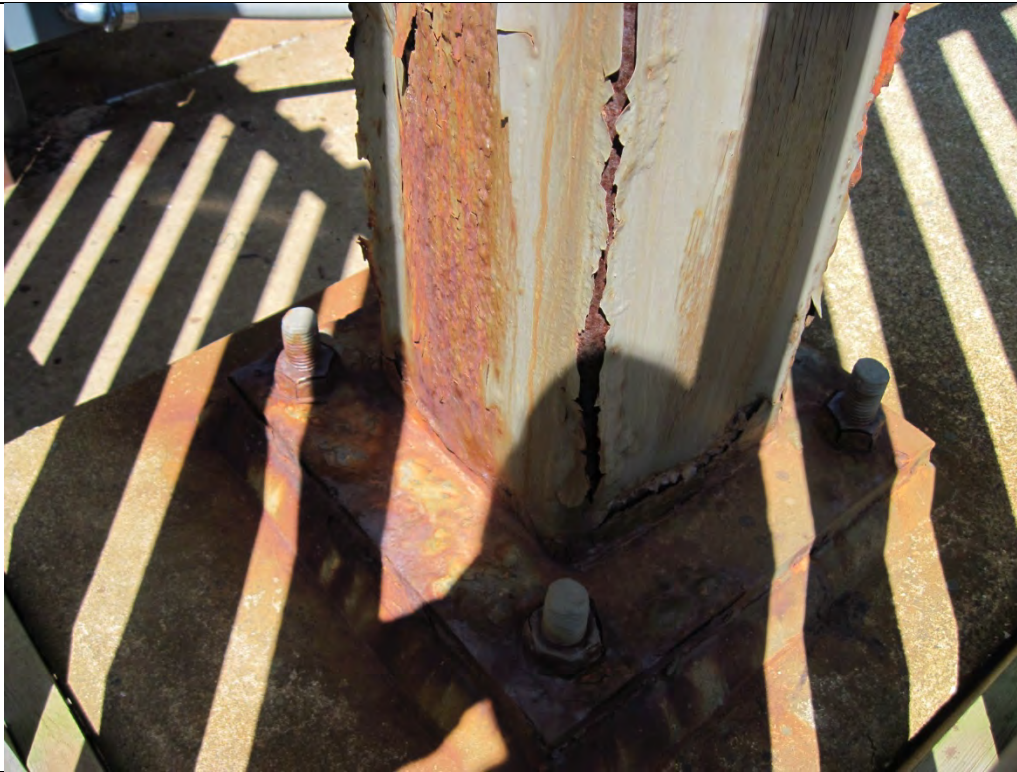
Support Deterioration

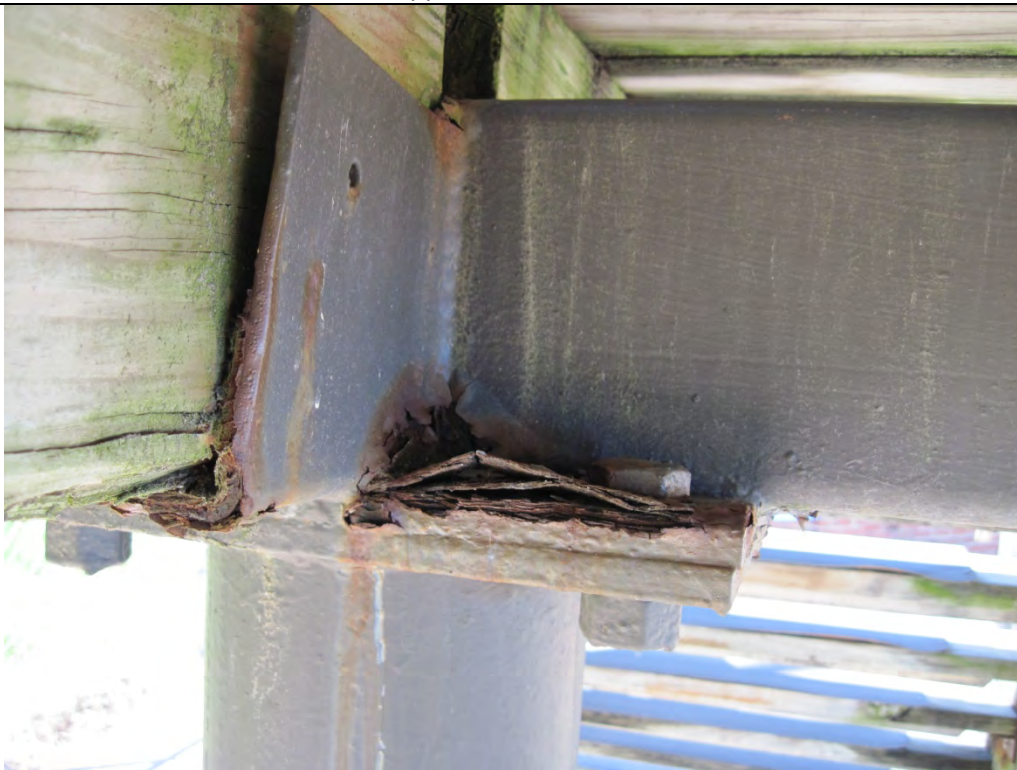
Step Support Deterioratoin

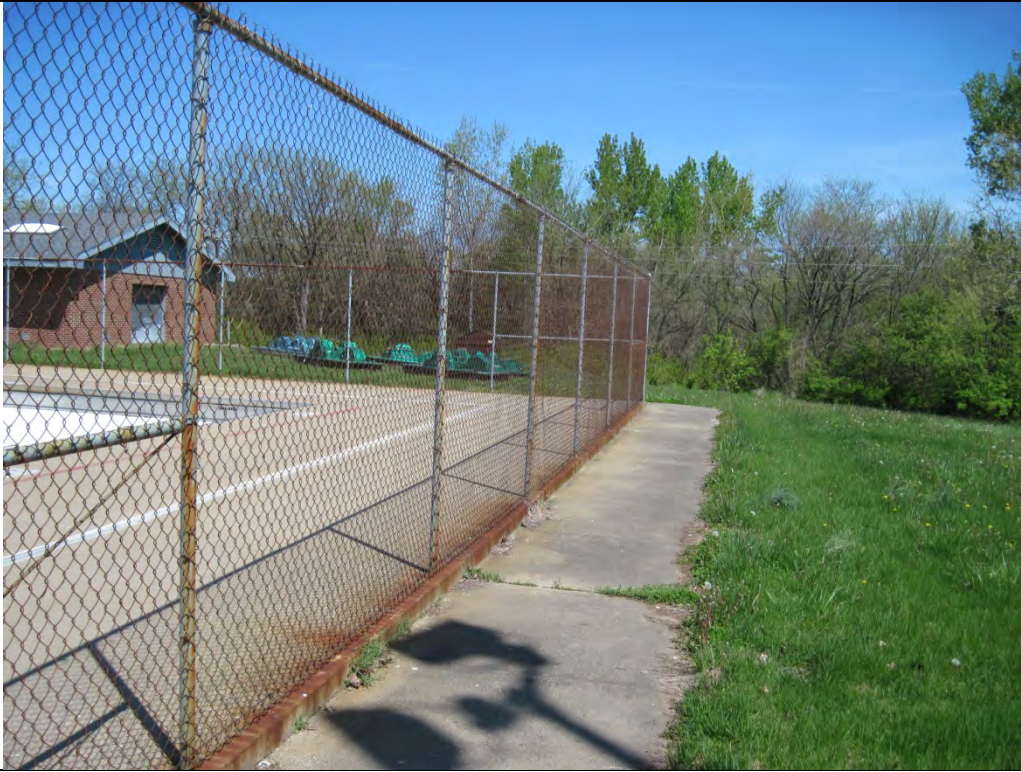
Fence Rusting

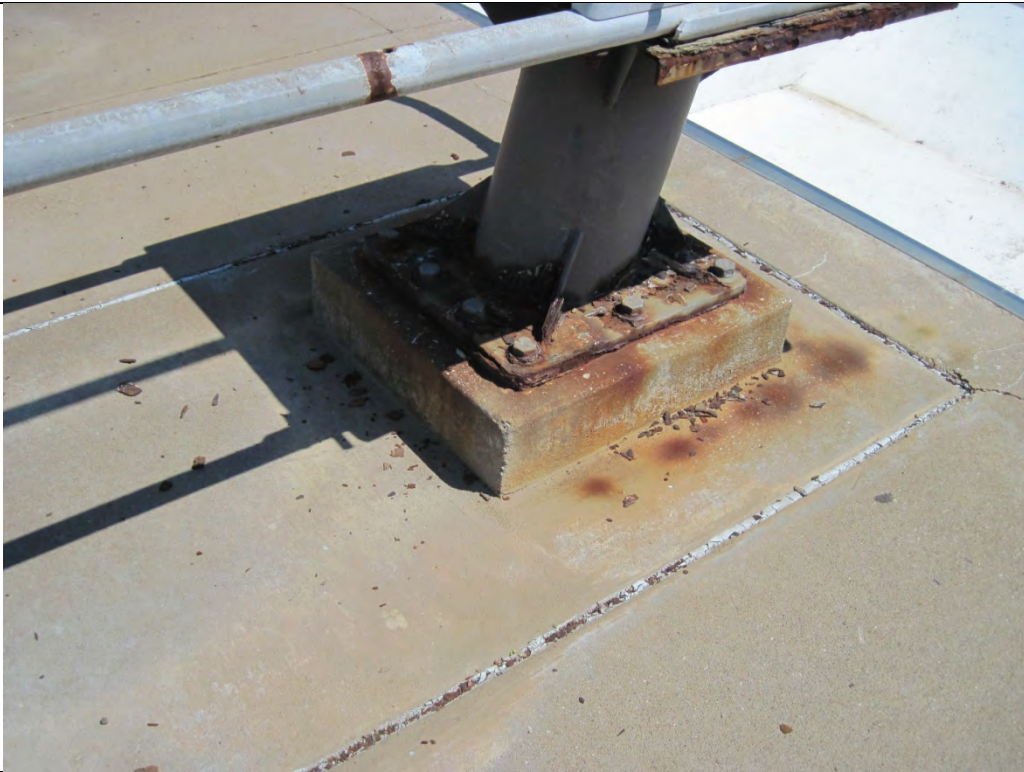
The diving board supports are badly rusted and may need replaced in the next 5 years.

Diving Board Support Rusting
