Quincy North Bay Bridge Inspection

Inspection Dates: October 7, 8, 2014

QUINCY NORTH BAY BRIDGE INSPECTION, QUINCY, IL
REPORT TO: KLINGNER & ASSOCIATES
INSPECTION PERFORMED ON
OCTOBER 7 & 8, 2014

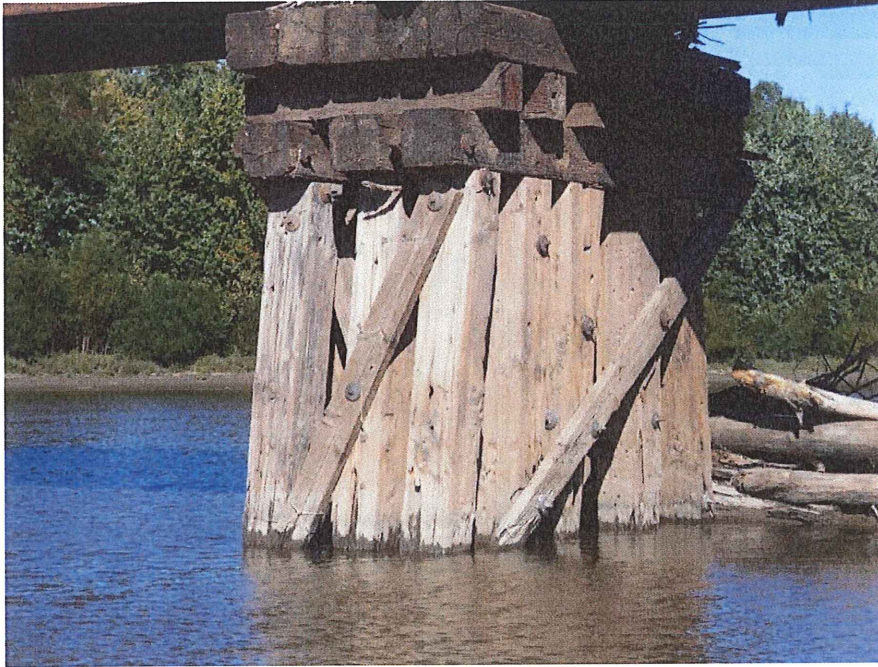
The bridge was originally built in 1898 as a railroad bridge. The bridge was built with five stone piers and two stone abutments, with four timber pile bents added later (see photos #1, #2, #3, #4). The west abutment was in the dry and therefore was not inspected. The topside conditions of the timber pile bents had already been determined to be in poor condition by Klingner & Associates and prior to the last inspection, MCDI was told not to perform a substructure inspection on them.

Photo #1: Timber Pile Bent

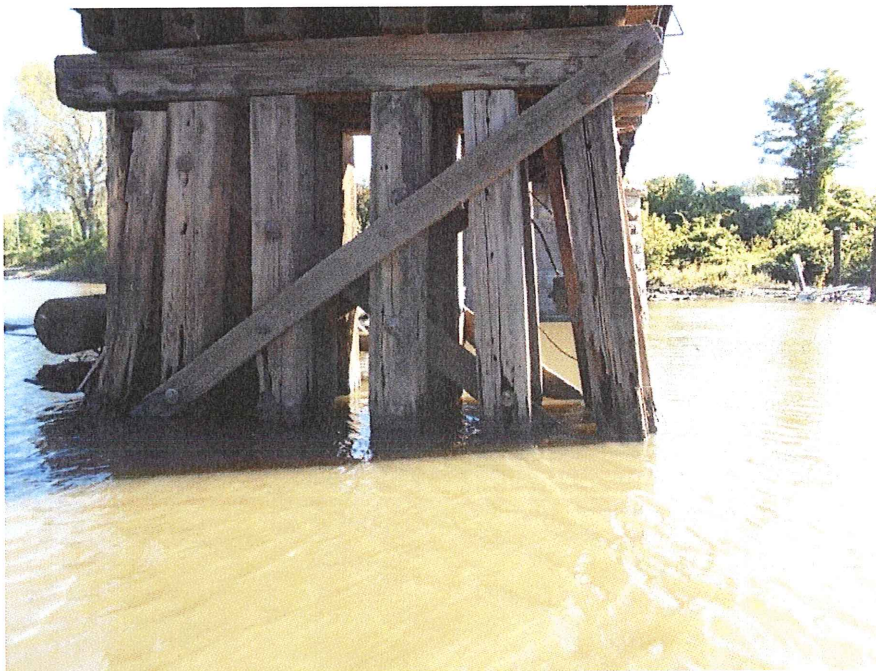
Photo #2: Timber Pile Bent

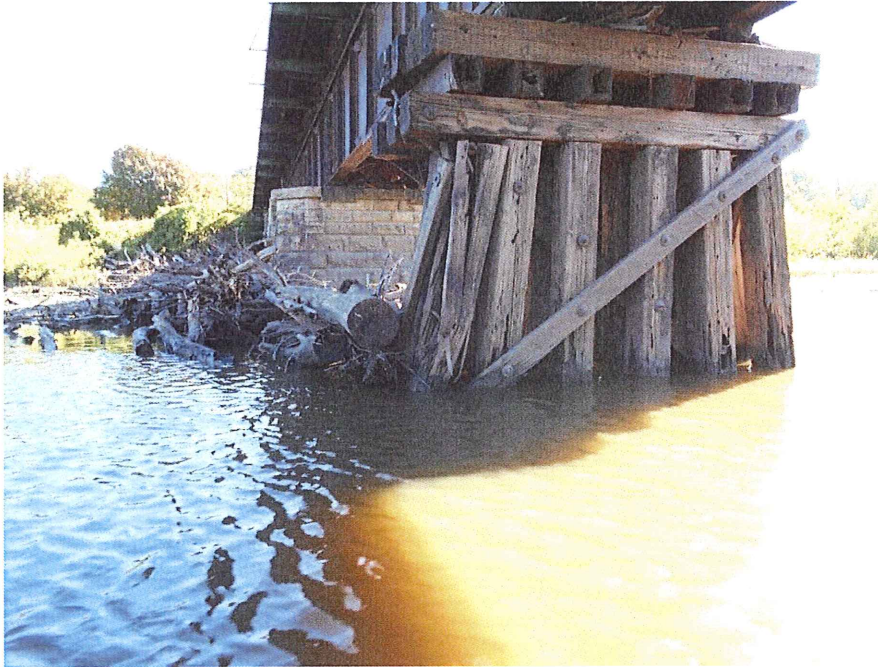
Photo #3: Timber Pile Bent/ Timber Debris Buildup

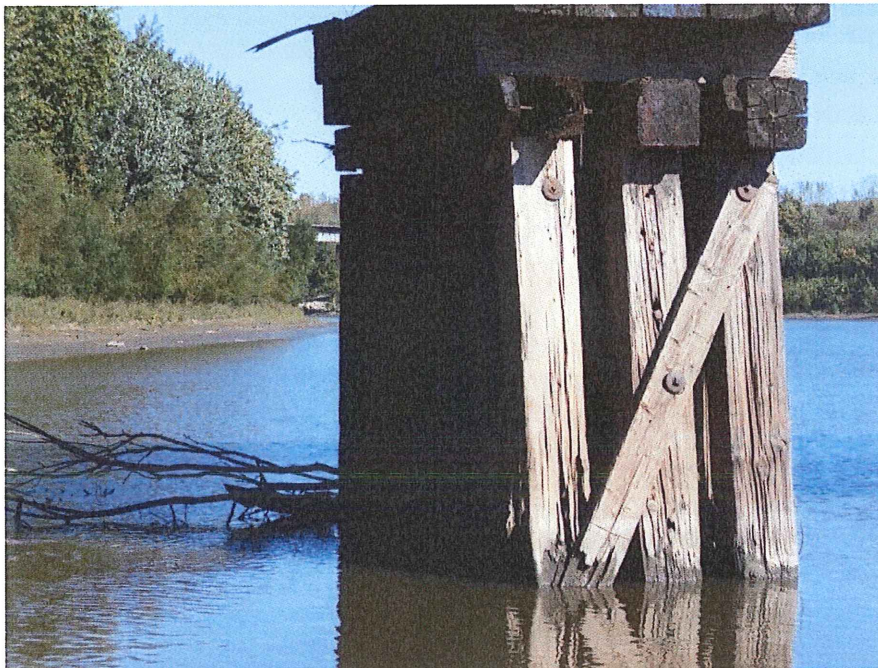
Photo #4: Timber Pile Bent

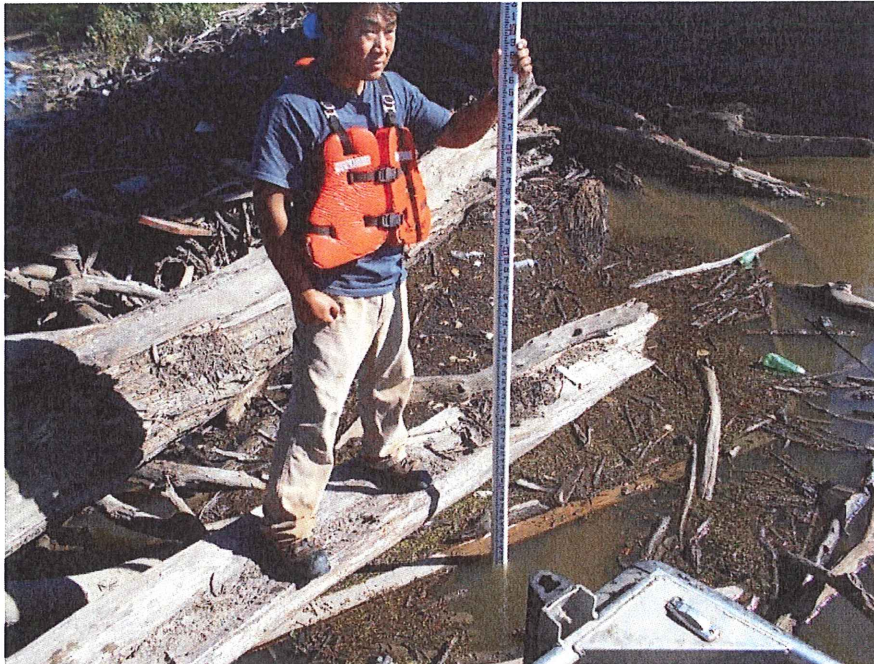
Photo #5: Timber Debris Buildup

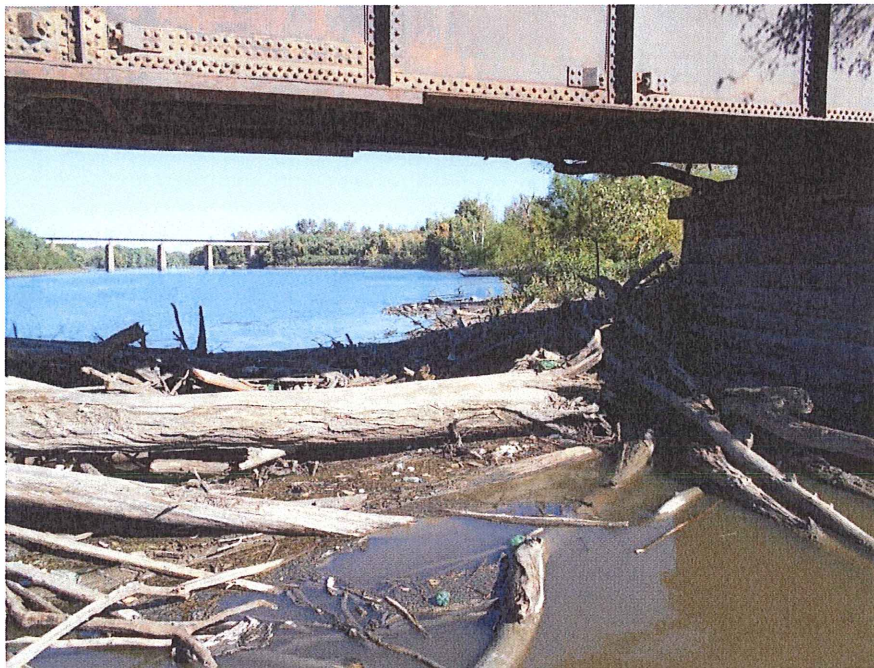
Photo #6: Timber Debris Buildup

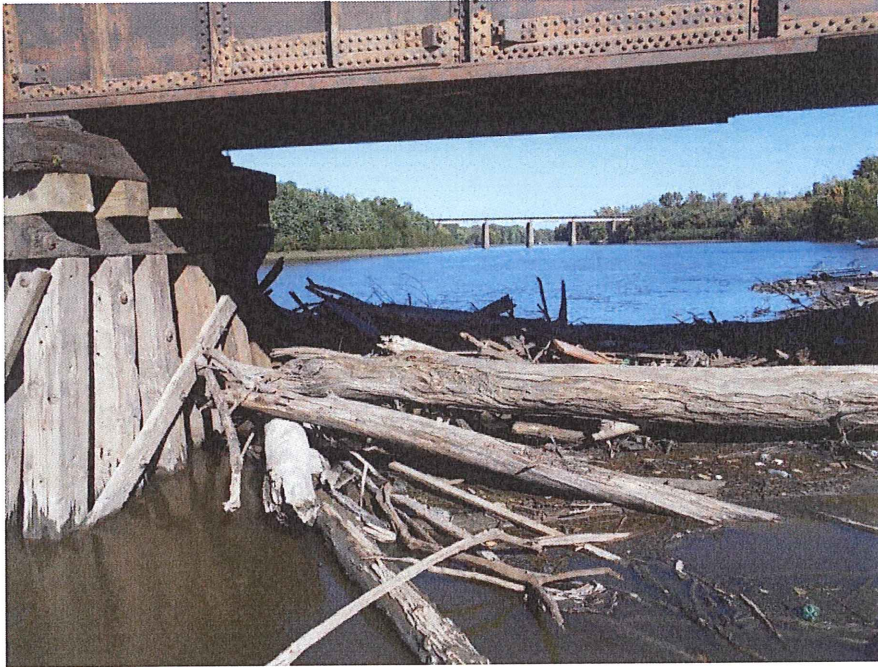
Photo #7: Timber Debris Buildup

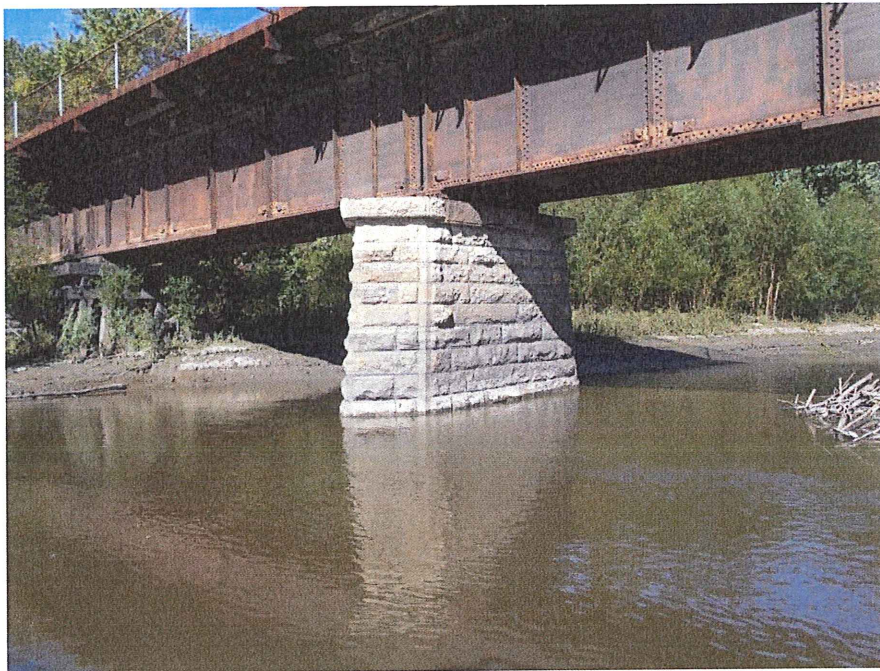
Photo #8: Pier #21

At the time of the inspection, Pier 21 was in 3' to 8' of water. The diver began the inspection on the west face of the pier. There was 3' of water along the edge of the pier. The diver inspected all of the underwater horizontal and vertical joints, looked for cracked or missing blocks, and attempted to locate a footing. No cracked or missing blocks were observed and the mortar appeared to be in good condition with very little mortar missing.

The diver used a 4' probe to probe around the base of the pier to try to locate a footing. The diver was able to probe around the west side of the pier without hitting anything solid. However, on the east side of the pier he reported a consistent probe depth of approximately 3' to 4' alongside the pier, which was possibly a footing. The substrate was primarily a soft, sand-silt mix.

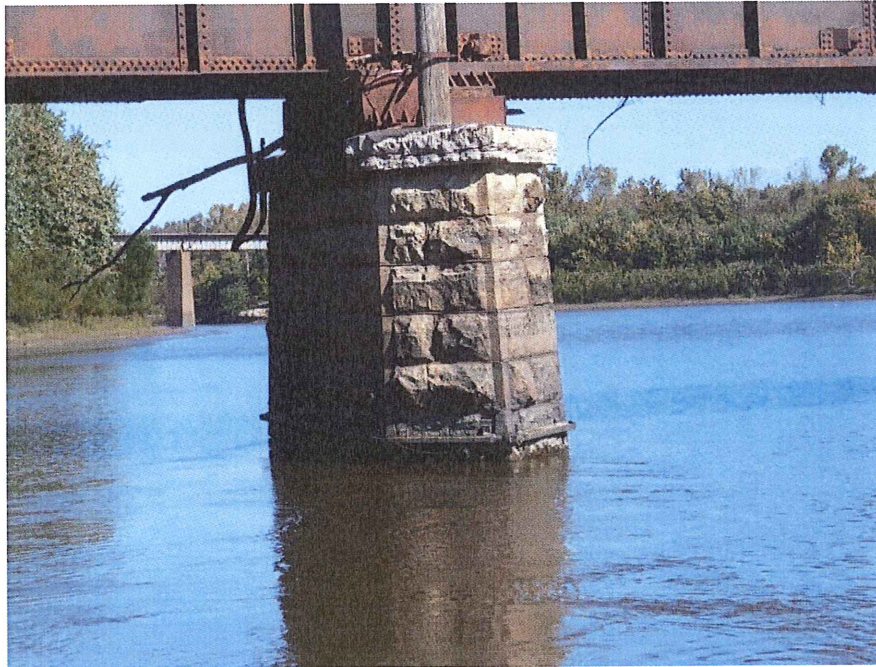
Photo #9: Pier #22

At the time of the inspection, pier 22 was in 11' to 21' of water. Pier 22 was of the same design as pier 21 except that it had two rub rails (fenders) that appeared to be made of railroad track steel. The first rub rail was at the water's edge and the second rub rail was approximately 3' below the water's surface. Each rub rail was constructed in two sections and then anchored to the blocks (see Photo #9).

The diver began the inspection on the west face and worked in a counter-clockwise direction around the pier. The diver inspected all of the underwater horizontal and vertical joints, looked for cracked or missing blocks, and looked for a footing. On the west face, the first three rows down from the water surface had a section of mortar missing along the horizontal joint, approximately 8" long, 3" deep, with a 1/2" wide gap. On the bottom row from the northwest miter, there was mortar loss on a horizontal joint over an 18" area, 6" deep, with a 3/4" wide gap. Near the center of the west face, there was a vertical joint with missing mortar, approximately 14" long, 12" deep, and 1/2" wide gap. This level of mortar loss was typical for all six faces of pier 22. There was a light layer (less than 1/16") of algae growth on the entire surface, a portion of which the diver wiped off for a more thorough inspection.

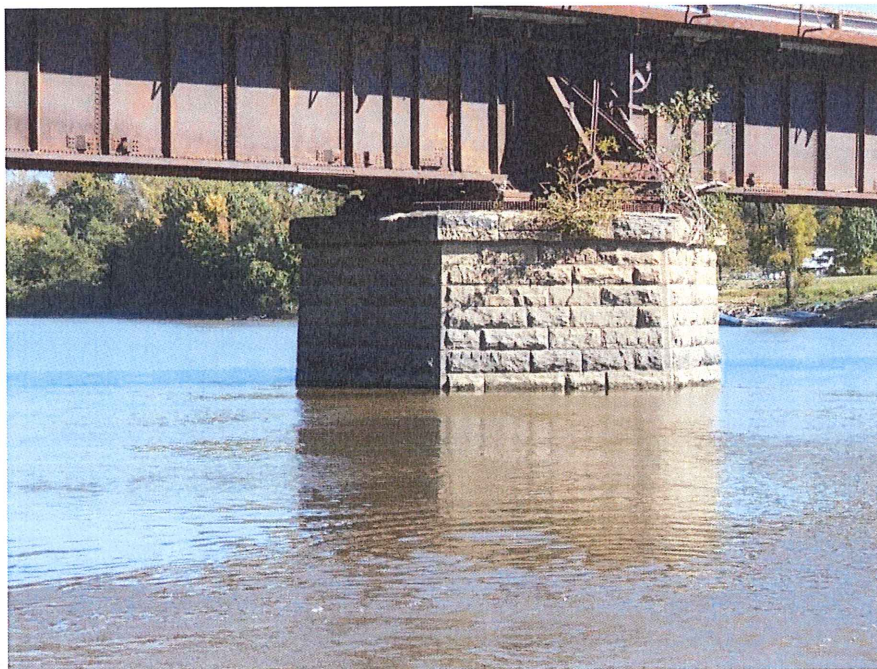
Photo #10: Pier #23

At the time of the inspection, pier 23 was in 5' to 10' of water. Pier 23 was a six sided hexagonal shaped pier that supported the movable span. The diver began his inspection on the south side of the pier. The diver inspected all of the horizontal and vertical joints, looked for cracked or missing blocks, and looked for a footing. The inspection crew observed that on the south face, above the water surface, there were three cracked blocks. The worst of these cracks was located on the pier cap on the southwest face. The horizontal crack on the southwest face ran the length of the block and was approximately 2-1/2" wide (see photos #11, #12). The second crack was located on the third row down from the aforementioned block (see photo #13). The third crack was located on the downstream adjacent block and ran vertical for the entire height of the block (see Photo #14). There was a section of the pier cap that appeared to be broken away on the northwest face (see Photos #15, #16).

The diver observed typical mortar conditions which consisted of sections with 2" to 3" of mortar loss, approximately 1/2" deep. The diver was able to probe 3' to 4' around the pier, except for the upstream side, which had a rip-rap substrate. The diver found approximately 12 blocks, which appeared to be used during the construction of the pier, randomly lying on the downstream side of the pier.

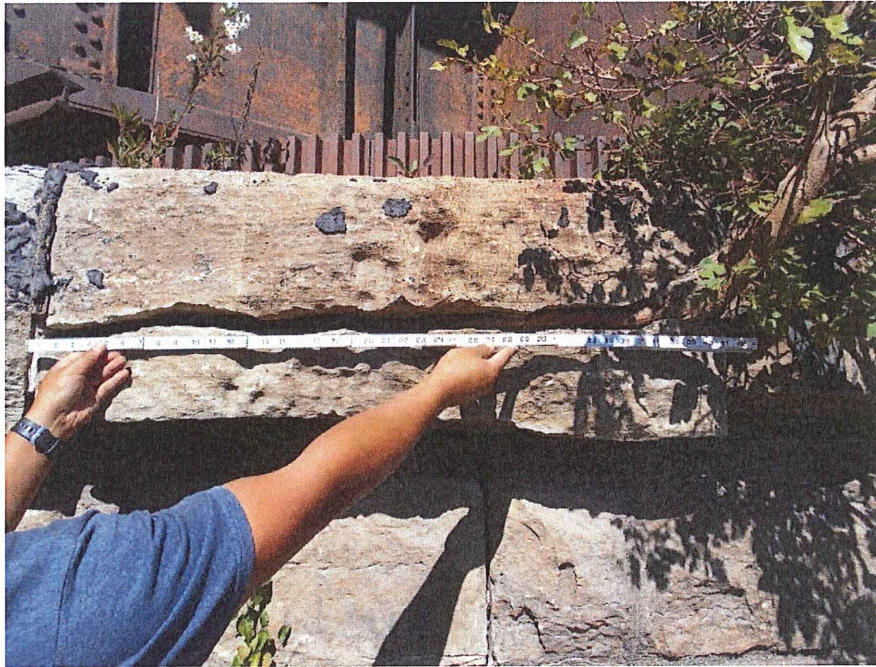
Photo #11: Horizontal Crack on the Southwest Face of Pier #23

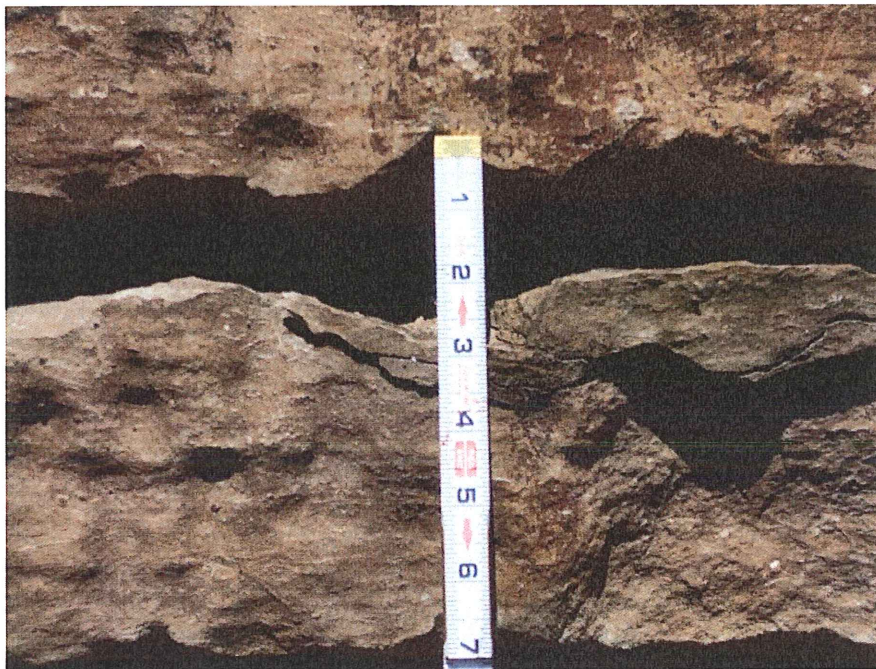
Photo #12: Horizontal Crack on the Southwest Face of Pier #23

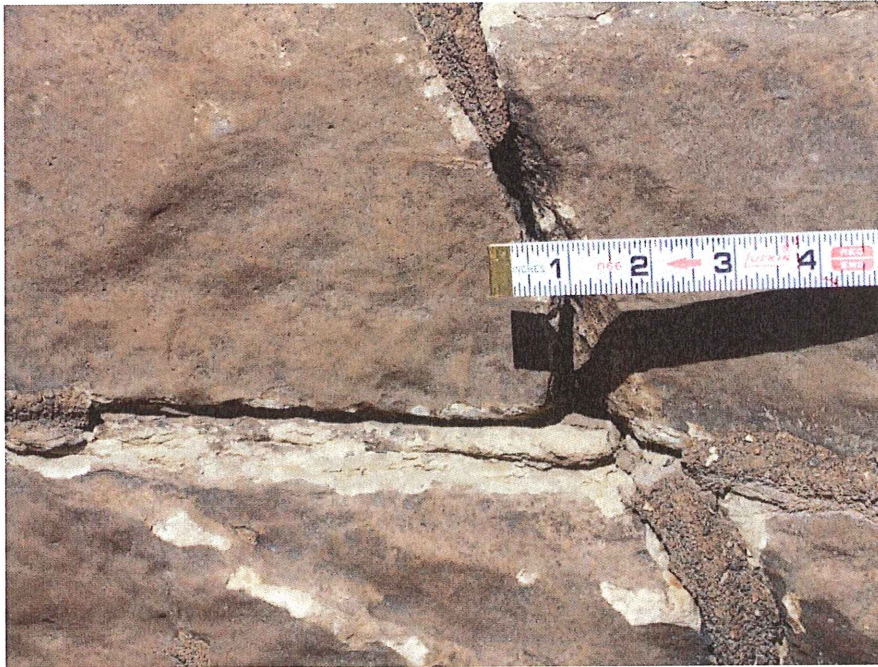
Photo #13: A Second Crack on the Southwest Face on Pier #23

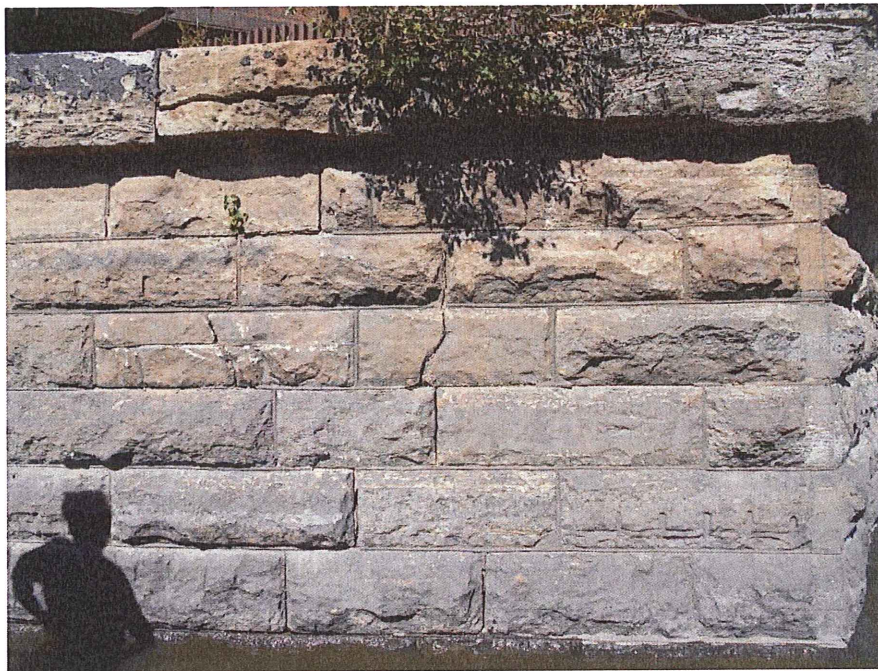
Photo #14: A Third Crack on the Southwest Face on Pier #23

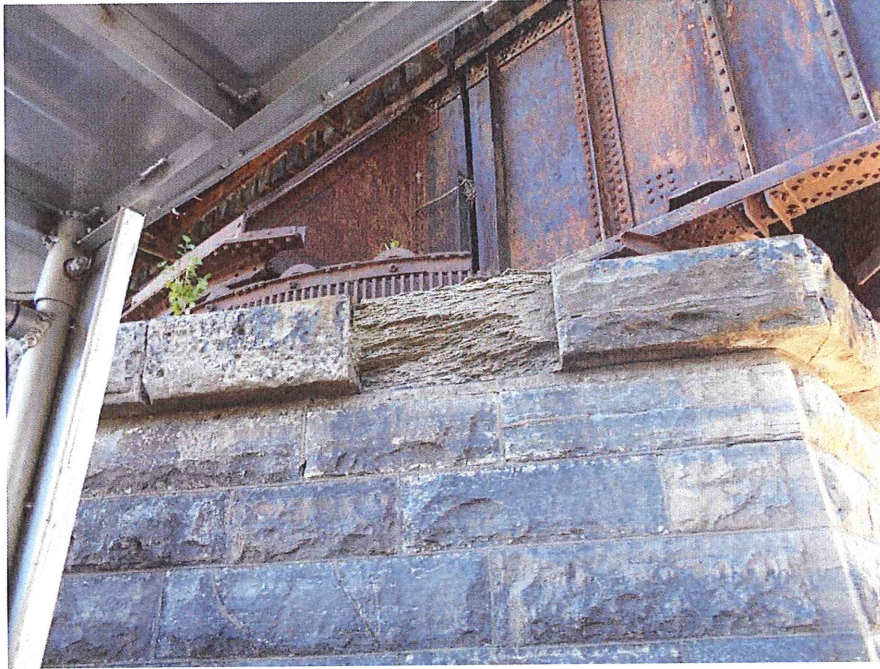
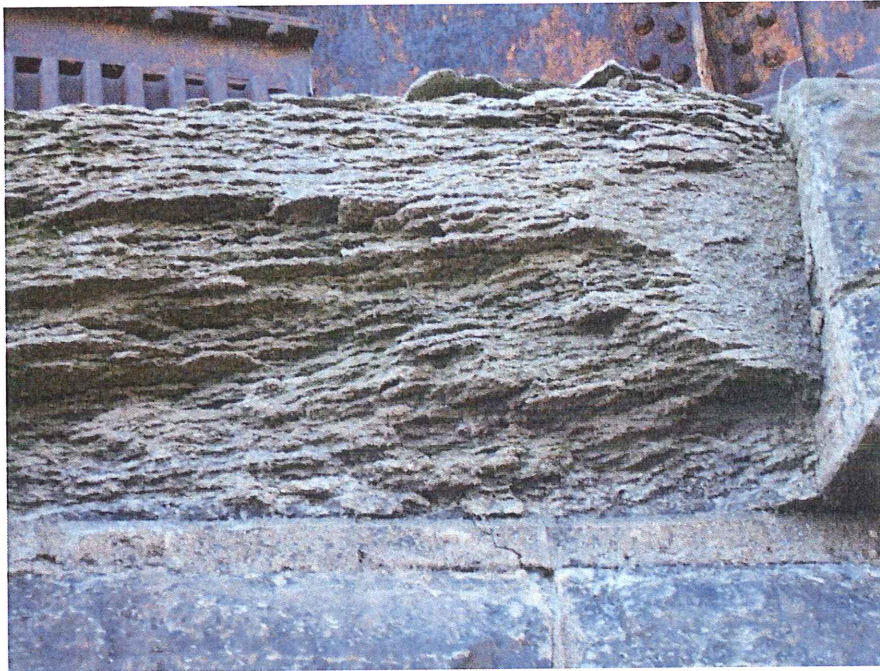
Photo #15: Broken Section of a Pier Cap on Pier #23

Photo #16: Broken Section of a Pier Cap on Pier #23

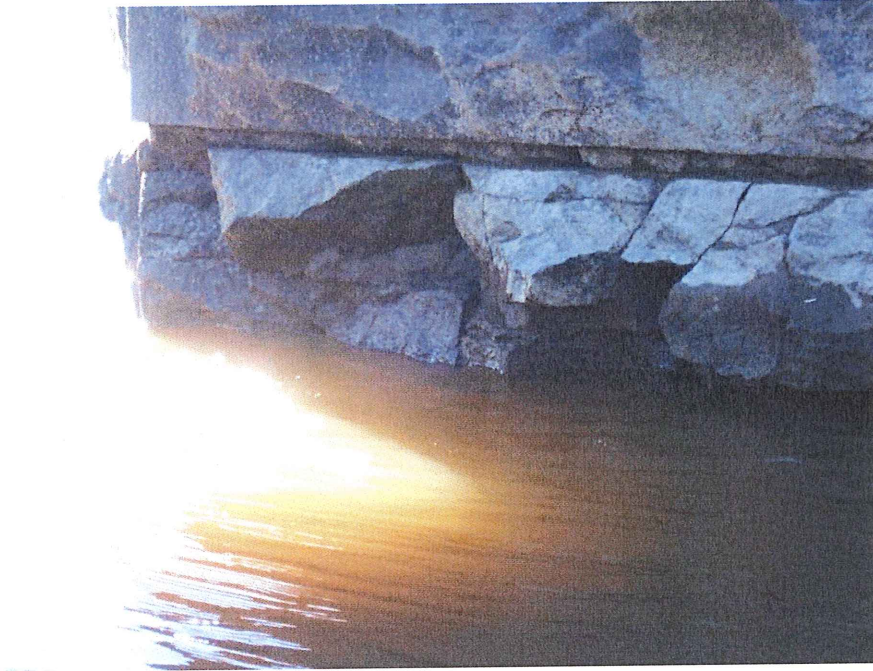
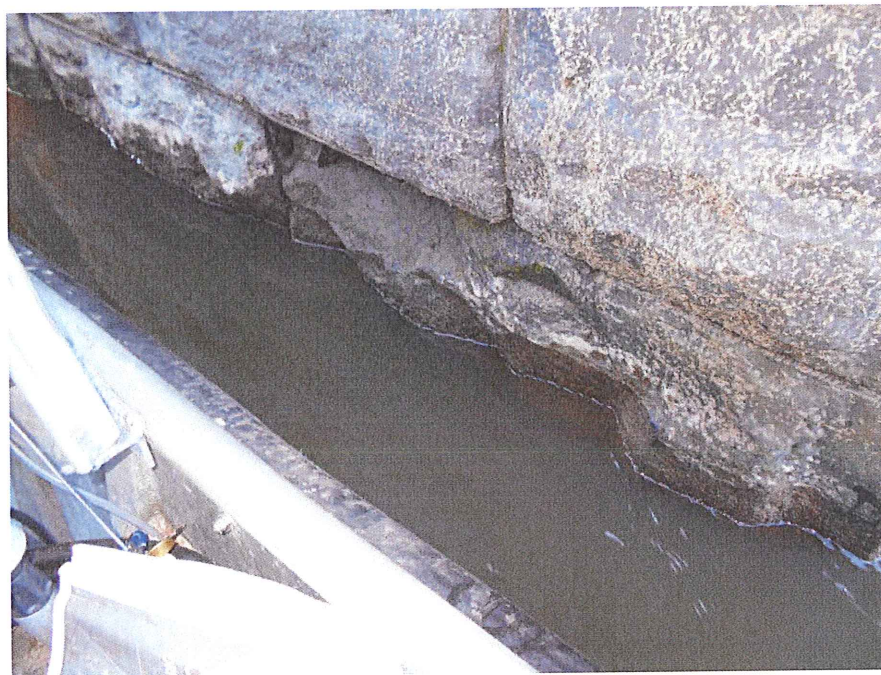
When the diver inspected the upstream face he found three blocks that appeared to have some possible impact damage. The first block was on the northeast face, at the water's surface, toward the downstream end of the face. The damage was approximately 36" long, 13" tall, and 7" deep at the deepest point (see photo #17 and video). The second block was also at the water's edge, on the northeast face, closer to the north. The damage was 25" long, 15" tall, and 4" deep at the deepest point (see photo #18 and video). The third damaged block was also at the water's edge, on the northwest face, near the north edge of the face. The damage was 12" long, 8" tall, and 4" deep at the deepest point (see Photo #19). There was a light layer of algae growth on the entire surface, a portion of which the diver wiped off for a more thorough inspection.

Photo #17: Damaged Area on Pier #23

Photo #18: Damaged Area on Pier #23

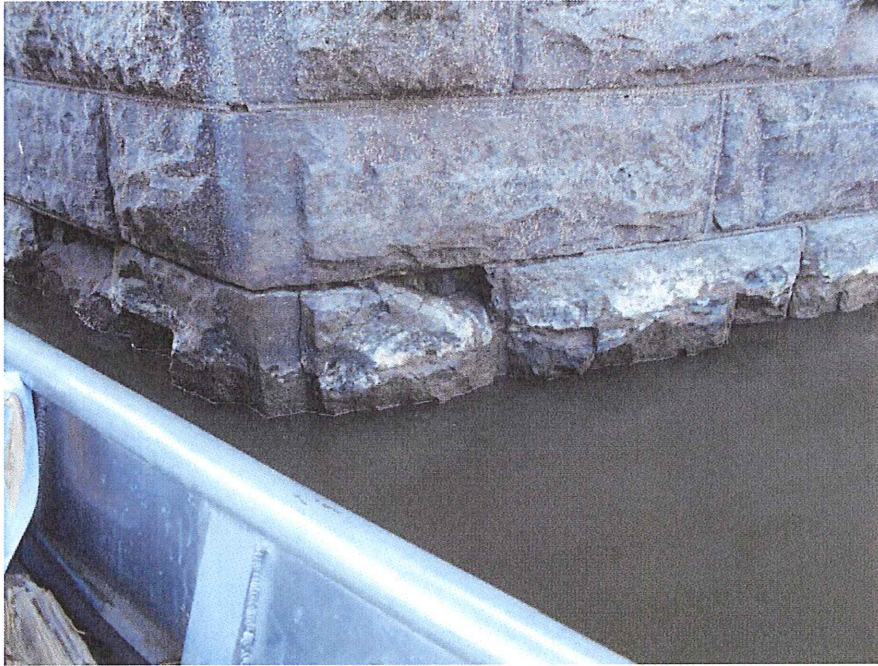
The diver began his inspection on the south side of the pier. The diver inspected all of the horizontal and vertical joints, looked for cracked or missing blocks, and looked for a footing. On the downstream face, the first horizontal mortar joint from the surface running from the southwest miter to the nose was missing mortar, approximately 12" deep with a 3/8" gap. There was a section of block missing on the southwest miter. The area was 3" long, 6" wide, and 2" deep. The east face had typical mortar loss. The center of the upstream nose, two blocks below the water surface, was missing a section of stone approximately 3" long, 3" wide, and 2" deep.

Photo #19: Damaged Area on Pier #24

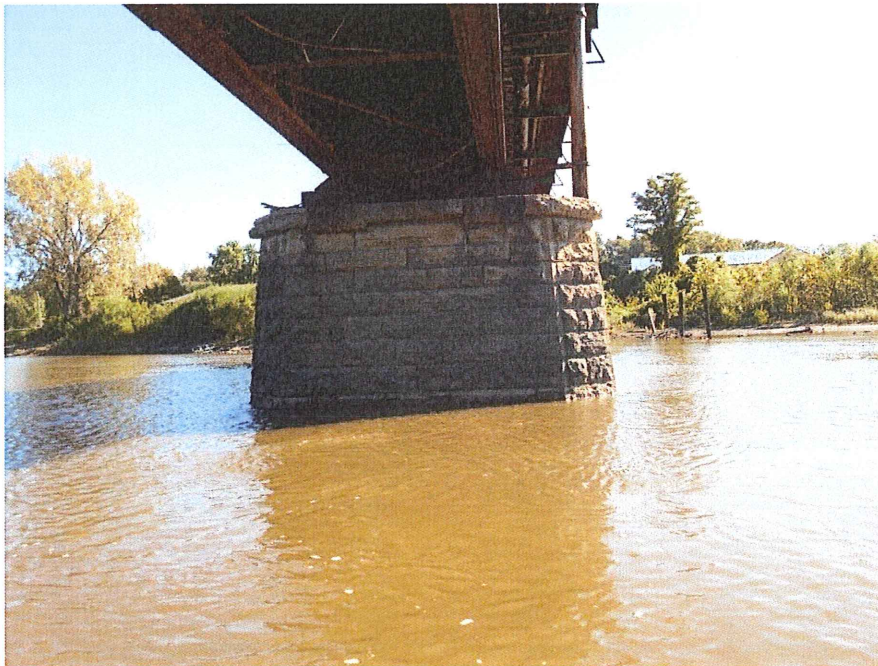
Photo #20: Pier #24

At the time of the inspection, pier 24 was in 10' to 12' of water. Pier 24 was of the same design as pier 21 and pier 22.

The diver found a section of exposed footing (stone ledge step out) on the southwest corner, with no undermining found. Approximately 18" to 20" of the ledge was exposed. The ledge was followed for 4' to the west before it became covered up by the river bottom. The ledge was followed for 11' to the north before it became covered up by the river bottom. The west ledge was found using a probe rod on the west side of the pier. The diver probed down an average of 12" to 18" before hitting the ledge. The substrate consisted of a soft infill. There was a light layer of algae growth on the entire surface.

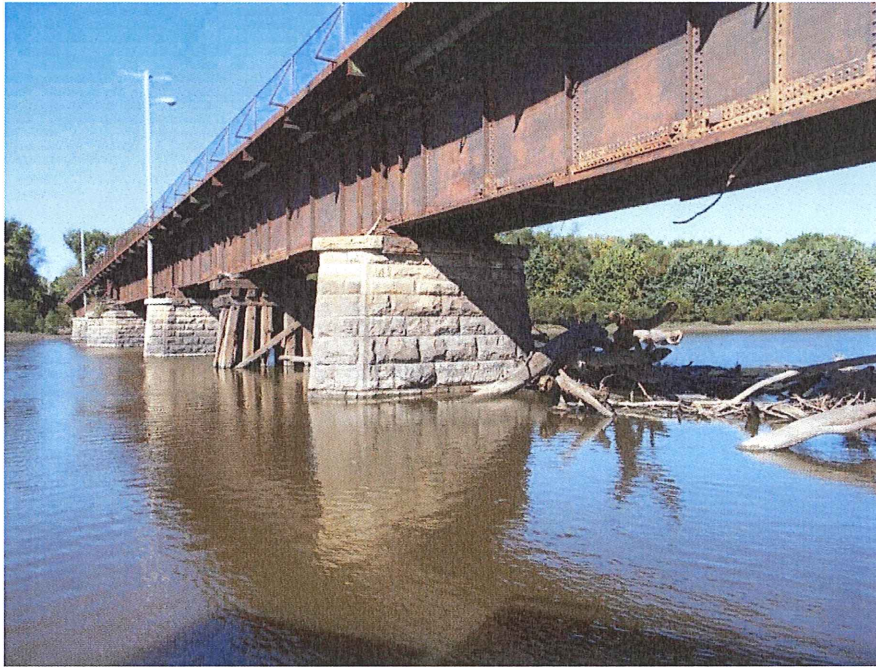
Photo #21: Pier #25

At the time of the inspection, pier 25 was in 8' to 11' of water. Heavy timber debris was noted on the upstream side of the pier. Pier 25 was of the same design as pier 21, pier 22, and pier 24.

The diver began his inspection on the south side of the pier. The diver inspected all of the horizontal and vertical joints, looked for cracked or missing blocks, and looked for a footing. The majority of the joints showed very little loss of mortar, and what loss had occurred was primarily on the upstream side. Where loss had occurred, the missing mortar was approximately 1/2" wide and 2"-3" deep on the north face. However, the south face had a little more erosion of the joints starting at the water's edge and extending downward. The widest area of mortar loss was located on the south face, approximately 6" above the water surface, and was approximately 3" wide, 12" long, and 3" deep (see Photo #22). The diver was not able to inspect all of the joints and was unable to check all the way around the pier for a footing due to heavy timber debris primarily on the north, east, and west sides (see photo #21). The diver was only able to inspect 10' down the east side of the pier, and 6' down the west side of the pier. The downstream side of the pier was completely accessible. In the areas that the diver could inspect, the joints appeared to be in good condition.

The diver was not able to locate a footing in the areas that were exposed. The diver attempted to probe around the pier, but was unable to due to a rip-rap and timber substrate. The substrate around the pier was rip-rap and sand on the downstream side and timber debris on the north, east, and west sides. There was a light algae growth on the pier.

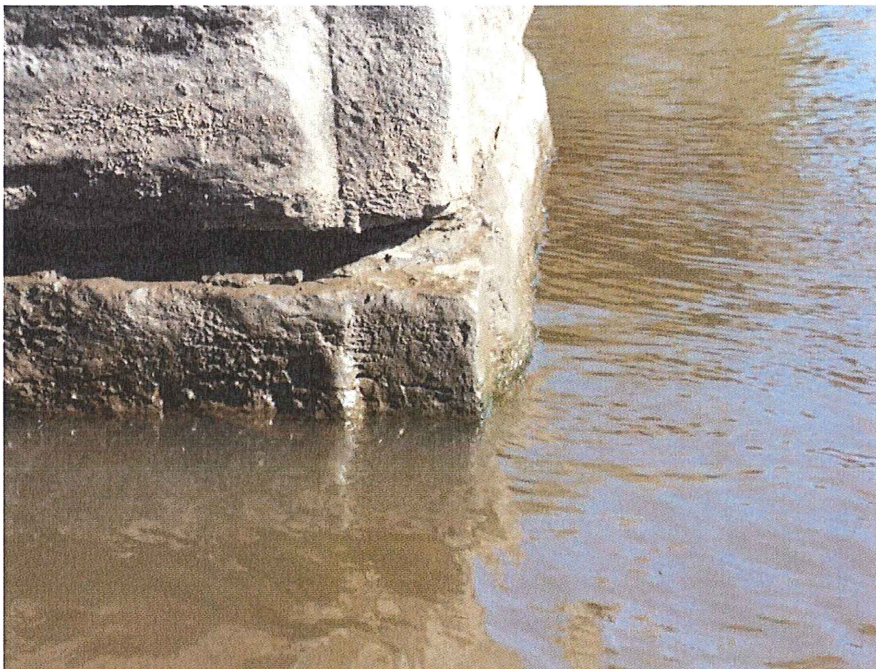
Photo #22: Missing Mortar on Pier #25

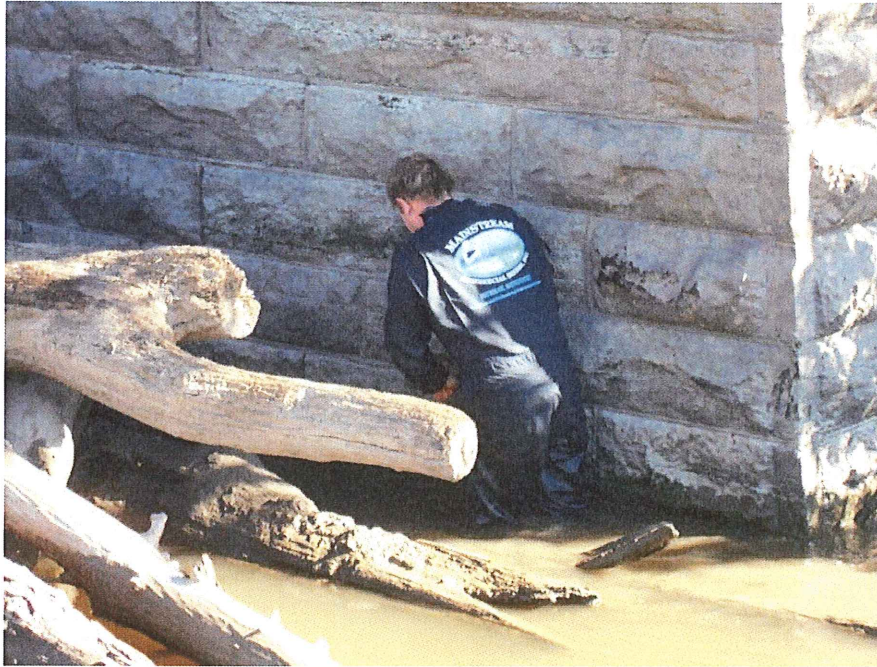
On the day of the inspection, the west face was the only portion of the abutment that was in the water. There was very heavy timber and brush debris accumulated in front of the west face (see photo #23). Due to the amount of debris and the fact that the water depth was 3' or less, the diver waded along the west face looking for cracks, missing blocks, and scour holes.

Photo #23: East Abutment and Timber Debris

While onsite, MCDI personnel informed Klingner personnel (Ryan Phelps, P.E.) of the rough dimensions of the scour hole under the pier. The scour is a significant concern and we feel should be addressed immediately, as well as the timber debris that is built up around the east abutment. We believe that the timber debris may be putting a significant strain on the uninspected timber bents and could be constricting flow causing the scouring at Pier 22. We were told in the field not to inspect the timber bents, and later told by Klingner that the timber bents are not touching or supporting the bridge structure. The scour hole wasn't present during the 2009 inspection and the timber debris has gotten significantly worse since the 2009 inspection. Further Level III inspection including penetration of the scour hole could be performed in order to obtain better dimensions of the scour and attempt to identify the number and location of the vertical piles if desired for engineering analysis.

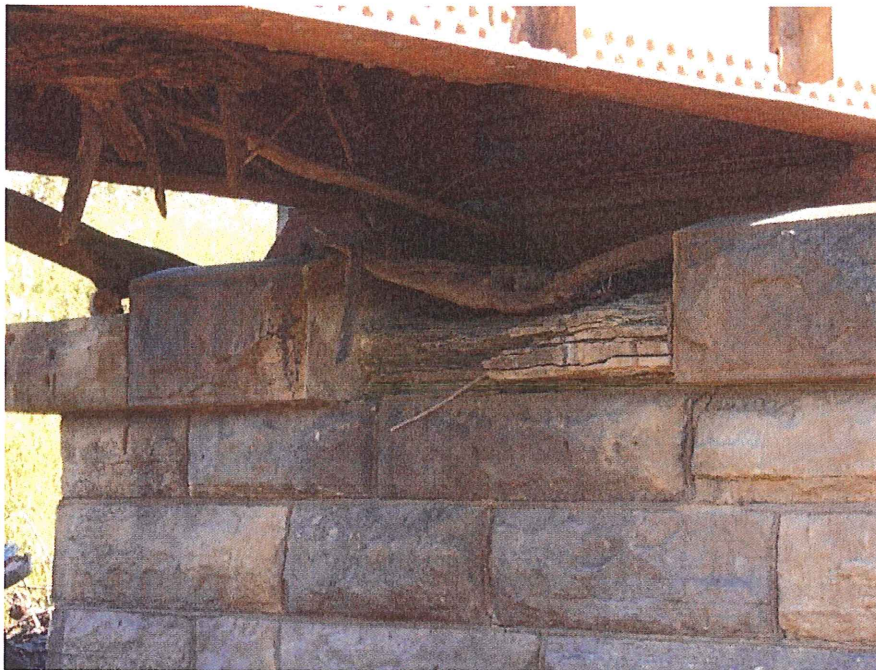
To conduct the inspection, the diver entered the water from the bank on the downstream side and worked his way upstream. The diver inspected all of the horizontal and vertical joints, looked for cracked or missing blocks, and looked for a footing. The pier cap of the abutment appeared to have a damaged block toward the center of the pier (see photo #24). No associated damage was observed underwater.

Photo #24: East Abutment and Timber Debris

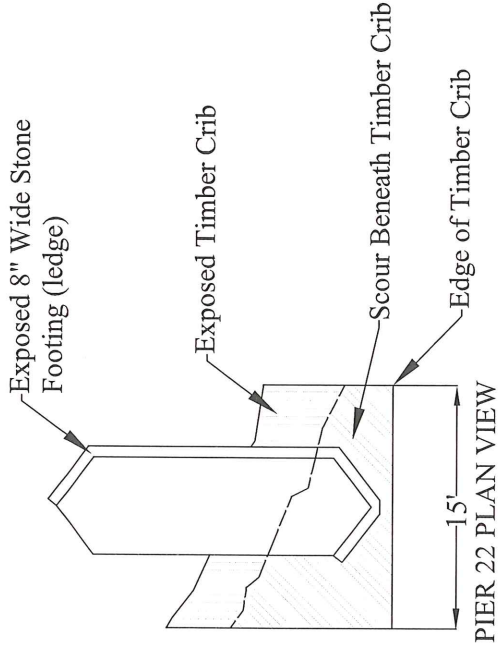
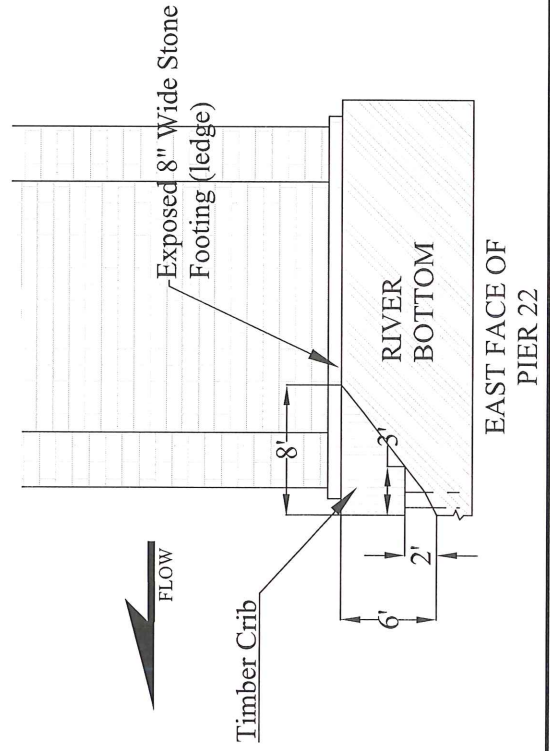
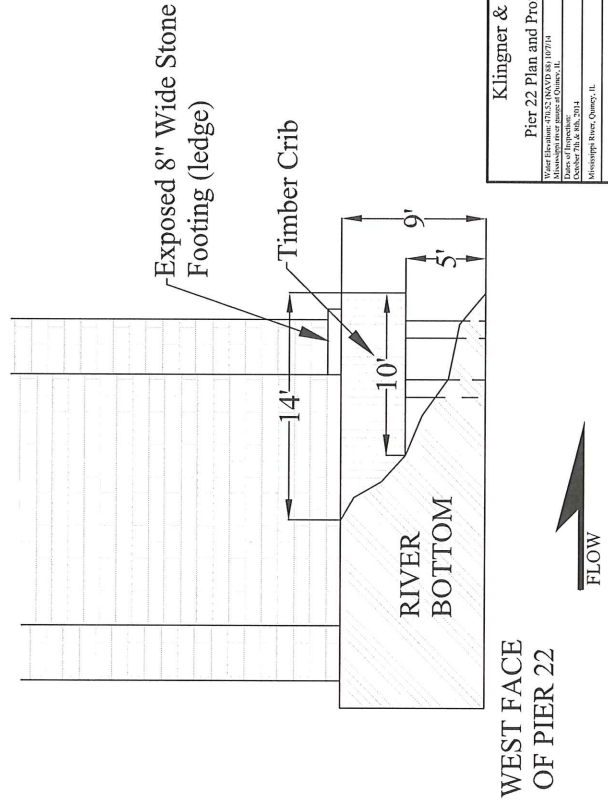
Localized scour has caused part of a timber crib foundation composed of horizontally positioned timbers and vertical timber piles, located beneath the masonry pier, to become undermined (see drawing 2). The pier had a stone footing (ledge) approximately 8" wider than the pier and composed of one course of stone, which was supported by the timber crib work and timber piles. The 8" wide stone ledge was evident around a majority of the base of the pier. The timber crib supporting the masonry pier was approximately 15' wide. The crib was founded on timber piles; however, the diver could not determine how the piles tied into the crib. The west side of the crib was undermined for approximately 10' starting from the southwest corner, and another 4' of the crib was exposed before the river bottom covered the top of the crib. Along the east side, 3' of the crib was undermined, and another 5' was exposed before the river bottom covered the top of the crib. The diver took a depth reading on top of the timber crib and recorded 13' of water, 17' on the bottom of the crib, and 20' on the river bottom below the downstream pier nose. The

diver found three vertical timber piles exposed. The diver noted that the condition of the timber elements were soft and decaying. The diver easily penetrated a timber pile with the tip of his dive knife approximately 3/4".

- Number and location of timber piles may not be accurate.
- Diver identified pilings by hand and felt what was believed to be additional pilings inside the scour hole with a probe rod.
- All dimensions are approximate as estimated by divers. Measurements were taken from the outside of the crib. Actual volume and shape of scour under the crib is unknown.
- Scour hole is believed to be caused by constriction of flow by timber debris in the area.
