Underwater Inspection Report

Owner: Quincy Park Authority
Structure: Quinsippi Island Bridge
Location: Quincy, Illinois
Body of Water: Mississippi River
Inspection Date: June 18, 2020

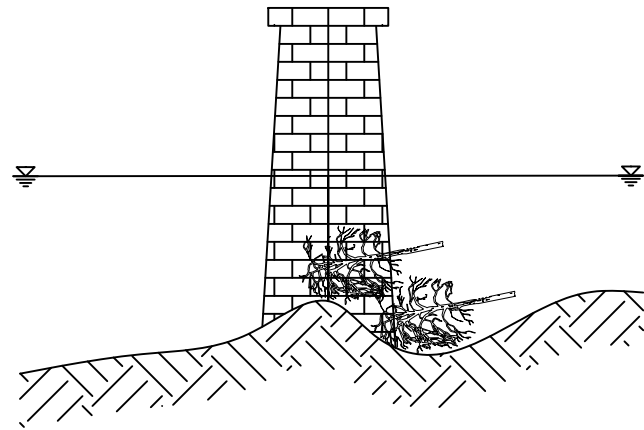
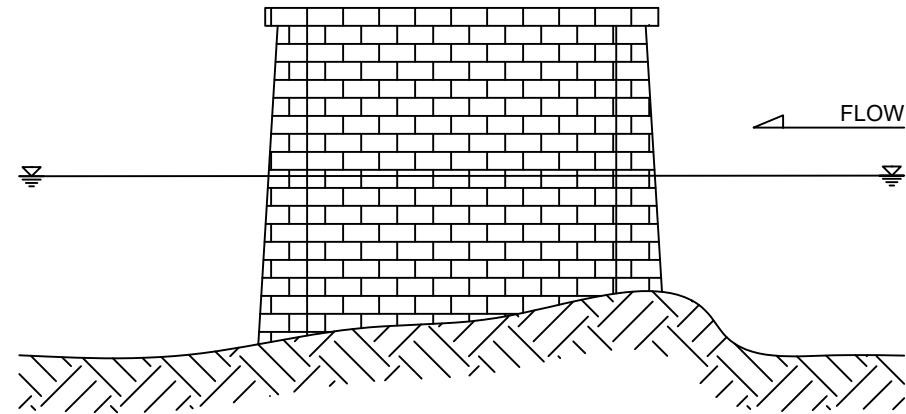
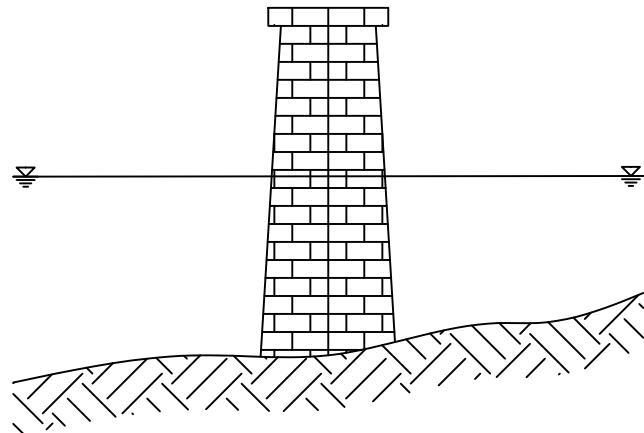
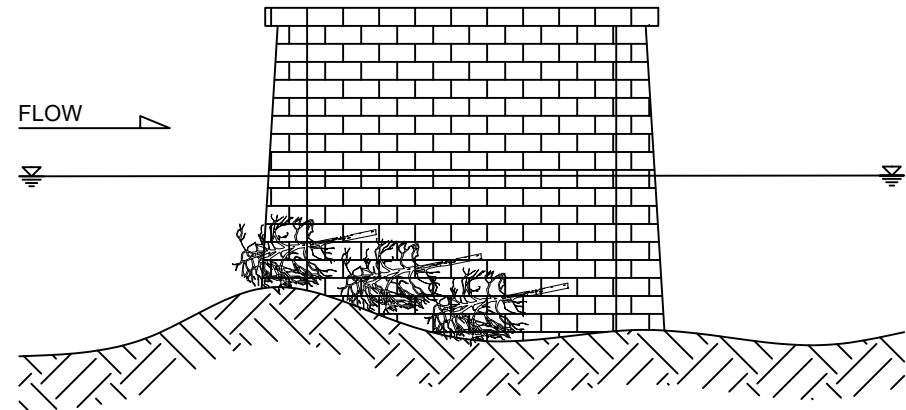
PIER 25

- OVERALL, THERE WAS MINOR MORTAR LOSS IN SPORADIC AREAS WITH MINOR DETERIORATION ALONG THE FREEZE/THAW ZONE.
- MODERATE AMOUNTS OF TIMBER DEBRIS WERE STACKED UP ALONG THE UPSTREAM BULLNOSE AND THE LEFT FACE.
- SOFT MUD / RIPRAP MADE UP THE MAJORITY OF THE RIVER BOTTOM SUBSTRATE.

Pier 25 had moderate amounts of debris stacked up along the Upstream Bullnose and Left Face. It is our recommendation that these debris piles be removed from the structures.

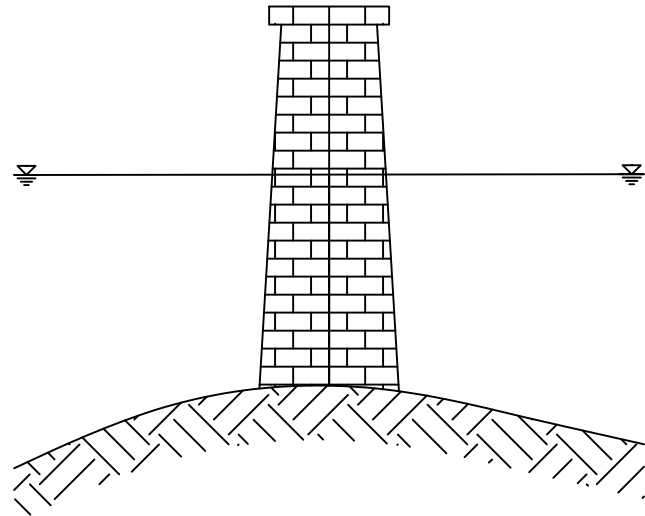
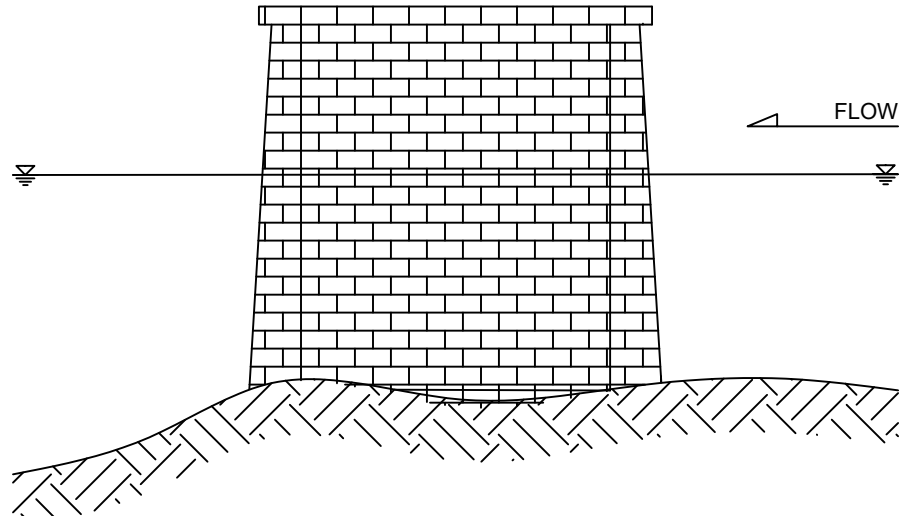
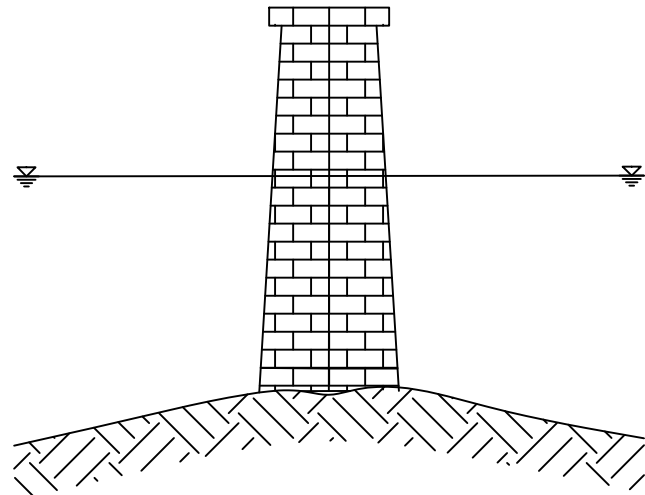
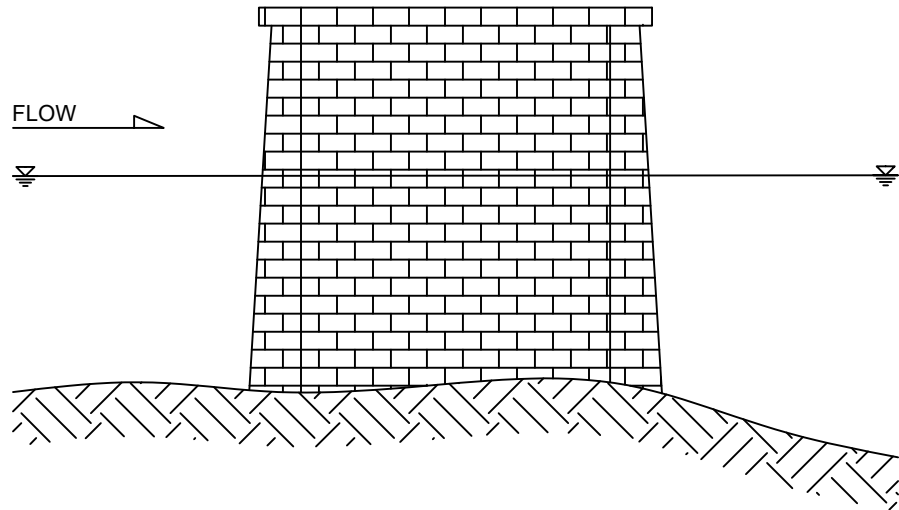
- OVERALL, THERE WAS MINOR MORTAR LOSS IN SPORADIC AREAS WITH MINOR DETERIORATION ALONG THE FREEZE/THAW ZONE.
- RIGHT FACE: THE TOP PORTION OF THE FOOTING WAS EXPOSED. THE FOOTING HAD AN EXPOSED HORIZONTAL FACE OF 1 1/2-FEET.
- DOWNSTREAM BULLNOSE: THE FOOTING WAS EXPOSED WITH A HORIZONTAL FACE OF 2 1/2-FEET AND A VERTICAL FACE OF 1 1/1-FEET. THE FOOTING WAS UNDERMINED MEASURING 1-FOOT WIDE BY 10-INCHES HIGH AND 12-INCHES DEEP.
- SOFT MUD / RIPRAP MADE UP THE MAJORITY OF THE RIVER BOTTOM SUBSTRATE.

Pier 24 had parts of its footing exposed. The horizontal face of the footing was exposed measuring 1½-feet. On the Downstream Bullnose the footing was exposed with a horizontal face of 2½-feet and a vertical face of 1½-feet. There was a portion of the footing that was undermined, this area measured 1-foot wide by 10-inches high and 1-foot deep. It is our recommendation to keep monitoring this Pier for furthering of the exposed footing and undermining.

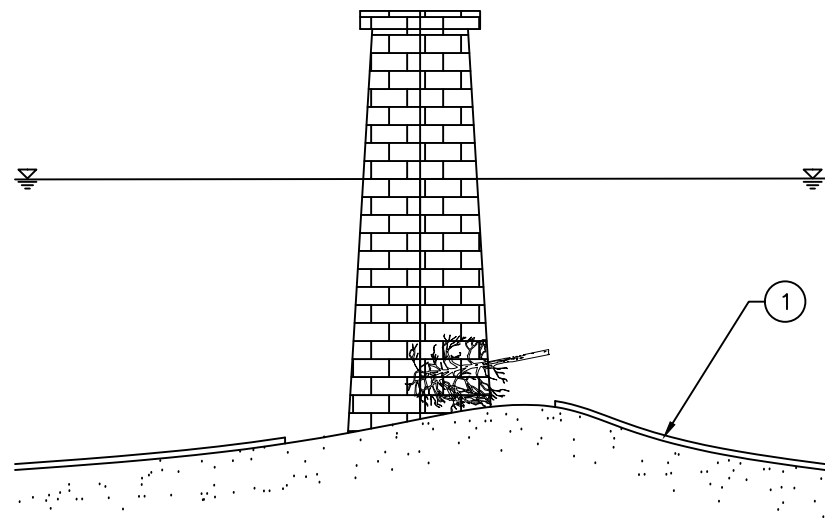
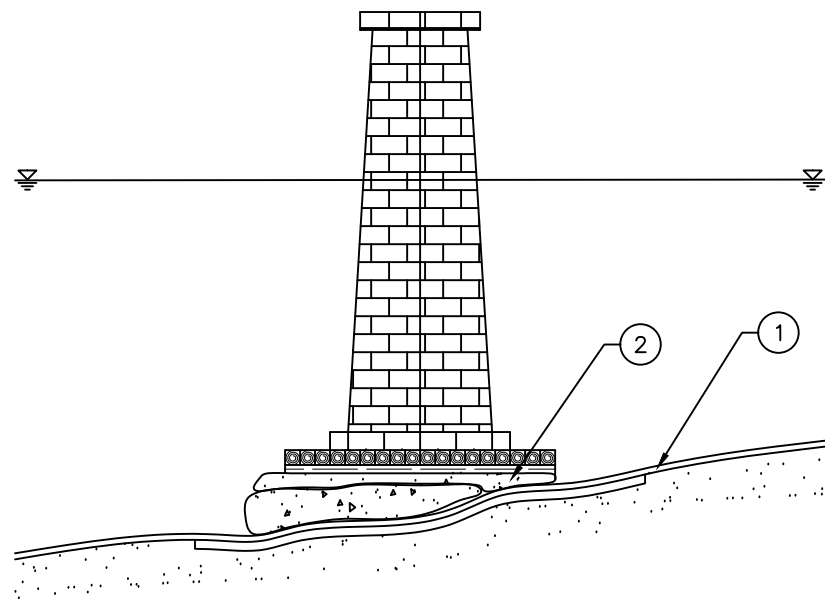
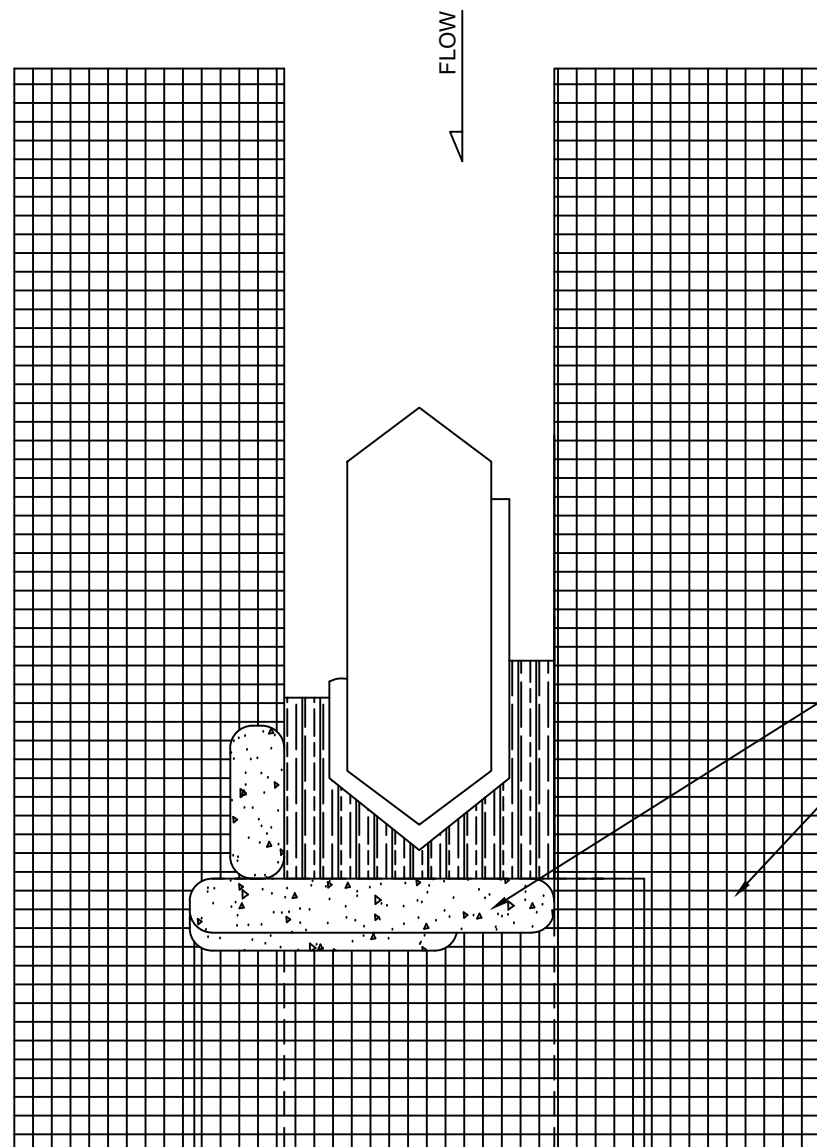
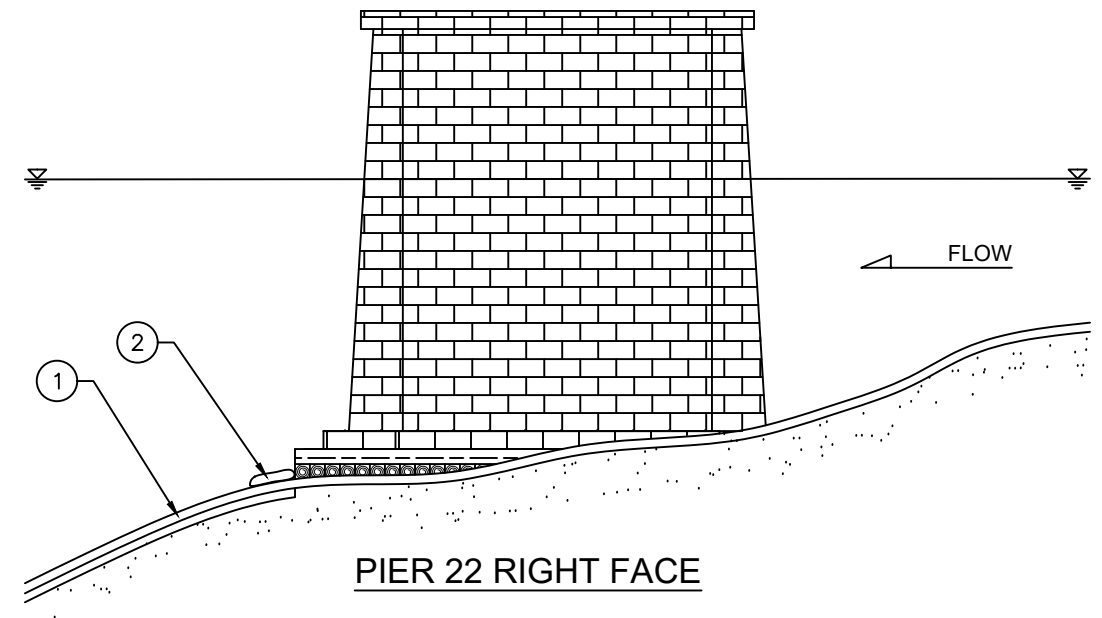
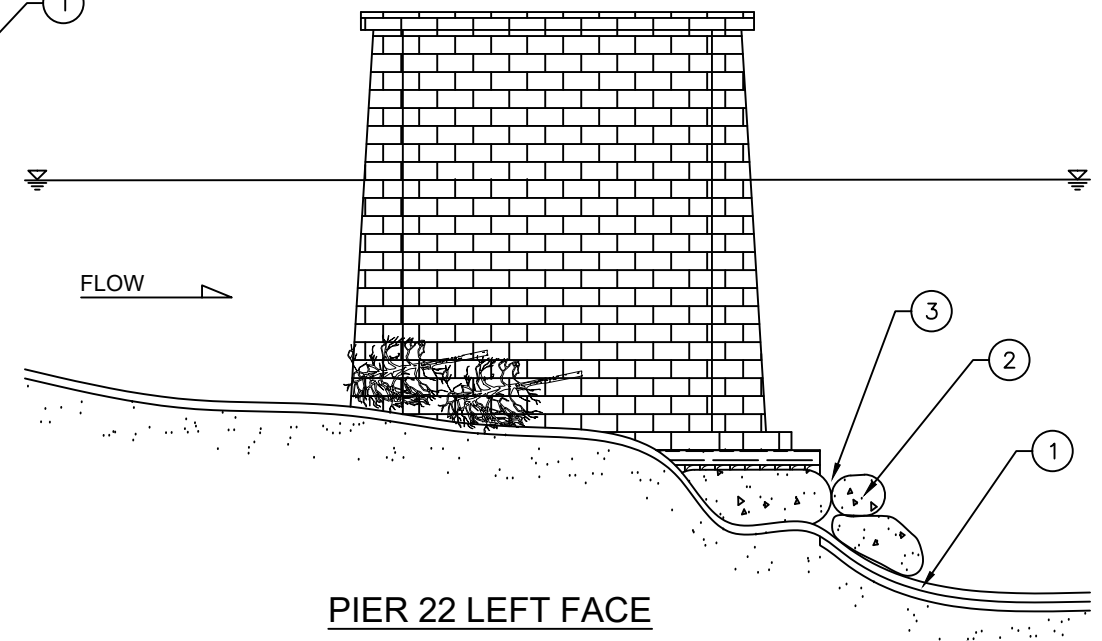
- OVERALL, THERE WAS MINOR MORTAR LOSS IN SPORADIC AREAS WITH MINOR DETERIORATION ALONG THE FREEZE/THAW ZONE.
- OVERALL, THE AB MAT APPEARED TO BE SECURED AROUND THE ENTIRE STRUCTURE.
- ON THE DOWNSTREAM BULLNOSE THERE WAS AN AREA OF MINOR UNDERMINING UNDER THE EXPOSED TIMBER CRIBBING. THIS AREA MEASURED 10-FEET WIDE BY 3-INCHES HIGH AND 1 1/2-FEET DEEP.
- MINOR AMOUNTS OF TIMBER DEBRIS WERE STACKED UP ALONG THE UPSTREAM BULLNOSE AND THE LEFT FACE.
- AB MAT / RIPRAP MADE UP THE MAJORITY OF THE RIVER BOTTOM SUBSTRATE.

Pier 22 had minor amounts debris stacked up along the Upstream Bullnose and the Left Face. Along the Downstream Bullnose there was a minor area of undermining under the Cribbing that measured 10-feet wide by 3-inches high and 1 ½-feet deep. We believe that once the mats settled it left a small area that could still be reached by the rushing waters. It is our recommendation that the debris be removed, along with continuously monitoring the undermined section.

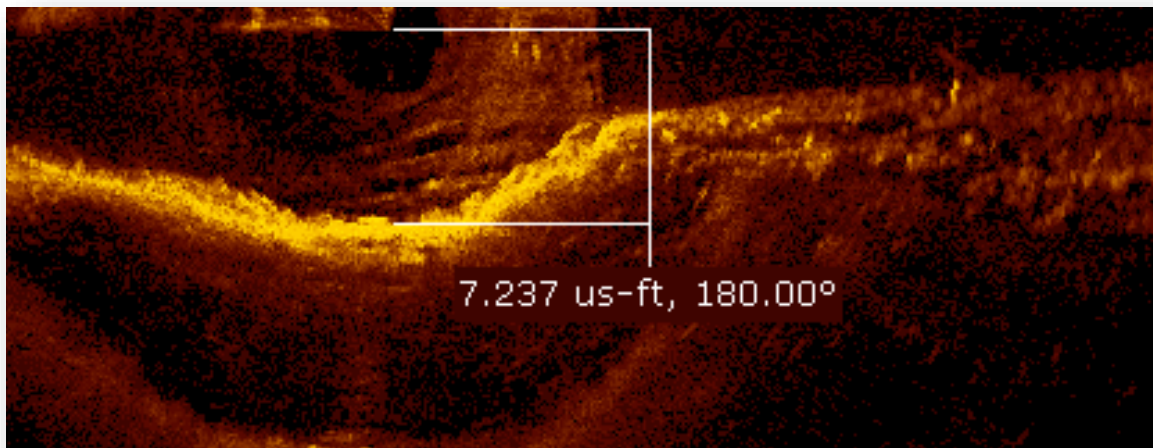
- Overall, there was minor mortar loss in sporadic areas with minor deterioration along the freeze/thaw zone.
- Upstream Face:
 - Overall, the masonry stone and mortar were in satisfactory condition above and below the waterline.
- Right Face:
 - Overall, the masonry stone and mortar were in satisfactory condition above and below the waterline.
 - This side of the Abutment was in very shallow water.
- Downstream Face:
 - Overall, the masonry stone and mortar were in satisfactory condition above and below the waterline.
- Left Face:
 - Overall, the masonry stone and mortar were in satisfactory condition above and below the waterline.
 - There was a minor amount of debris stacked up (See 'Appendix B, Figure 27').
- The bottom substrate consisted of small riprap and mud.

Figure 27 - East Abutment, Left Face Minor Scour Sector Scan

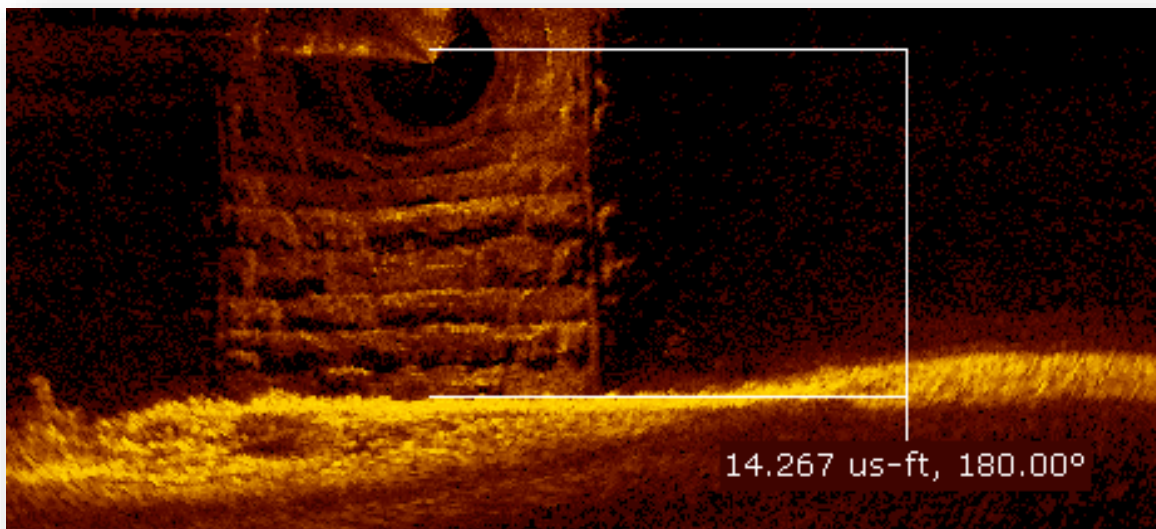
- Right Face:
 - Overall, the masonry stone and mortar were in satisfactory condition above and below the waterline.
 - The top of the footing was exposed and had a 1½-foot horizontal face. The vertical face was not exposed as it was flush with the riprap mud bottom (See 'Appendix B, Figure 30').

Figure 30 - Pier 24, Right Face Minor Debris Sector Scan

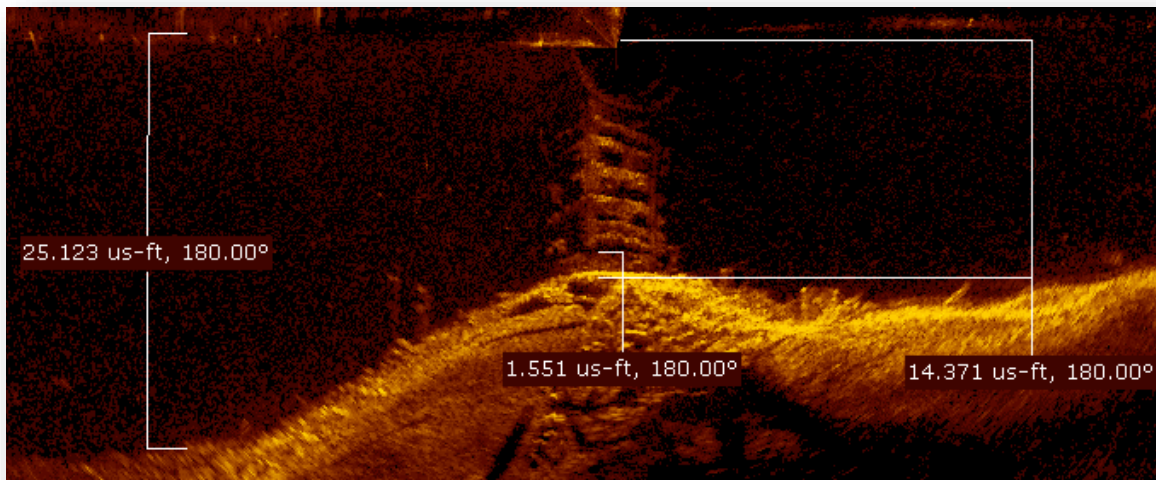
- Undermining was found under the exposed footing and measured 1-foot wide by 10-inches high and had up to 1-foot of loss (See 'Appendix B, Figure 31').

Figure 31 - Pier 24, Downstream Bullnose Debris Pile & Scour Sector Scan

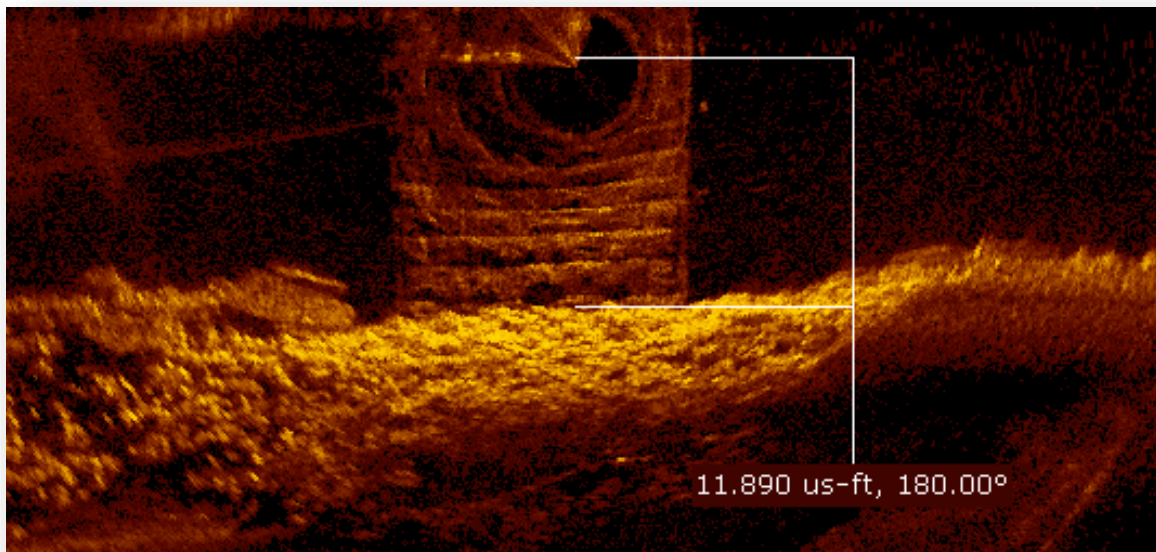
- Overall, the masonry stone and mortar were in satisfactory condition above and below the waterline.
- There was a minor amount of debris stacked up (See 'Appendix B, Figure 32').
- Downstream Bullnose:
 - Overall, the masonry stone and mortar were in satisfactory condition above and below the waterline.
- Left Face:
 - Overall, the masonry stone and mortar were in satisfactory condition above and below the waterline.
- The bottom substrate consisted of riprap and mud.

Figure 32 - Pier 23, Right Face Riprap Sector Scan

Pier 23 had minor amounts of debris stacked up along the Right Face. It is our recommendation that this debris pile be removed.

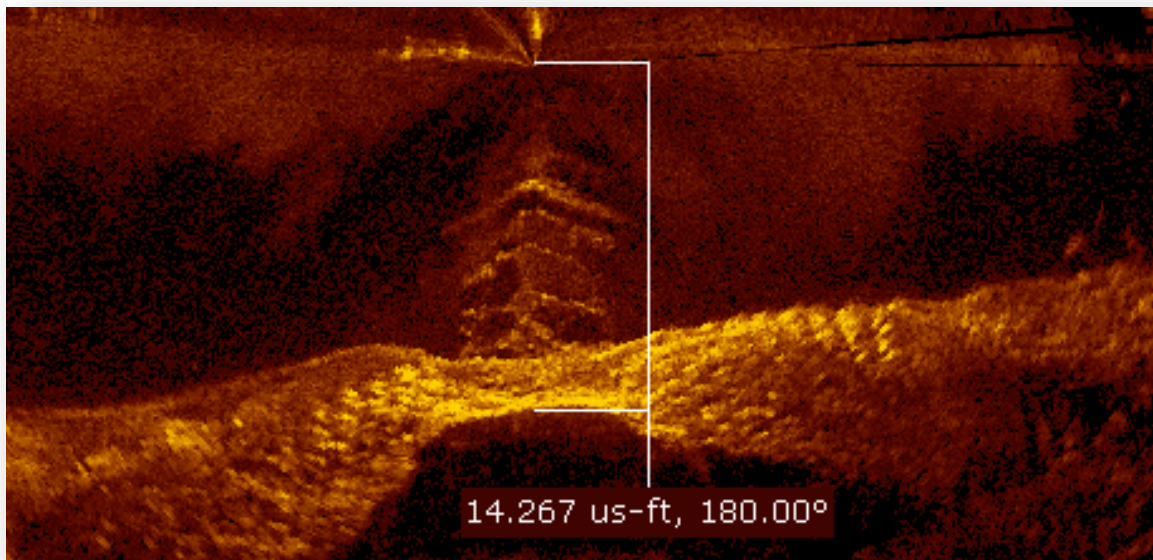
- There was a minor amount of debris stacked up (See 'Appendix B, Figures 33 & 34').
- Right Face:
 - Overall, the masonry stone and mortar were in satisfactory condition above and below the waterline.

Figure 33 - Pier 22, Upstream Bullnose AB Mat Sector Scan

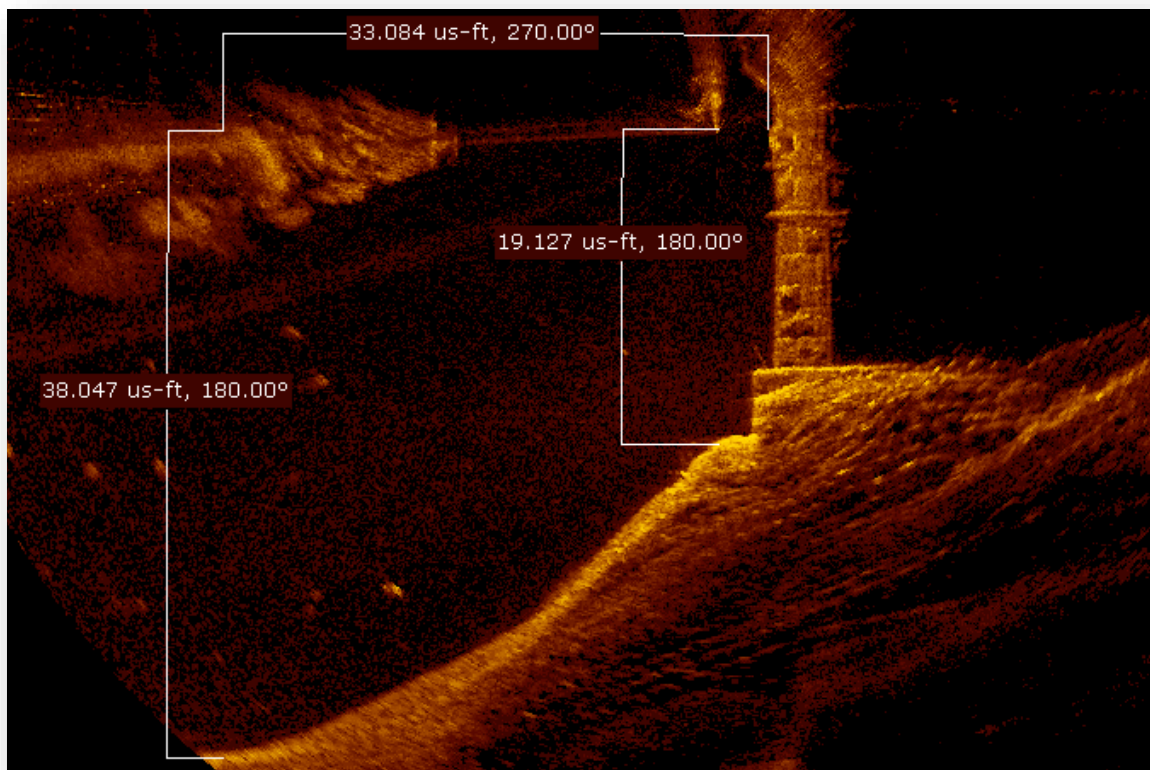
Figure 34 - Pier 22, Upstream Bullnose AB Mat & Exposed Footing/Cribbing Profile Sector Scan

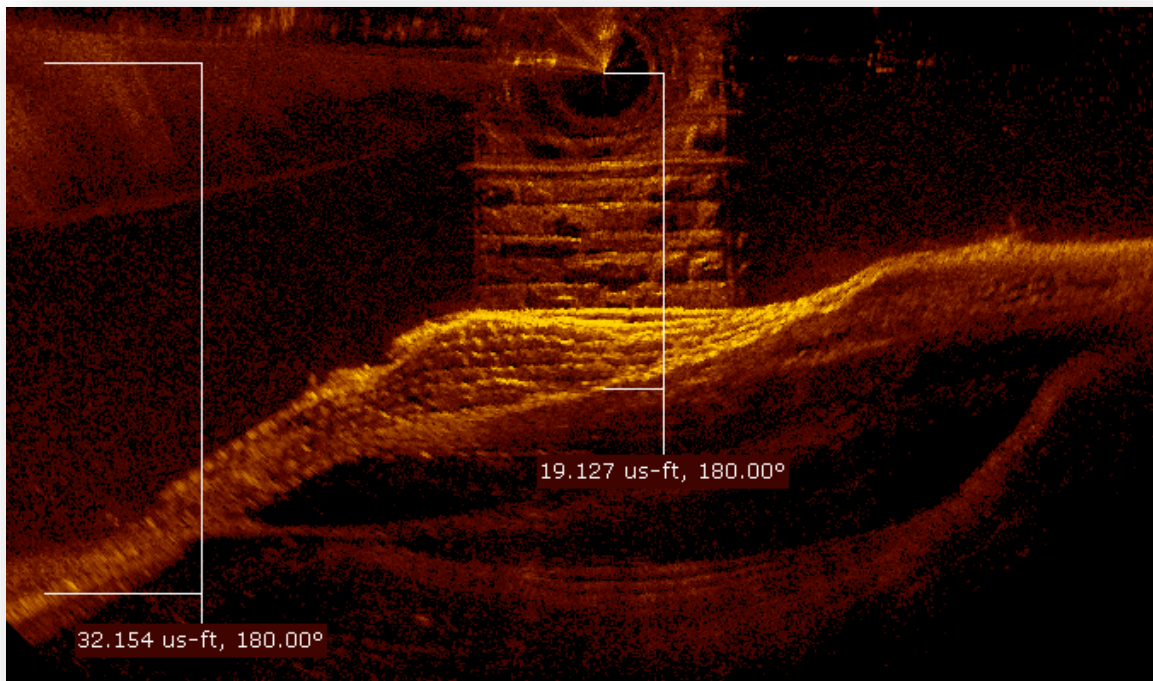
- The footing was exposed and had a vertical face of 10-inches down to the AB Mat.
 - The AB Mat appeared to be secured in place and in good overall condition (See 'Appendix B, Figure 35').

Figure 35 - Pier 22, Right Face AB Mat & Scour Sector Scan

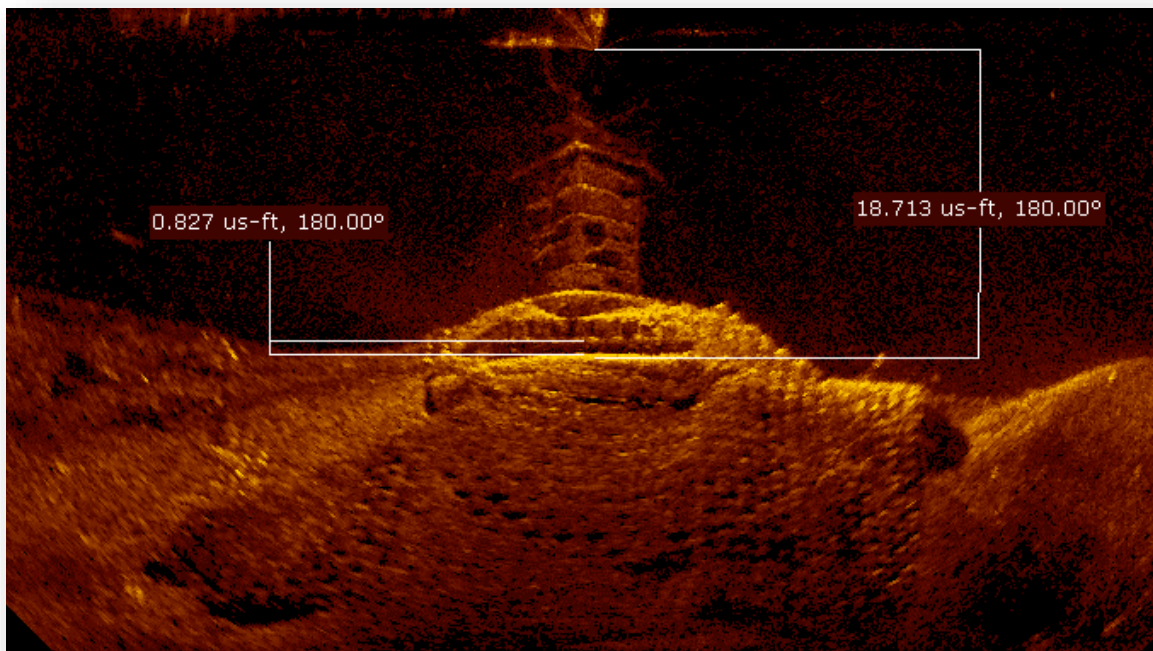
- Downstream Bullnose:
 - Overall, the masonry stone and mortar were in satisfactory condition above and below the waterline.
 - The footing was exposed and had a 1½-foot horizontal face with a vertical face of 2-feet. Under the vertical face of the footing approximately 2-feet of the timber cribbing was exposed (See 'Appendix B, Figure 36').

- The timber cribbing was found to be undermined. This area measured 10-feet wide at center by 3-inches high and had up to 1½-feet of loss.

Figure 36 - Pier 22, Downstream Bullnose AB Mat Sector Scan

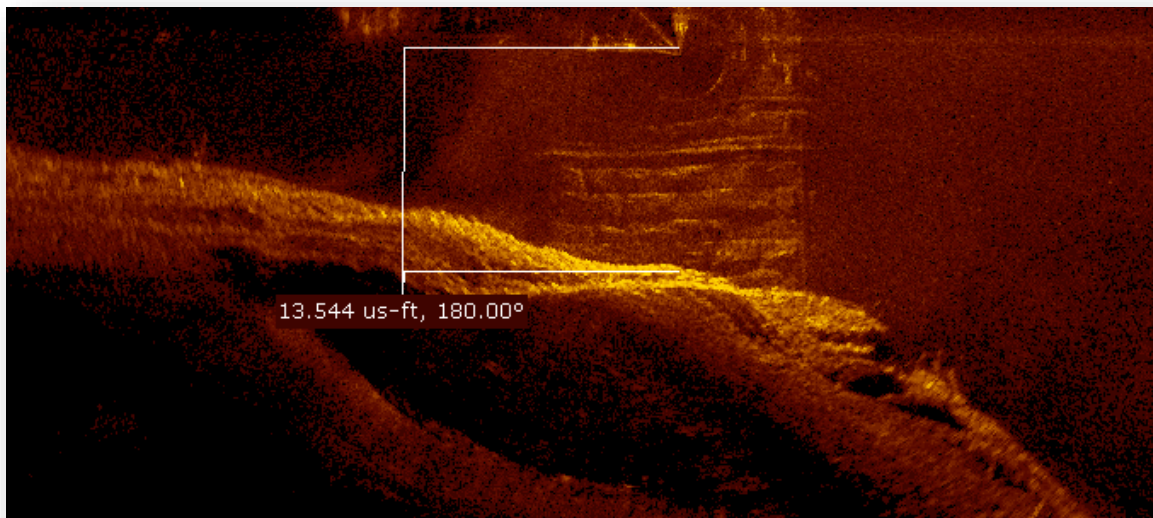
- Left Face:
 - Overall, the masonry stone and mortar were in satisfactory condition above and below the waterline.
 - The AB Mat appeared to be secured in place and in good overall condition. There was no exposed footing (See 'Appendix B, Figure 37').
 - There was a minor amount of debris stacked up.
- The bottom substrate consisted of riprap and the installed AB Mats.
 - There was an area of heavy scour along Downstream Bullnose. Directly at the Pier was approximately 19-feet and 20-feet downstream of the pier the depth was 34-feet.

Figure 37 - Pier 22, Left Face AB Mat & Scour Sector Scan
