Appendix A: Community Input

Focus Group Summary Report

Quincy Park District ***Quincy, Illinois***

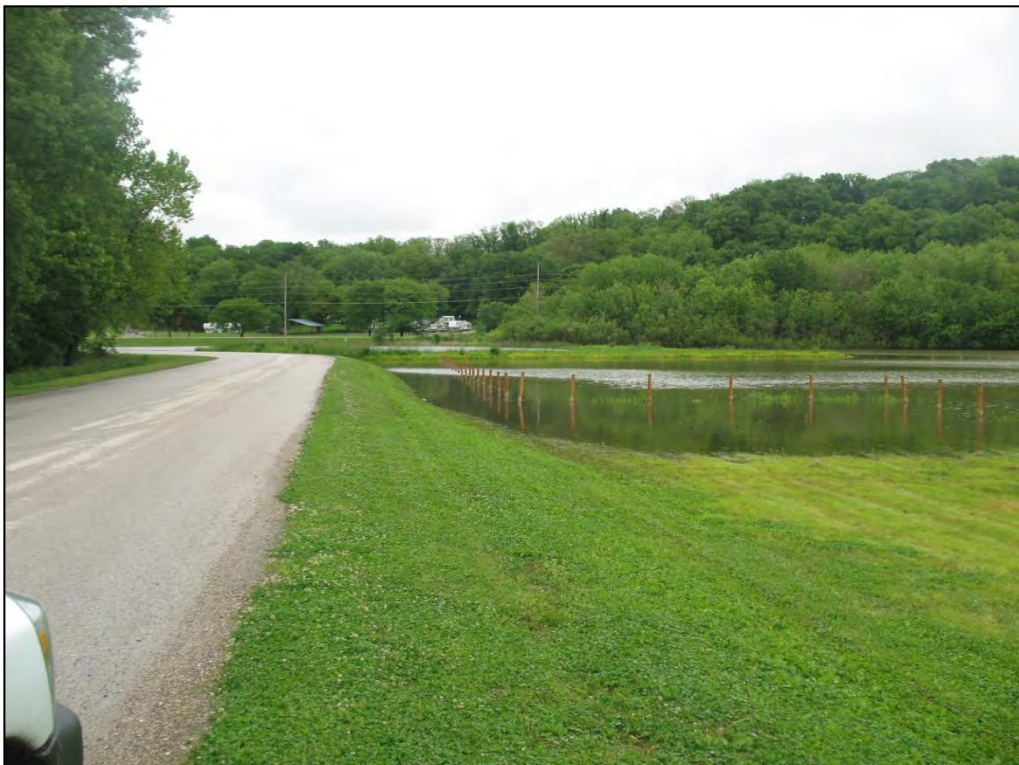
Photo 2:

The park is continually wet or flooded inhibiting recreational use for the majority of the year. Replacing existing turf with a wetland and mesic prairie seed mix would provide natural water retention and an educational experience for the public.

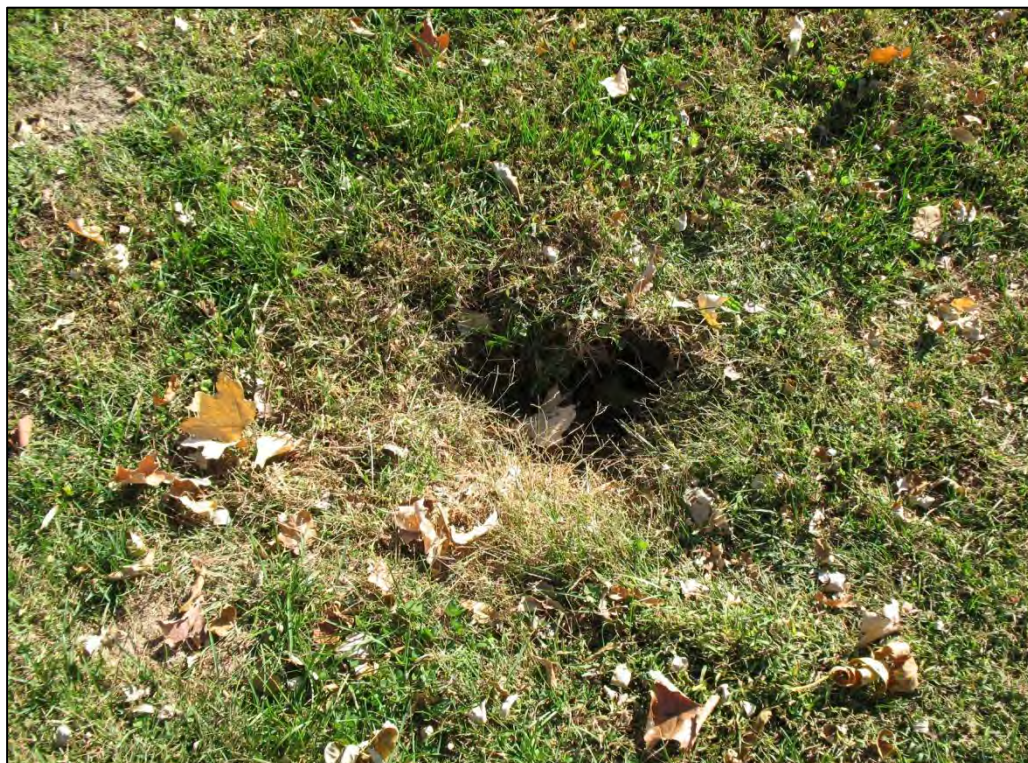
Photo 4:

The drainage low point of this turf lawn would benefit from a natural rain garden to filter and decelerate stormwater before it flows into its final destination.

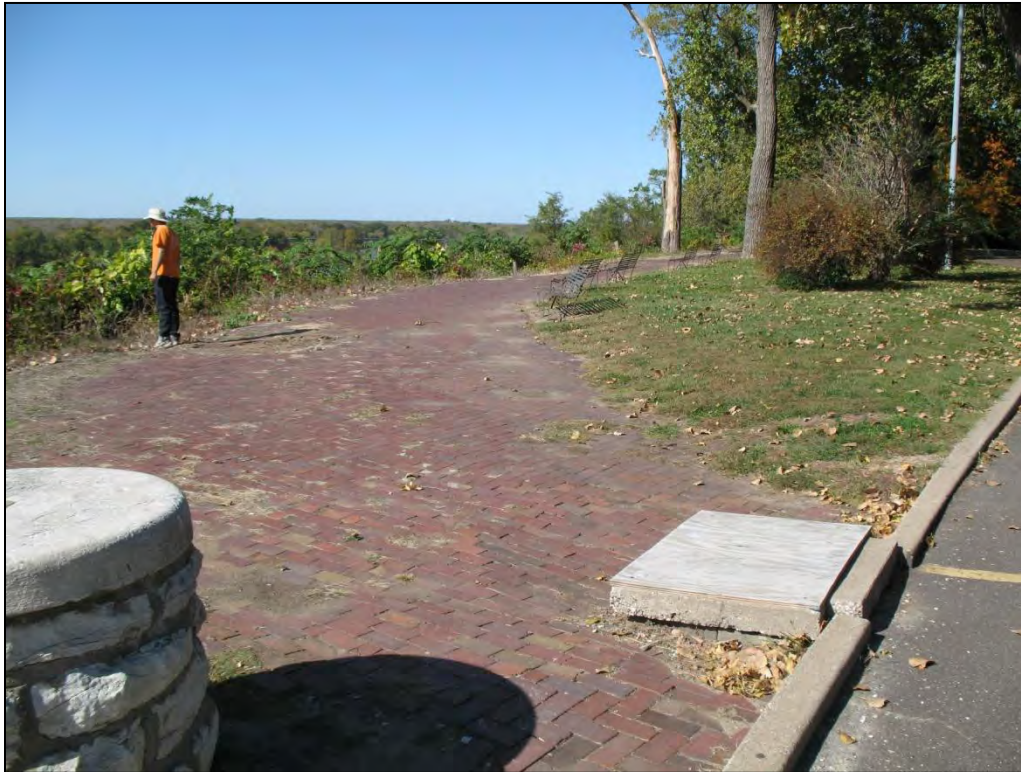
Photo 5:

The brick pathway extends a pedestrian view of the river yet it's scattered with invasive woody material bordering the hill edge and high maintenance turf to the right. Formal native landscaping at the pathway entrance with a backdrop of prairie will give this look out a more formal appeal.

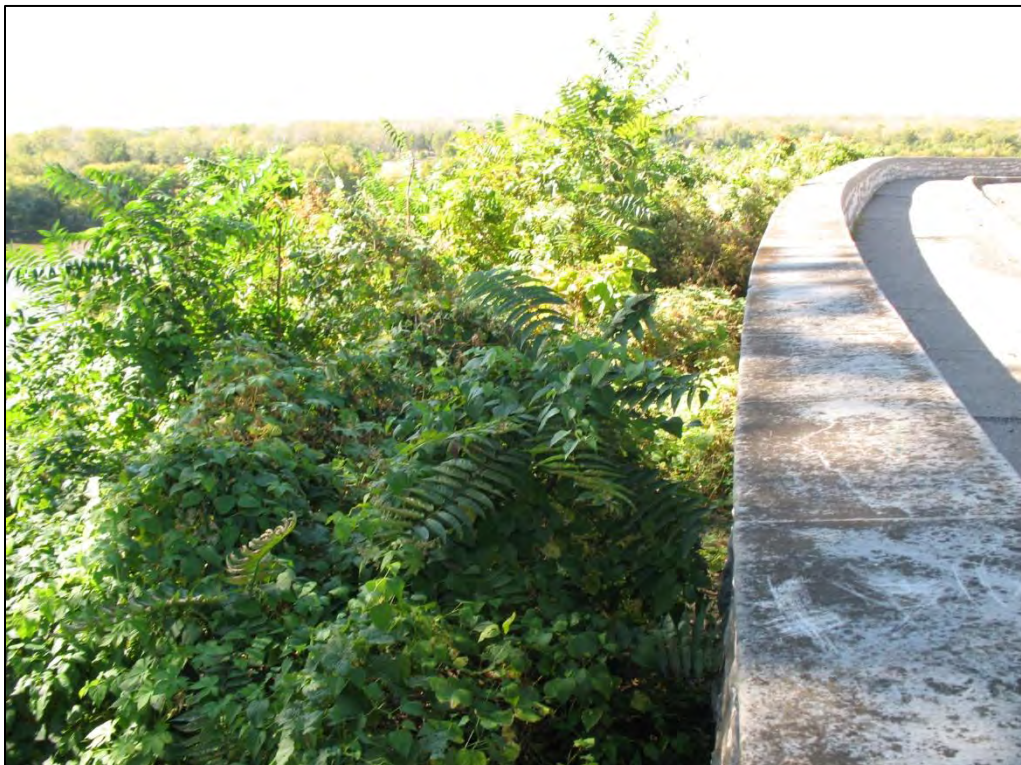
Photo 6:

Sumac, Tree of Heaven, and Honeysuckle have grown excessively tall, inhibiting the public view of the river. All invasive and weedy plants such as these should be eradicated from the site to provide adequate growth for native species.

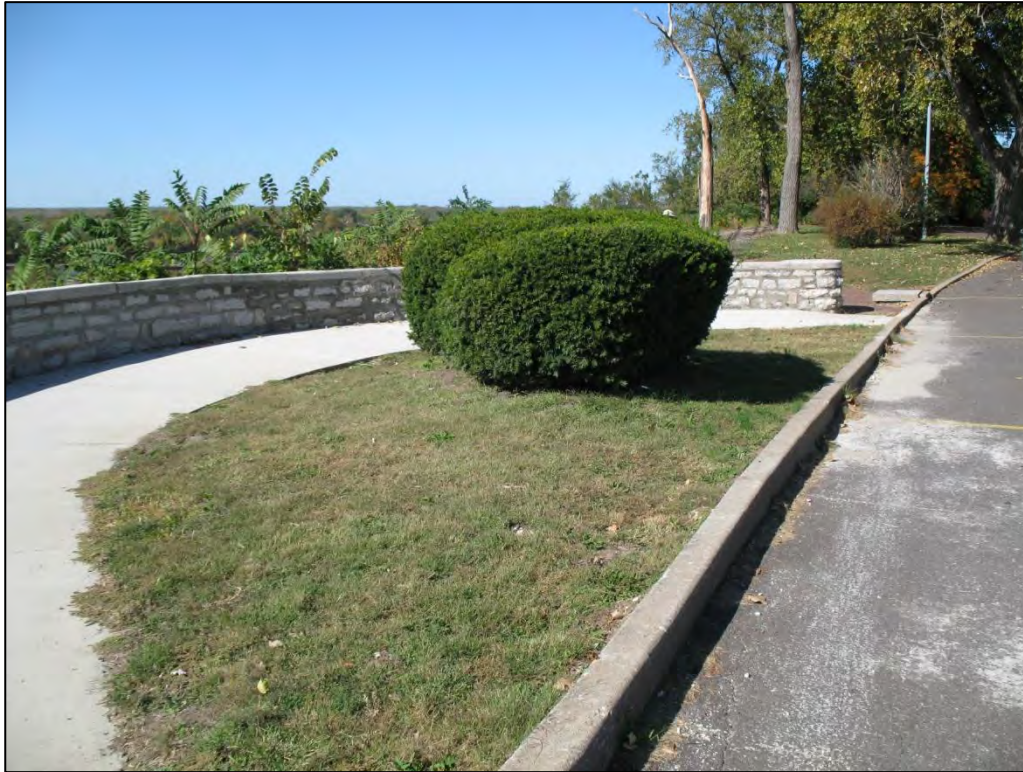
Photo 7:

Two Yew shrubs are two of many random shrubs among the Sunset/Gardner landscape that consume maintenance time and money without providing visual value.

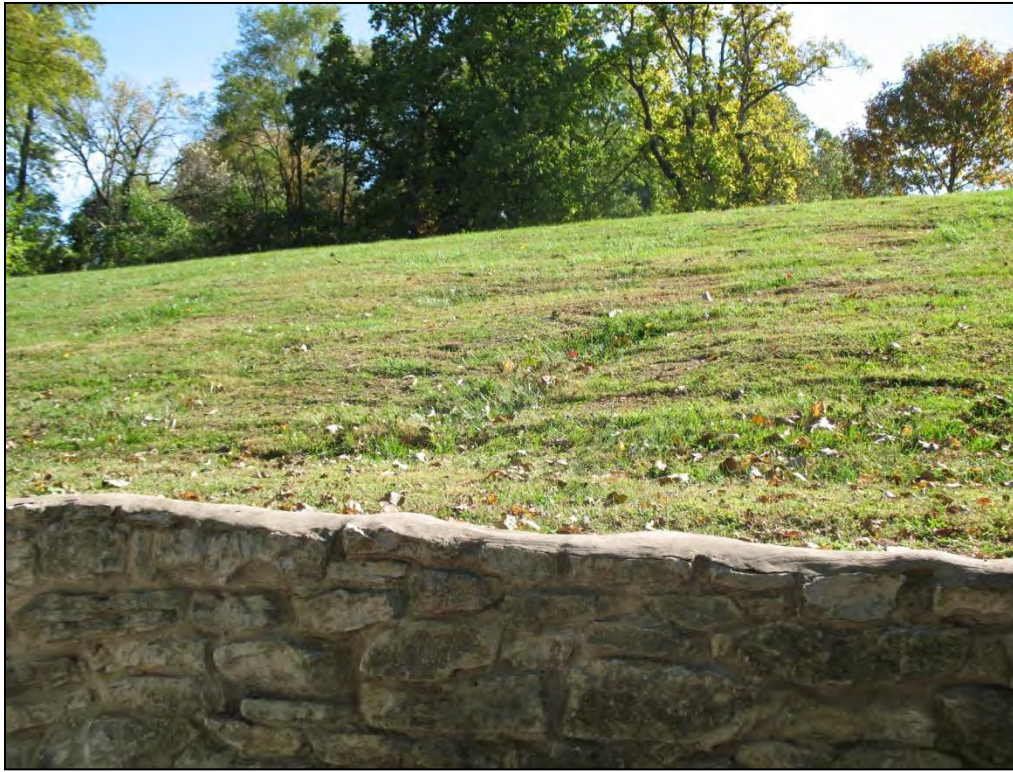
Photo 9:

Excess water flow has eroded lines into the turf lawn. By replacing turf with native prairie, the dynamic root system of these plants will absorb water like a sponge and curb soil from moving.

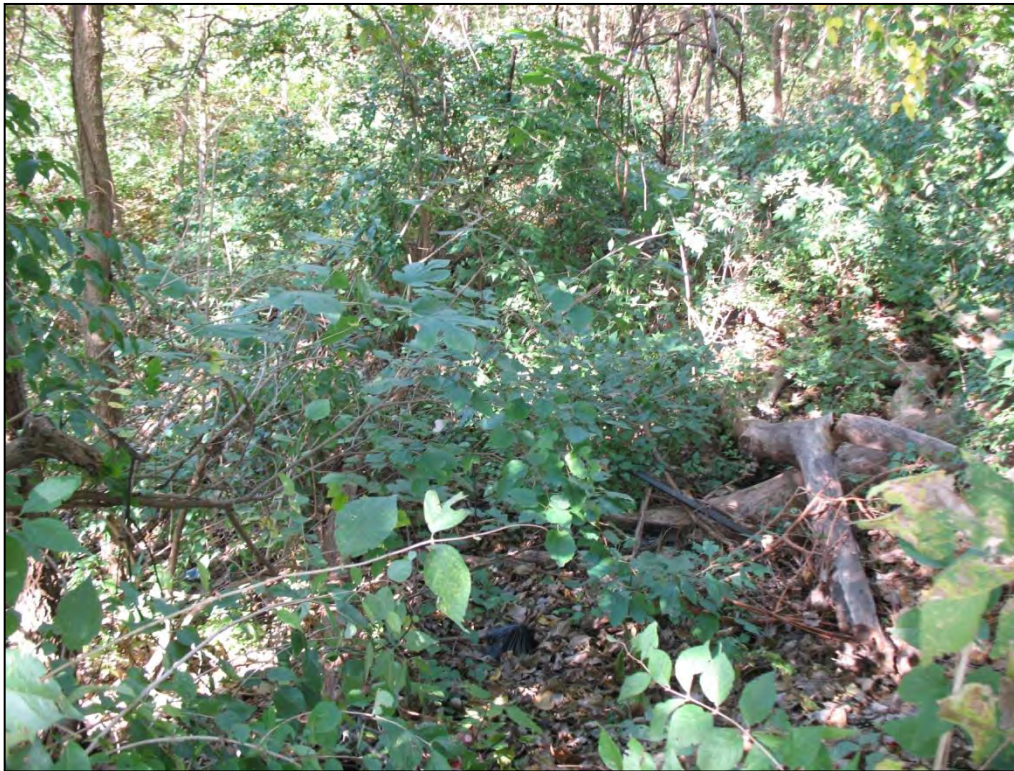
Photo 10:

Honeysuckle and Sugar Maple dominate the woodland understory.

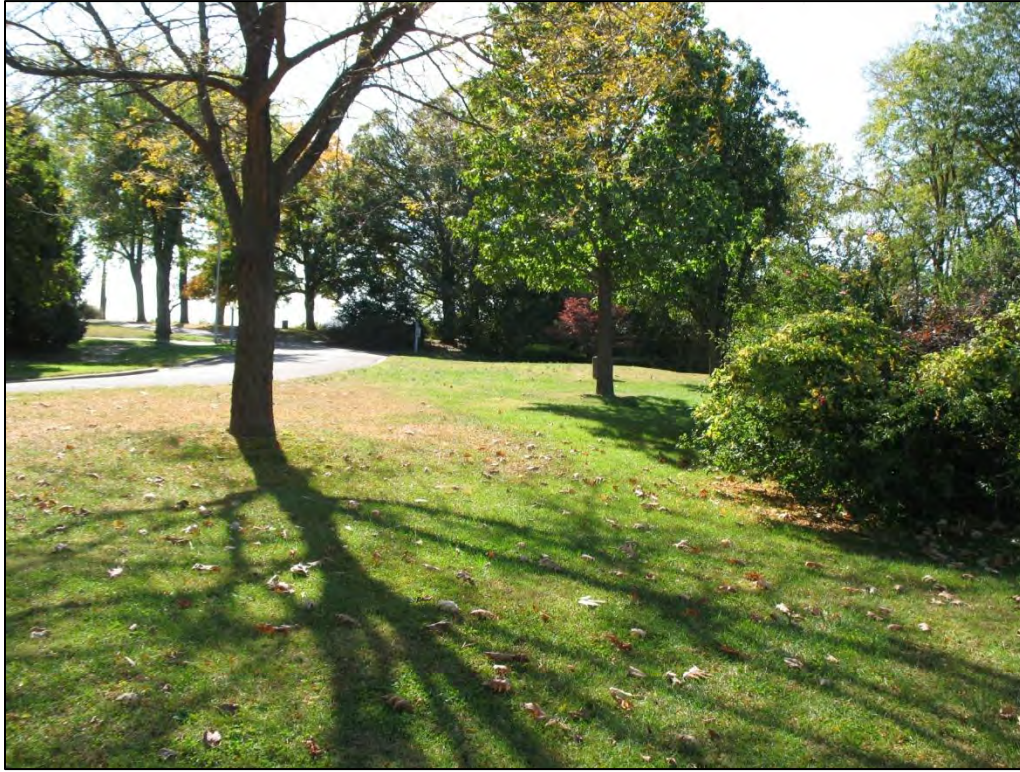
Photo 11:

The northern stretch of Gardner Park is lined with turf lawn and scattered canopy trees. Turning this landscape into natural area would accentuate the picturesque views created by the winding road with swaths of native grasses and perennial color.

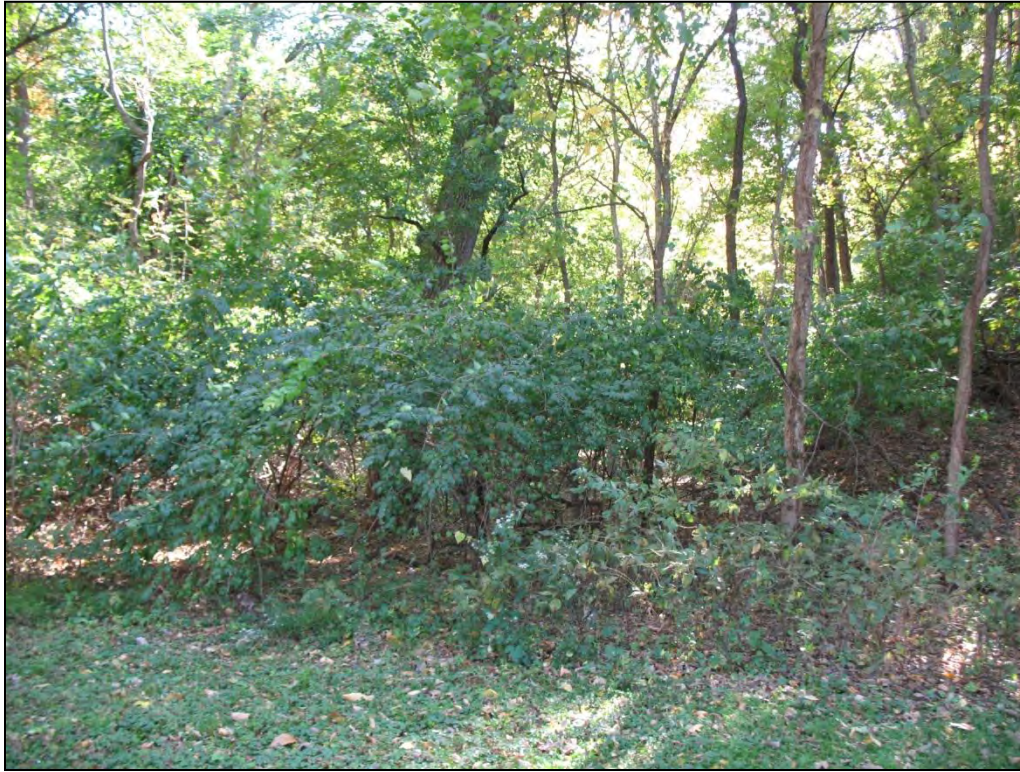
Photo 13:

Honeysuckle has dominated all of the QPD wooded sites, eliminating the open woodland form.

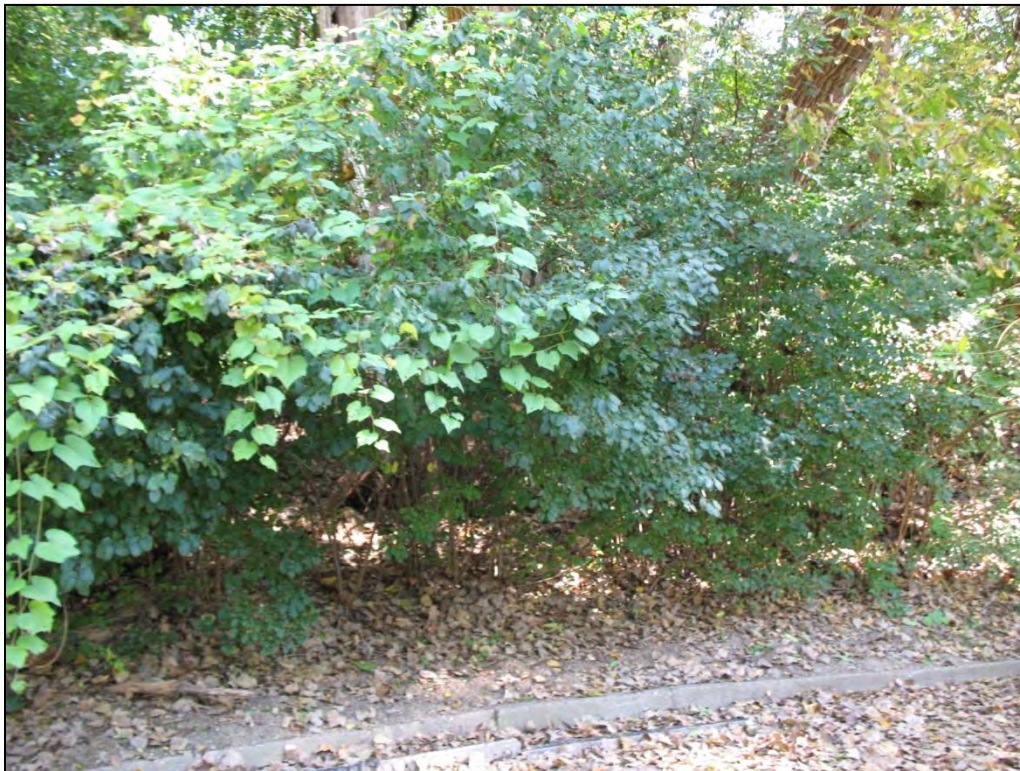
Photo 14:

Exotic Buckthorn and Riverbank Grape spread rapidly along the woodland ground plain, choking native perennials out. Seen here in Sunset Park, either species will have to be cleared to provide proper development of a diverse native woodland understory.

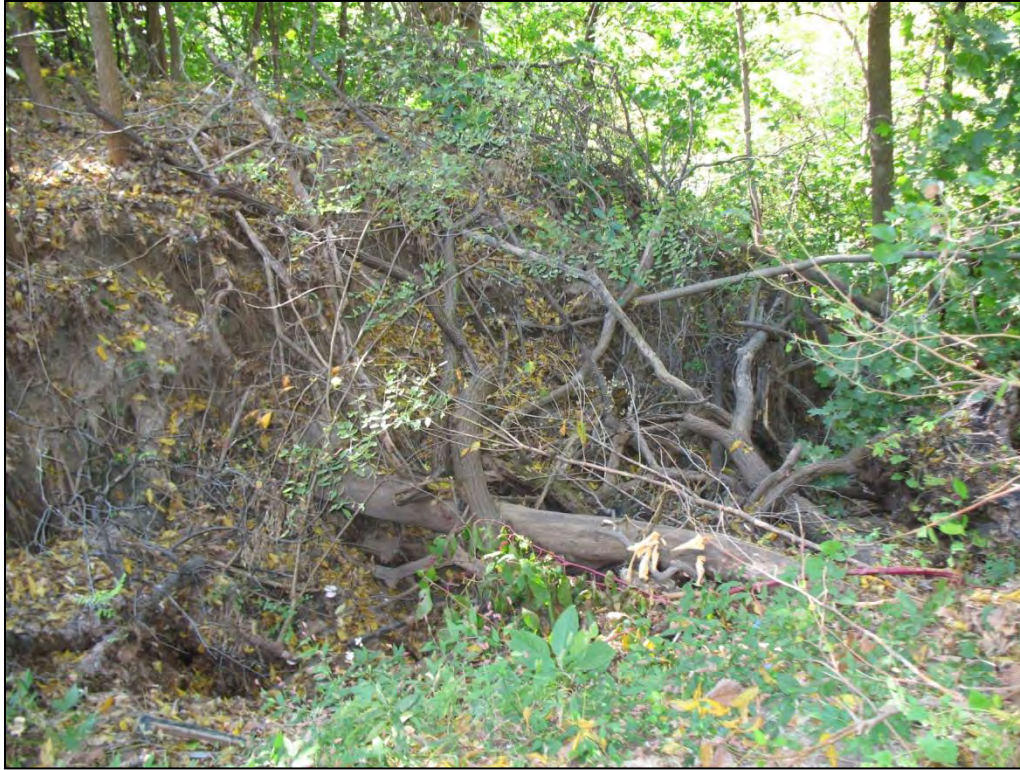
Photo 19:

A portion of the woodland ravines are eroding from a lack of native herbaceous understory growth. The current action of adding garbage and construction materials to eroded areas has become unsightly and dangerous to the public.

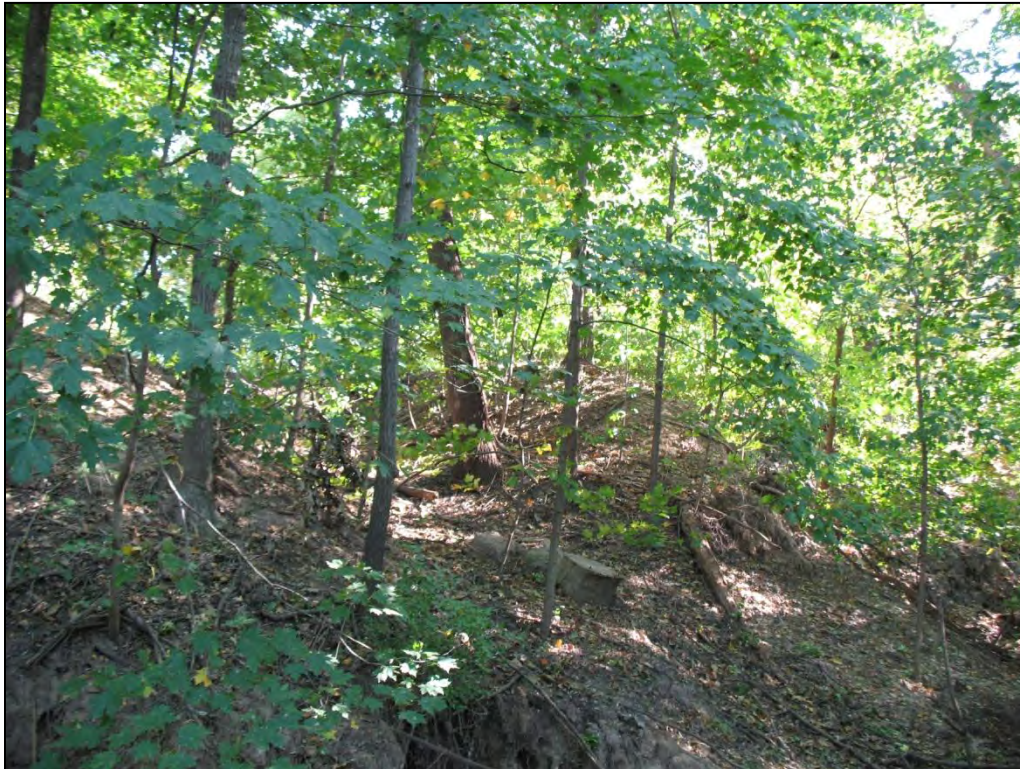
Photo 20:

Sugar Maple, while native, casts extremely dense shade that prevents the growth of an herbaceous understory. Removing/ thinning Maple saplings and restoring the herbaceous layer to the woodland will prevent future erosion from the QPD site ravines.

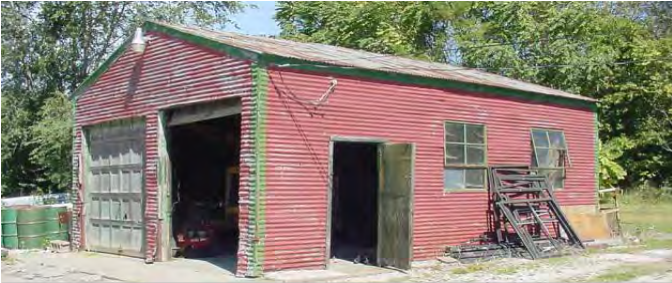
Facility Audit
General Information
 Facility Name: Maint. One Storage Shed
 Location: 1419 Bonansinga Drive
 Approximate Sq. Ft.: 600 (30' x 20')
 General Condition: 2
 Seasons: All
 Hours: When Maint. Worker are present
 Year Built: 1960
 Year(s) of Major Renovations: None
 Type of Construction: Metal Skin/Frame
 Estimated Replacement \$: \$43,500
 Number of Stories: 1
 Current Primary Type of Use: Maint/Vehicle Storage
 Wheelchair Accessible: No

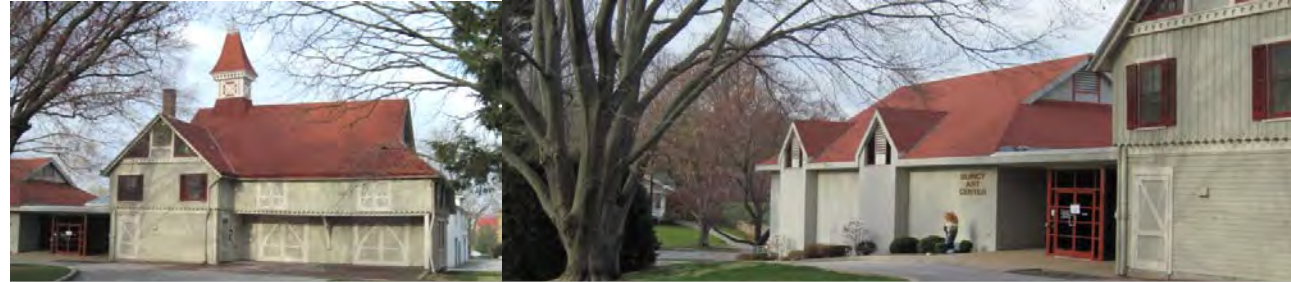
Facility Name: Quincy Art Center
Location: 1515 Jersey Street
Approximate Sq. Ft.: 12,000 160'x40'
General Condition: 2
Seasons: All
Hours: 9 a.m. - 4 p.m. M-F
Year Built: 1870/1990
Year(s) of Major Renovations: 1990
Type of Construction: Wood Frame
Estimated Replacement \$: \$1,039,000
Number of Stories: 2
Current Primary Type of Use: Art Museum/Education
Wheelchair Accessible: Yes

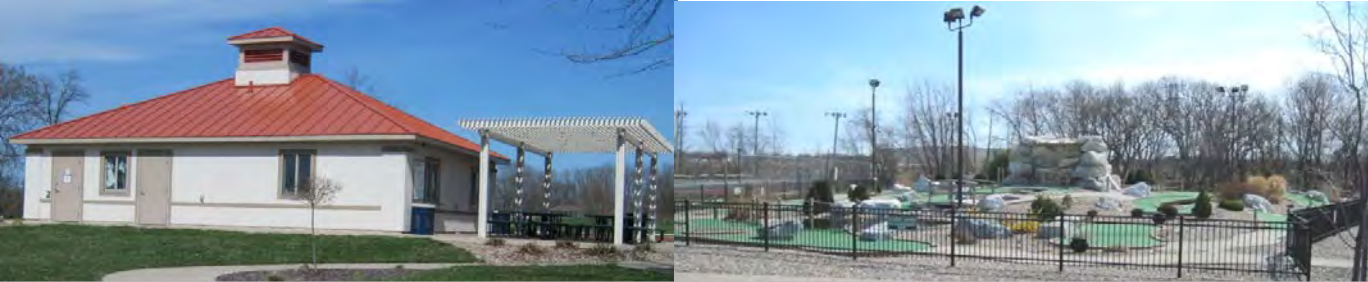
Facility Name: Batting Cage Complex
Location: 1608 Moorman Park Road
Approximate Sq. Ft.: 1200 sq ft. Concession (40'x30')
General Condition: 2
Seasons: Summer
Hours: 11:00 - 7:00
Year Built: 2002
Year(s) of Major Renovations: None
Type of Construction: Concrete/Frame Building
Estimated Replacement \$: \$612,000
Number of Stories: 1
Current Primary Type of Use: Concessions
Wheelchair Accessible: Yes

STRUCTURE/FOUNDATION	General Information	Item in Need of Maintenance/ Repair/Replacement								Estimated
			2012	2013	2014	2015	2016	Sum 1-5	2017-2021	Cost
Type:	Concrete Footing/Wood Frame							\$0	\$0	\$0
Age:	6							\$0	\$0	\$0
General Condition:	2							\$0	\$0	\$0
Estimated Replacement \$:	\$90,000							\$0	\$0	\$0
SECURITY										
Type:	Steel Doors w/locks (4)							\$0	\$0	\$0
Age:	10							\$0	\$0	\$0
General Condition:	2							\$0	\$0	\$0
Estimated Replacement \$:	\$10,000							\$0	\$0	\$0
SECURITY										
Type:	Video Recorder/Cameras							\$0	\$0	\$0
Age:	5							\$0	\$0	\$0
General Condition:	2							\$0	\$0	\$0
Estimated Replacement \$:	\$15,000							\$0	\$0	\$0
OTHER										
Type:	Concession Deck/Pergola							\$0	\$0	\$0
Age:	20							\$0	\$0	\$0
General Condition:	2							\$0	\$0	\$0
Estimated Replacement \$:	\$30,000							\$0	\$0	\$0
Type:	Miniature Golf Course	Replace course carpet		\$15,000				\$15,000	\$0	\$15,000

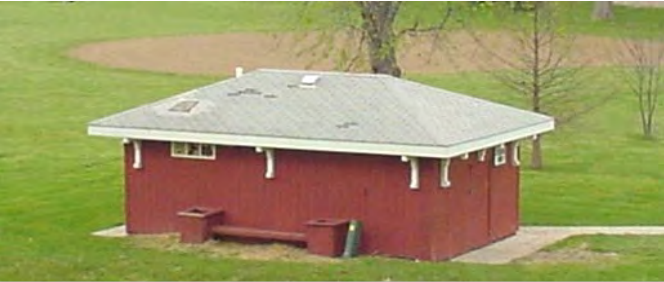
Facility Name: Berrian Restroom
Location: 1128 N. 12th Street
Approximate Sq. Ft.: 504 (28' x 18')
General Condition: 2
Seasons: All
Hours: 30 Min. before SR -11:00 pm Spr,Su,Fall.
Year Built: 1975
Year(s) of Major Renovations: None
Type of Construction: Wood Frame/Asphalt Shingle Roof
Estimated Replacement \$: \$86,000
Number of Stories: 1
Current Primary Type of Use: Restroom & Maintenance Storage
Wheelchair Accessible: No

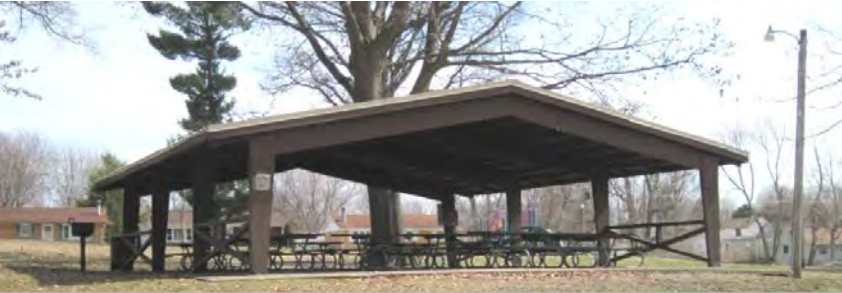
Facility Audit
General Information
 Facility Name: Berrian Shelter
 Location: 1200 N. 13th Street
 Approximate Sq. Ft.: 1,260 (36' x 35')
 General Condition: 2
 Seasons: Spring, Summer, Fall
 Hours: 30 Min. before SR -11:00 pm
 Year Built: 1975
 Year(s) of Major Renovations: None
 Type of Construction: Wood Frame/Slab/Metal Roof
 Estimated Replacement \$: \$63,000
 Number of Stories: 1
 Current Primary Type of Use: Picnic Shelter
 Wheelchair Accessible: Yes

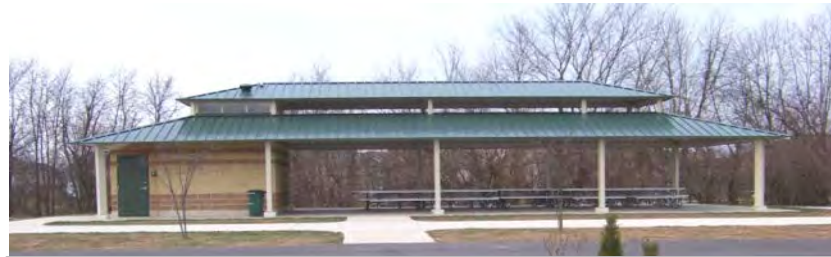
Facility Name: Bob Mays Shelter/Restroom
Location: 2533 N. 18th Street
Approximate Sq. Ft.: 2,450 (70'x35') All, 390 (23'x17')-RR/Storage
General Condition: 2
Seasons: Spring, Summer, Fall
Hours: 30 Minute before Sunrise - 11:00 p.m.
Year Built: 2008
Year(s) of Major Renovations: None
Type of Construction: Steel Frame/Steel Roof/Concrete Block
Estimated Replacement \$: \$264,500
Number of Stories: 1
Current Primary Type of Use: Picnic Shelter and Restrooms
Wheelchair Accessible: Yes

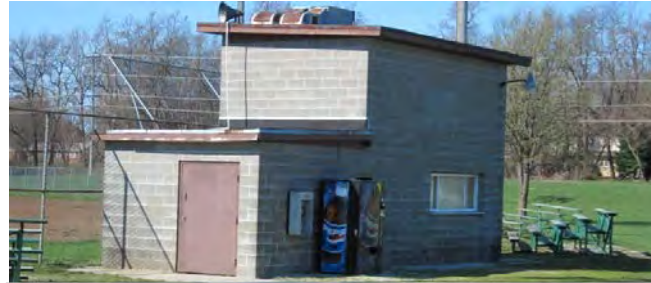
Facility Name: Boots Bush Concession
Location: 4234 Maine
Approximate Sq. Ft.: 200 (20' x 10')
General Condition: 2
Seasons: All
Hours: 30 Min. before SR -11:00 pm Spr,Su,Fall.
Year Built: 1985
Year(s) of Major Renovations: None
Type of Construction: Concrete Block/Concrete Slab
Estimated Replacement \$: \$41,000
Number of Stories: 2
Current Primary Type of Use: Concession/Field Scoring
Wheelchair Accessible: No

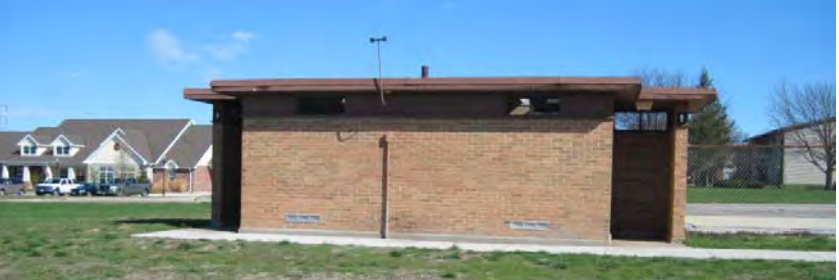
Facility Name: Boots Bush Restroom
Location: 4234 Maine
Approximate Sq. Ft.: 264 (22' x 12')
General Condition: 2
Seasons: Spring, Summer, Fall
Hours: 30 Minute before Sunrise - 11:00 p.m.
Year Built: 1975
Year(s) of Major Renovations: None
Type of Construction: Brick/Flat Roof
Estimated Replacement \$: \$71,500
Number of Stories: 1
Current Primary Type of Use: Picnic Shelter
Wheelchair Accessible:

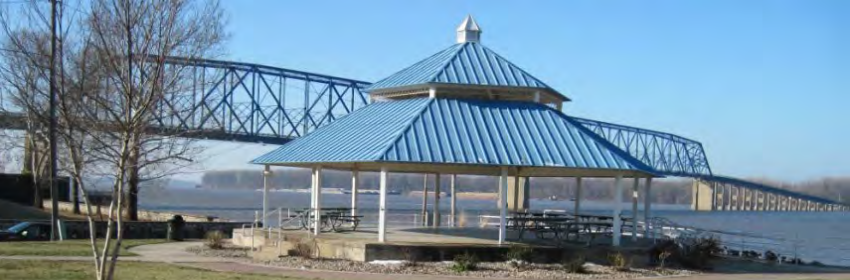
Facility Name: Clat Adams Gazebo
Location: 201 N. Front Street
Approximate Sq. Ft.: 45'x45' Hex (1426 sq ft)
General Condition: 2
Seasons: Spring, Summer, Fall
Hours: 30 Minute before Sunrise - 11:00 p.m.
Year Built: 1993
Year(s) of Major Renovations: None
Type of Construction: Steel Frame/Metal Roof
Estimated Replacement \$: \$114,000
Number of Stories: 1
Current Primary Type of Use: Picnic/Wedding
Wheelchair Accessible: Yes

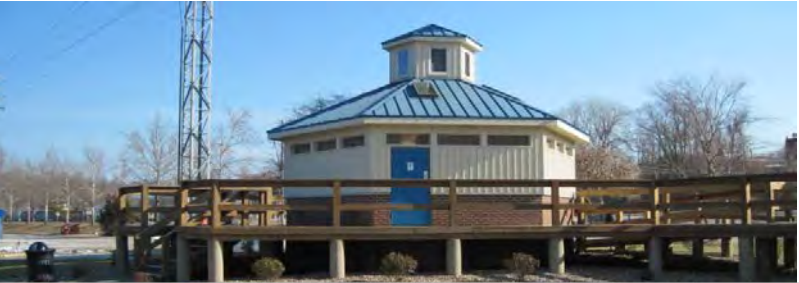
Facility Name: Clat Adams Restroom
Location: 201 N. Front Street
Approximate Sq. Ft.: 900 30'x30' Hex
General Condition: 2
Seasons: All
Hours: 30 Min. before SR -11:00 pm Spr,Su,Fall.
Year Built: 1993
Year(s) of Major Renovations: None
Type of Construction: Brick/Block/Wood
Estimated Replacement \$: \$179,500
Number of Stories: 1
Current Primary Type of Use: Restroom
Wheelchair Accessible: Yes

<u>OTHER</u>		Item in Need of Maintenance/ <u>Repair/Replacement</u>	<u>2012</u>	<u>2013</u>	<u>2014</u>	<u>2015</u>	<u>2016</u>	<u>Sum 1-5</u>	<u>2017-2021</u>	Estimated <u>Cost</u>
Type:	Wood Deck	Replace Deck		\$40,000				\$40,000	\$0	\$40,000
Age:	19							\$0	\$0	\$0
General Condition:	3							\$0	\$0	\$0
Estimated Replacement \$:	\$40,000							\$0	\$0	\$0

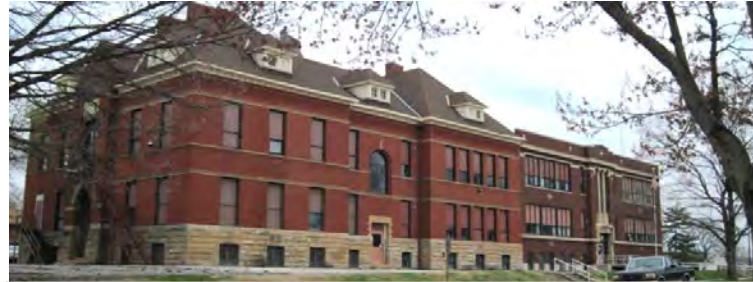
Facility Audit
General Information
 Facility Name: Emerson Community Center
 Location: 1310 Washington Street
 Approximate Sq. Ft.: 37,000
 General Condition: 3
 Seasons: Spring, Summer, Fall
 Hours: 30 Min. before SR -11:00 pm
 Year Built: 1900/1925
 Year(s) of Major Renovations: None
 Type of Construction: Wood Frame/Slab/Metal Roof
 Estimated Replacement \$: \$3,316,000
 Number of Stories: 3
 Current Primary Type of Use: Picnic Shelter
 Wheelchair Accessible: Yes

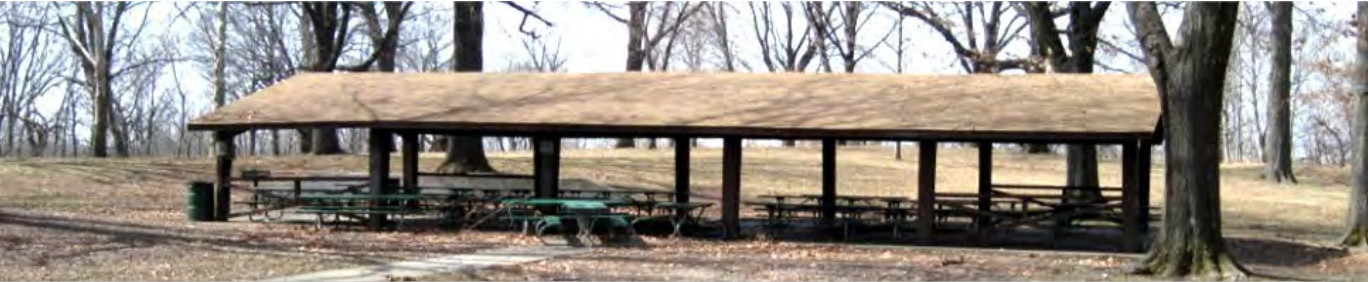
Facility Name: Gardner Shelter
Location: 1831 N. 3rd
Approximate Sq. Ft.: 2,275 (65' x 35')
General Condition: 2
Seasons: Spring, Summer, Fall
Hours: 30 Minute before Sunrise - 11:00 p.m.
Year Built: 1975
Year(s) of Major Renovations: None
Type of Construction: Wood Frame/Asphalt Shingle Roof
Estimated Replacement \$: \$102,000
Number of Stories: 1
Current Primary Type of Use: Picnic Shelter
Wheelchair Accessible:

Item in Need of Maintenance/ Repair/Replacement		2012	2013	2014	2015	2016	Sum 1-5	2017-2021	Estimated Cost
ROOF									
Type:	Stained Wood Sheathing/Asphalt Shingle						\$0	\$0	\$0
Age:	37						\$0	\$0	\$0
General Condition:	2						\$0	\$0	\$0
Estimated Replacement \$:	\$10,000						\$0	\$0	\$0

EXTERIOR/WINDOWS									
Type:	Stained Wood Frame/Truss						\$0	\$0	\$0
Age:	37						\$0	\$0	\$0
General Condition:	2						\$0	\$0	\$0
Estimated Replacement \$:	\$2,000						\$0	\$0	\$0

INTERIOR/FINISHES									
Type:	Stained Wood Frame/Truss						\$0	\$0	\$0
Age:	2						\$0	\$0	\$0
General Condition:	3						\$0	\$0	\$0
Estimated Replacement \$:	\$2,000						\$0	\$0	\$0

Item in Need of Maintenance/ Repair/Replacement	2012	2013	2014	2015	2016	Sum 1-5	2017-2021	Estimated Cost
ELECTRICAL/LIGHTING										
Type:	100 amp, 8 outlets, 6 CFL Lights	Electrical Upgrade					\$5,000	\$5,000	\$0	\$5,000
Age:	37							\$0	\$0	\$0
General Condition:	3							\$0	\$0	\$0
Estimated Replacement \$:	\$8,000							\$0	\$0	\$0
STRUCTURE/FOUNDATION										
Type:	Wood Support/Truss							\$0	\$0	\$0
Age:	37							\$0	\$0	\$0
General Condition:	2							\$0	\$0	\$0
Estimated Replacement \$:	\$60,000							\$0	\$0	\$0
Type:	Reinforced Concrete Slab/Footing							\$0	\$0	\$0
Age:	37							\$0	\$0	\$0
General Condition:	3							\$0	\$0	\$0
Estimated Replacement \$:	\$20,000							\$0	\$0	\$0
SECURITY										
Type:								\$0	\$0	\$0
Age:								\$0	\$0	\$0
General Condition:								\$0	\$0	\$0
Estimated Replacement \$:								\$0	\$0	\$0
OTHER										
Type:								\$0	\$0	\$0
Age:								\$0	\$0	\$0

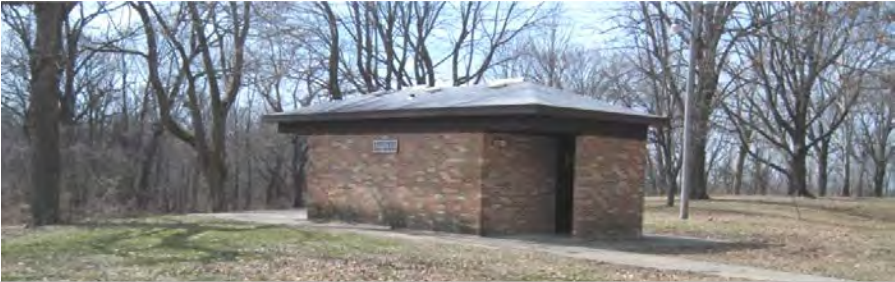
Facility Name: Gardner Restroom
Location: 1831 N. 3rd
Approximate Sq. Ft.: 300 (25' x 12')
General Condition: 2
Seasons: Spring, Summer, Fall
Hours: 30 Minute before Sunrise - 11:00 p.m.
Year Built: 1975
Year(s) of Major Renovations: None
Type of Construction: Wood Frame/Asphalt Shingle Roof
Estimated Replacement \$: \$81,500
Number of Stories: 1
Current Primary Type of Use: Picnic Shelter
Wheelchair Accessible: No

<u>ROOF</u>		<u>Item in Need of Maintenance/Repair/Replacement</u>	<u>2012</u>	<u>2013</u>	<u>2014</u>	<u>2015</u>	<u>2016</u>	<u>Sum 1-5</u>	<u>2017-2021</u>	<u>Estimated Cost</u>
Type:	Asphalt Shingle							\$0	\$0	\$0
Age:	37							\$0	\$0	\$0
General Condition:	2							\$0	\$0	\$0
Estimated Replacement \$:	\$4,000							\$0	\$0	\$0

<u>PLUMBING</u>										
Type:	City Water							\$0	\$0	\$0
Age:	37							\$0	\$0	\$0
General Condition:	2							\$0	\$0	\$0
Estimated Replacement \$:	\$15,000							\$0	\$0	\$0

Type:	Electric Hot Water (Tank)							\$0	\$0	\$0
Age:	20							\$0	\$0	\$0
General Condition:	2							\$0	\$0	\$0
Estimated Replacement \$:	\$1,500							\$0	\$0	\$0

Item in Need of Maintenance/ Repair/Replacement	2012	2013	2014	2015	2016	Sum 1-5	2017-2021	Estimated Cost
<u>RESTROOMS</u>										
Type:	2T, 2L (1 each side M/W)							\$0	\$0	\$0
Age:	37							\$0	\$0	\$0
General Condition:	2							\$0	\$0	\$0
Estimated Replacement \$:	\$6,000							\$0	\$0	\$0
<u>EXTERIOR/WINDOWS</u>										
Type:	Brick							\$0	\$0	\$0
Age:	37							\$0	\$0	\$0
General Condition:	2							\$0	\$0	\$0
Estimated Replacement \$:	\$2,000							\$0	\$0	\$0
<u>INTERIOR/FINISHES</u>										
Type:	Painted Block							\$0	\$0	\$0
Age:	37							\$0	\$0	\$0
General Condition:	2							\$0	\$0	\$0
Estimated Replacement \$:	\$2,000							\$0	\$0	\$0
<u>ELECTRICAL/LIGHTING</u>										
Type:	100 amp, 4 MH Lights							\$0	\$0	\$0
Age:	25							\$0	\$0	\$0
General Condition:	2							\$0	\$0	\$0
Estimated Replacement \$:	\$6,000							\$0	\$0	\$0
<u>STRUCTURE/FOUNDATION</u>										
Type:	Wood Frame/Brick							\$0	\$0	\$0

Age:	37							\$0	\$0	\$0
General Condition:	2							\$0	\$0	\$0
Estimated Replacement \$:	\$20,000							\$0	\$0	\$0
Type:	Reinforced Concrete Slab/Footing							\$0	\$0	\$0
Age:	37							\$0	\$0	\$0
General Condition:	2							\$0	\$0	\$0
Estimated Replacement \$:	\$20,000							\$0	\$0	\$0
<u>SECURITY</u>										
Type:	Steel Doors w/Locks (2)							\$0	\$0	\$0
Age:	37							\$0	\$0	\$0
General Condition:	2							\$0	\$0	\$0
Estimated Replacement \$:	\$5,000							\$0	\$0	\$0

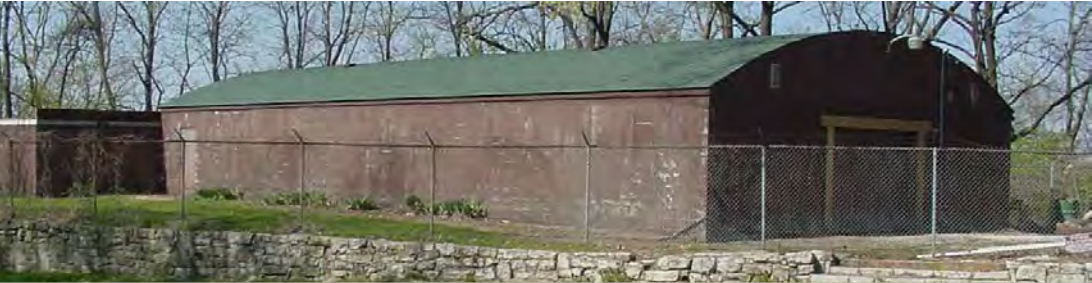
Facility Audit
General Information
 Facility Name: Indian Mounds Storage
 Location: Indian Mounds Road
 Approximate Sq. Ft.: 2,450 (70' x 35')
 General Condition: 2
 Seasons: All
 Hours: No Public Hours
 Year Built: 1967
 Year(s) of Major Renovations: None
 Type of Construction: Concrete Block
 Estimated Replacement \$: \$85,000
 Number of Stories: 1
 Current Primary Type of Use: Park Maintenance Facility
 Wheelchair Accessible: No

<u>ROOF</u>	<u>General Information</u>	<u>Item in Need of Maintenance/ Repair/Replacement</u>	<u>2012</u>	<u>2013</u>	<u>2014</u>	<u>2015</u>	<u>2016</u>	<u>Sum 1-5</u>	<u>2017-2021</u>	<u>Estimated Cost</u>
Type:	Fiberglass Shingle/Wood Frame							\$0	\$0	\$0
Age:	15							\$0	\$0	\$0
General Condition:	2							\$0	\$0	\$0
Estimated Replacement \$:	\$10,000							\$0	\$0	\$0

<u>EXTERIOR/WINDOWS</u>	<u>General Information</u>	<u>Item in Need of Maintenance/ Repair/Replacement</u>	<u>2012</u>	<u>2013</u>	<u>2014</u>	<u>2015</u>	<u>2016</u>	<u>Sum 1-5</u>	<u>2017-2021</u>	<u>Estimated Cost</u>
Type:	Painted Concrete Block							\$0	\$0	\$0
Age:	44							\$0	\$0	\$0
General Condition:	2							\$0	\$0	\$0
Estimated Replacement \$:	\$2,000							\$0	\$0	\$0

<u>INTERIOR/FINISHES</u>	<u>General Information</u>	<u>Item in Need of Maintenance/ Repair/Replacement</u>	<u>2012</u>	<u>2013</u>	<u>2014</u>	<u>2015</u>	<u>2016</u>	<u>Sum 1-5</u>	<u>2017-2021</u>	<u>Estimated Cost</u>
Type:	Concrete Block							\$0	\$0	\$0
Age:	44							\$0	\$0	\$0
General Condition:	2							\$0	\$0	\$0
Estimated Replacement \$:	\$1,000							\$0	\$0	\$0

STRUCTURE/FOUNDATION	General Information	Item in Need of Maintenance/ Repair/Replacement						Estimated	
			2012	2013	2014	2015	2016	Sum 1-5	2017-2021 Cost
Type:	Concrete Foundation/Floor/Block							\$0	\$0
Age:	44							\$0	\$0
General Condition:	2							\$0	\$0
Estimated Replacement \$:	\$70,000							\$0	\$0
SECURITY									
Type:	Door W/Lock							\$0	\$0
Age:	30							\$0	\$0
General Condition:	2							\$0	\$0
Estimated Replacement \$:	\$2,000							\$0	\$0
OTHER									
Type:								\$0	\$0
Age:								\$0	\$0
General Condition:								\$0	\$0
Estimated Replacement \$:								\$0	\$0

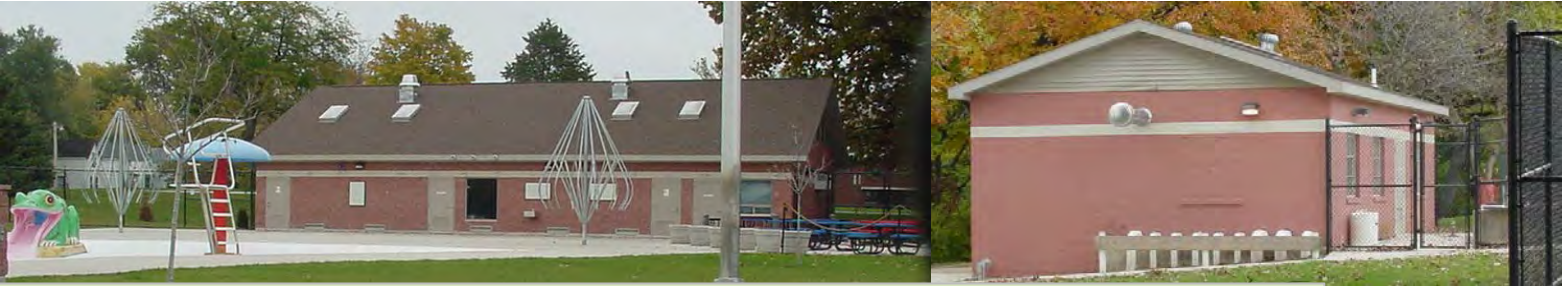
Facility Audit
General Information
 Facility Name: Indian Mounds Pool
 Location: 1400 S. 5th Street
 Approximate Sq. Ft.: 3800 Basin, 2600 Bathhouse, 840 Filter
 General Condition: 2
 Seasons: Summer
 Hours: 11:00 - 7:00
 Year Built: 2002
 Year(s) of Major Renovations: None
 Type of Construction: Concrete
 Estimated Replacement \$: \$1,476,000
 Number of Stories: 1
 Current Primary Type of Use: Swimming
 Wheelchair Accessible: Yes

<u>2012</u>	<u>2013</u>	<u>2014</u>	<u>2015</u>	<u>2016</u>	<u>Sum 1-5</u>	<u>2017-2021</u>	<u>Estimated Cost</u>
Indian Mounds Pool	\$62,000	\$0	\$0	\$0	\$0	\$62,000	\$0	\$62,000

<u>HVAC</u>		<u>General Information</u>	<u>Item in Need of Maintenance/Repair/Replacement</u>	<u>2012</u>	<u>2013</u>	<u>2014</u>	<u>2015</u>	<u>2016</u>	<u>Sum 1-5</u>	<u>2017-2021</u>	<u>Estimated Cost</u>
Type:	Window AC								\$0	\$0	\$0
Age:	10								\$0	\$0	\$0
General Condition:	2								\$0	\$0	\$0
Estimated Replacement \$:	\$2,000								\$0	\$0	\$0
<u>PLUMBING</u>											
Type:	City Water								\$0	\$0	\$0
Age:	10								\$0	\$0	\$0
General Condition:	2								\$0	\$0	\$0
Estimated Replacement \$:	\$15,000								\$0	\$0	\$0
Type:	Spray fountains/Water Circulation								\$0	\$0	\$0
Age:	10								\$0	\$0	\$0
General Condition:	2								\$0	\$0	\$0
Estimated Replacement \$:	\$100,000								\$0	\$0	\$0

PLUMBING	General Information	Item in Need of Maintenance/ Repair/Replacement	2012	2013	2014	2015	2016	Sum 1-5	2017-2021	Estimated Cost
Type:	2 HW Heater, Wash sink							\$0	\$0	\$0
Age:	10							\$0	\$0	\$0
General Condition:	2							\$0	\$0	\$0
Estimated Replacement \$:	\$7,000							\$0	\$0	\$0
<u>RESTROOMS</u>										
Type:	3T, 3U, 2L (M), 6T, 2L (W), 4 Shwrs ea side							\$0	\$0	\$0
Age:	10							\$0	\$0	\$0
General Condition:	2							\$0	\$0	\$0
Estimated Replacement \$:	\$80,000							\$0	\$0	\$0
<u>ROOF</u>										
Type:	Asphalt Shingles							\$0	\$0	\$0
Age:	15							\$0	\$0	\$0
General Condition:	2							\$0	\$0	\$0
Estimated Replacement \$:	\$20,000							\$0	\$0	\$0
<u>EXTERIOR/WINDOWS</u>										
Type:	Concrete Block							\$0	\$0	\$0
Age:	10 Bath/50 Filter							\$0	\$0	\$0
General Condition:	2							\$0	\$0	\$0
Estimated Replacement \$:	\$5,000							\$0	\$0	\$0
<u>EXTERIOR/WINDOWS</u>

Type:	Concession Window (2)							\$0	\$0	\$0
Age:	10							\$0	\$0	\$0
General Condition:	2							\$0	\$0	\$0
Estimated Replacement \$:	\$4,000							\$0	\$0	\$0
<u>INTERIOR/FINISHES</u>										
Type:	Painted Concrete Block							\$0	\$0	\$0
Age:	10							\$0	\$0	\$0
General Condition:	2							\$0	\$0	\$0
Estimated Replacement \$:	\$5,000							\$0	\$0	\$0
<u>ELECTRICAL/LIGHTING</u>										
Type:	400 Amp, 8 Flr, 6 MH							\$0	\$0	\$0
Age:	37							\$0	\$0	\$0
General Condition:	2							\$0	\$0	\$0
Estimated Replacement \$:	\$120,000							\$0	\$0	\$0

SANITARY/CUSTODIAL	General Information	Item in Need of Maintenance/ Repair/Replacement	2012	2013	2014	2015	2016	Sum 1-5	2017-2021	Estimated Cost
Type:	City Sewer							\$0	\$0	\$0
Age:	10							\$0	\$0	\$0
General Condition:	2							\$0	\$0	\$0
Estimated Replacement \$:	\$15,000							\$0	\$0	\$0
STRUCTURE/FOUNDATION										
Type:	Bathhouse - Concrete Footing/Block							\$0	\$0	\$0
Age:	10							\$0	\$0	\$0
General Condition:	2							\$0	\$0	\$0
Estimated Replacement \$:	\$150,000							\$0	\$0	\$0
Type:	Filter Bldg - Concrete Footing/Block							\$0	\$0	\$0
Age:	37							\$0	\$0	\$0
General Condition:	2							\$0	\$0	\$0
Estimated Replacement \$:	\$60,000							\$0	\$0	\$0
Type:	Basin - Concrete Footing/Concrete Sides	Replace deck drains	\$62,000					\$62,000	\$0	\$62,000
Age:	10							\$0	\$0	\$0
General Condition:	2							\$0	\$0	\$0
Estimated Replacement \$:	\$500,000							\$0	\$0	\$0
SECURITY

Type:	Steel Doors w/locks (5)							\$0	\$0	\$0
Age:	10							\$0	\$0	\$0
General Condition:	2							\$0	\$0	\$0
Estimated Replacement \$:	\$15,000							\$0	\$0	\$0
Type:	750' Black vinyl chain link fence							\$0	\$0	\$0
Age:	10							\$0	\$0	\$0
General Condition:	2							\$0	\$0	\$0
Estimated Replacement \$:	\$50,000							\$0	\$0	\$0
Type:	Video Recorder/Cameras							\$0	\$0	\$0
Age:	10							\$0	\$0	\$0
General Condition:	2							\$0	\$0	\$0
Estimated Replacement \$:	\$8,000							\$0	\$0	\$0

<u>OTHER</u>	Item in Need of Maintenance/									Estimated
	<u>General Information</u>	<u>Repair/Replacement</u>	<u>2012</u>	<u>2013</u>	<u>2014</u>	<u>2015</u>	<u>2016</u>	<u>Sum 1-5</u>	<u>2017-2021</u>	<u>Cost</u>
Type:	DE Filter and Feature Pumps							\$0	\$0	\$0
Age:	30							\$0	\$0	\$0
General Condition:	2							\$0	\$0	\$0
Estimated Replacement \$:	\$200,000							\$0	\$0	\$0
<u>OTHER</u>										
Type:	Disinfection/Controller							\$0	\$0	\$0
Age:	10							\$0	\$0	\$0
General Condition:	2							\$0	\$0	\$0
Estimated Replacement \$:	\$80,000							\$0	\$0	\$0
Type:	Water Features (Frog/Umbrella)							\$0	\$0	\$0
Age:	10							\$0	\$0	\$0
General Condition:	2							\$0	\$0	\$0
Estimated Replacement \$:	\$40,000							\$0	\$0	\$0

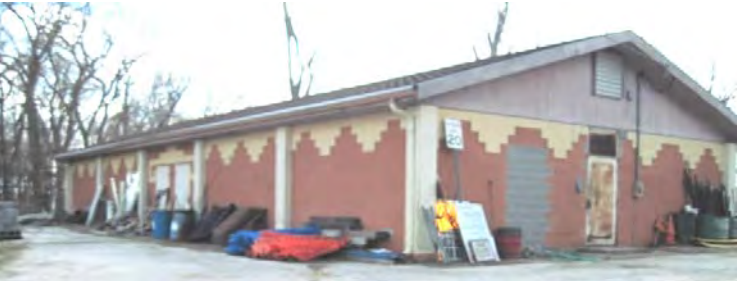
Facility Name: Island Storage (Museum)
Location: 1009 Quinsippi Island Road
Approximate Sq. Ft.: 3200, 80'x40'
General Condition: 2
Seasons: Sp, Su, Fa
Hours: No Public Hours
Year Built: 1968
Year(s) of Major Renovations: None
Type of Construction: Metal Frame/Roof/Floats
Estimated Replacement \$: \$152,000
Number of Stories: 1
Current Primary Type of Use: Storage
Wheelchair Accessible: No

<u>ROOF</u>	<u>General Information</u>	<u>Item in Need of Maintenance/ Repair/Replacement</u>	<u>2012</u>	<u>2013</u>	<u>2014</u>	<u>2015</u>	<u>2016</u>	<u>Sum 1-5</u>	<u>2017-2021</u>	<u>Estimated Cost</u>
Type:	Fiberglass Shingle							\$0	\$0	\$0
Age:	44							\$0	\$0	\$0
General Condition:	2							\$0	\$0	\$0
Estimated Replacement \$:	\$12,000							\$0	\$0	\$0

<u>INTERIOR/FINISHES</u>										
Type:	Concert Block Walls/Concrete Floor							\$0	\$0	\$0
Age:	42							\$0	\$0	\$0
General Condition:	2							\$0	\$0	\$0
Estimated Replacement \$:	\$2,000							\$0	\$0	\$0

<u>EXTERIOR/WINDOWS</u>										
Type:	Painted Concrete Block							\$0	\$0	\$0
Age:	44							\$0	\$0	\$0
General Condition:	2							\$0	\$0	\$0
Estimated Replacement \$:	\$10,000							\$0	\$0	\$0

Item in Need of Maintenance/							Estimated	
<u>ELECTRICAL/LIGHTING</u>	<u>General Information</u>	<u>Repair/Replacement</u>	<u>2012</u>	<u>2013</u>	<u>2014</u>	<u>2015</u>	<u>2016</u>	<u>Sum 1-5</u>	<u>2017-2021</u>	<u>Cost</u>
Type:	100 Amp							\$0	\$0	\$0
Age:	10							\$0	\$0	\$0
General Condition:	2							\$0	\$0	\$0
Estimated Replacement \$:	\$8,000							\$0	\$0	\$0
<u>STRUCTURE/FOUNDATION</u>										
Type:	Concrete footing/Floor/Block Walls							\$0	\$0	\$0
Age:	44							\$0	\$0	\$0
General Condition:	2							\$0	\$0	\$0
Estimated Replacement \$:	\$120,000							\$0	\$0	\$0

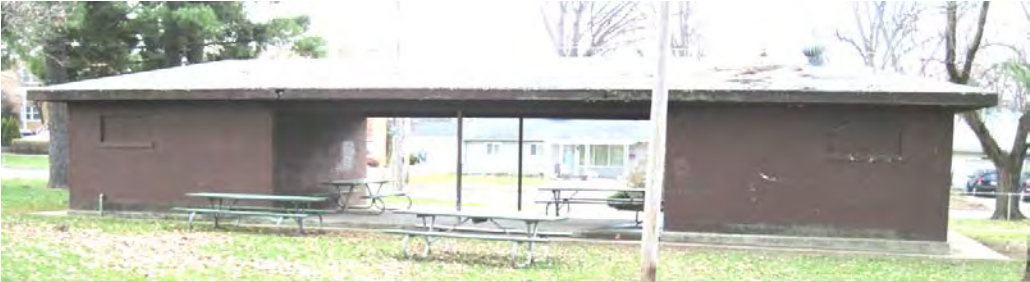
Facility Name: Johnson Restroom
Location: 1901 Harrison Street
Approximate Sq. Ft.: 600 (40' x 15')
General Condition: 2
Seasons: All
Hours: 30 Min. before SR -11:00 pm Spr,Su,Fall.
Year Built: 1975
Year(s) of Major Renovations: None
Type of Construction: Brick/Block/Asphalt Shingle Roof
Estimated Replacement \$: \$112,000
Number of Stories: 1
Current Primary Type of Use: Restroom & Maintenance Storage
Wheelchair Accessible: Yes

<u>2012</u>	<u>2013</u>	<u>2014</u>	<u>2015</u>	<u>2016</u>	<u>Sum 1-5</u>	<u>2017-2021</u>	<u>Estimated Cost</u>
Johnson Restroom	\$0	\$9,000	\$0	\$0	\$0	\$9,000	\$0	\$9,000

Item in Need of Maintenance/ Repair/Replacement										<u>Estimated Cost</u>
<u>PLUMBING</u>			<u>2012</u>	<u>2013</u>	<u>2014</u>	<u>2015</u>	<u>2016</u>	<u>Sum 1-5</u>	<u>2017-2021</u>	
Type:	City Water							\$0	\$0	\$0
Age:	37							\$0	\$0	\$0
General Condition:	2							\$0	\$0	\$0
Estimated Replacement \$:	\$10,000							\$0	\$0	\$0
<u>RESTROOMS</u>										
Type:	2 Toilet, 2 Lav (1 each side m/w)							\$0	\$0	\$0
Age:	37							\$0	\$0	\$0
General Condition:	2							\$0	\$0	\$0
Estimated Replacement \$:	\$6,000							\$0	\$0	\$0
<u>ROOF</u>										
Type:	Asphalt Shingles	Replace Roof Shingles		\$3,000				\$3,000	2017	\$3,000
Age:	15	Repair Soffit/Fascia		\$6,000				\$6,000	\$0	\$6,000
General Condition:	2							\$0	\$0	\$0
Estimated Replacement \$:	\$4,000							\$0	\$0	\$0

Item in Need of Maintenance/ Repair/Replacement	2012	2013	2014	2015	2016	Sum 1-5	2017-2021	Estimated Cost
<u>EXTERIOR/WINDOWS</u>										
Type:	Painted Brick							\$0	\$0	\$0
Age:	37							\$0	\$0	\$0
General Condition:	2							\$0	\$0	\$0
Estimated Replacement \$:	\$2,000							\$0	\$0	\$0
<u>INTERIOR/FINISHES</u>										
Type:	Painted Concrete Block							\$0	\$0	\$0
Age:	37							\$0	\$0	\$0
General Condition:	2							\$0	\$0	\$0
Estimated Replacement \$:	\$2,000							\$0	\$0	\$0
<u>ELECTRICAL/LIGHTING</u>										
Type:	100 Amp Service/2 CFL Lights							\$0		\$0
Age:	37							\$0	\$0	\$0
General Condition:	2							\$0	\$0	\$0
Estimated Replacement \$:	\$8,000							\$0	\$0	\$0
<u>SANITARY/CUSTODIAL</u>										
Type:	City Sewer							\$0	\$0	\$0
Age:	37							\$0	\$0	\$0
General Condition:	2							\$0	\$0	\$0
Estimated Replacement \$:	\$15,000							\$0	\$0	\$0
Type:	Maint. Storage 10 x 15							\$0	\$0	\$0

Age:	37							\$0	\$0	\$0
General Condition:	2							\$0	\$0	\$0
Estimated Replacement \$:	\$10,000							\$0	\$0	\$0
<u>STRUCTURE/FOUNDATION</u>										
Type:	Concrete Slab/Brick/Concrete Block							\$0	\$0	\$0
Age:	37							\$0	\$0	\$0
General Condition:	2							\$0	\$0	\$0
Estimated Replacement \$:	\$40,000							\$0	\$0	\$0
<u>SECURITY</u>										
Type:	Steel Doors w/locks (2)							\$0	\$0	\$0
Age:	37							\$0	\$0	\$0
General Condition:	2							\$0	\$0	\$0
Estimated Replacement \$:	\$5,000							\$0	\$0	\$0

<u>OTHER</u>	Item in Need of Maintenance/ Repair/Replacement		<u>2012</u>	<u>2013</u>	<u>2014</u>	<u>2015</u>	<u>2016</u>	<u>Sum 1-5</u>	<u>2017-2021</u>	Estimated <u>Cost</u>
Type:	Covered Area							\$0	\$0	\$0
Age:	37							\$0	\$0	\$0
General Condition:	2							\$0	\$0	\$0
Estimated Replacement \$:	\$10,000							\$0	\$0	\$0

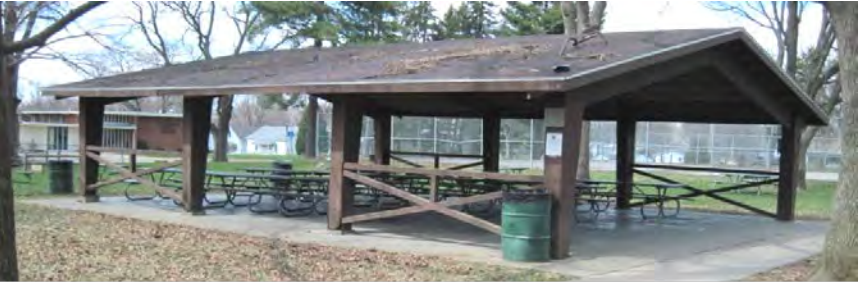
Facility Audit
General Information
 Facility Name: Johnson Park Shelter
 Location: 1901 Harrison Street
 Approximate Sq. Ft.: 1,600 (40' x 40')
 General Condition: 2
 Seasons: Spring, Summer, Fall
 Hours: 30 Min. before SR -11:00 pm
 Year Built: 1975
 Year(s) of Major Renovations: None
 Type of Construction: Wood Frame/Slab/Metal Roof
 Estimated Replacement \$: \$70,000
 Number of Stories: 1
 Current Primary Type of Use: Picnic Shelter
 Wheelchair Accessible: Yes

<u>2012</u>	<u>2013</u>	<u>2014</u>	<u>2015</u>	<u>2016</u>	<u>Sum 1-5</u>	<u>2017-2021</u>	<u>Estimated Cost</u>
Johnson Park Shelter	\$0	\$0	\$12,000	\$4,000	\$0	\$16,000	\$0	\$16,000

<u>ROOF</u>	<u>General Information</u>	<u>Item in Need of Maintenance/Repair/Replacement</u>	<u>2012</u>	<u>2013</u>	<u>2014</u>	<u>2015</u>	<u>2016</u>	<u>Sum 1-5</u>	<u>2017-2021</u>	<u>Estimated Cost</u>
Type:	Fiberglass Shingle/Wood Rafters							\$0	\$0	\$0
Age:	37							\$0	\$0	\$0
General Condition:	2							\$0	\$0	\$0
Estimated Replacement \$:	\$4,000							\$0	\$0	\$0

<u>EXTERIOR/WINDOWS</u>										
Type:	Stained Wood							\$0	\$0	\$0
Age:	20							\$0	\$0	\$0
General Condition:	2							\$0	\$0	\$0
Estimated Replacement \$:	\$1,000							\$0	\$0	\$0

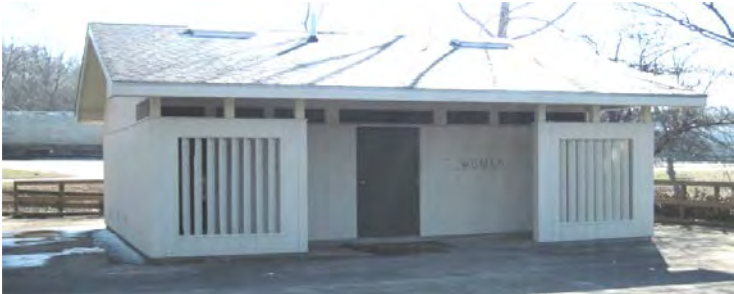
Facility Name: Kesler Restroom
Location: 801 Bonansinga Drive
Approximate Sq. Ft.: 30'x30' (900 sq ft)
General Condition: 2
Seasons: Spring, Summer, Fall
Hours: 30 Minute before Sunrise - 11:00 p.m.
Year Built: 1985
Year(s) of Major Renovations: None
Type of Construction: Block/Wood Exterior/Fiberglass Shingles
Estimated Replacement \$: \$191,000
Number of Stories: 1
Current Primary Type of Use: Restroom
Wheelchair Accessible: Yes

2012	2013	2014	2015	2016	Sum 1-5	2017-2021	Estimated Cost
Kesler Restroom	\$0	\$0	\$4,500	\$0	\$0	\$4,500	\$0	\$4,500

<u>SECURITY</u>	Item in Need of Maintenance/									Estimated
	<u>General Information</u>	<u>Repair/Replacement</u>	<u>2012</u>	<u>2013</u>	<u>2014</u>	<u>2015</u>	<u>2016</u>	<u>Sum 1-5</u>	<u>2017-2021</u>	<u>Cost</u>
Type:	4 Steel Doors w/locks							\$0	\$0	\$0
Age:	27							\$0	\$0	\$0
General Condition:	2							\$0	\$0	\$0
Estimated Replacement \$:	\$10,000							\$0	\$0	\$0
<u>OTHER</u>										
Type:	60'x50' Concrete Deck	Repair/Replace Railing			\$4,500			\$4,500	\$0	\$4,500
Age:	50							\$0	\$0	\$0
General Condition:	2							\$0	\$0	\$0
Estimated Replacement \$:	\$30,000							\$0	\$0	\$0
