Appendix A: Community Input

Focus Group Summary Report

Quincy Park District ***Quincy, Illinois***

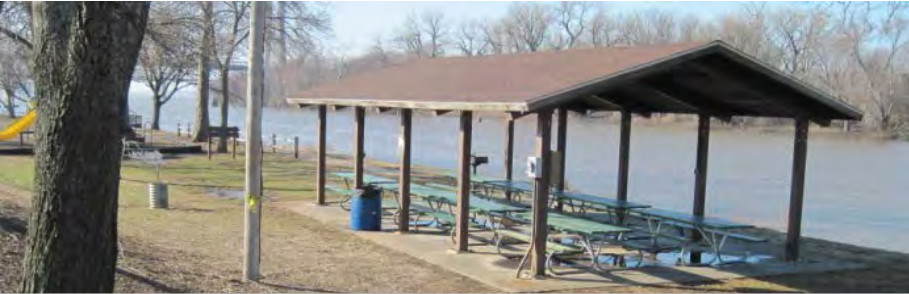
Facility Name: Kesler Shelter
Location: 701 Bonansinga Drive
Approximate Sq. Ft.: 35'x20' (700 sq ft)
General Condition: 2
Seasons: Spring, Summer, Fall
Hours: 30 Minute before Sunrise - 11:00 p.m.
Year Built: 1995
Year(s) of Major Renovations: None
Type of Construction: Steel Frame/Wood Sheathing/Shingles
Estimated Replacement \$: \$40,000
Number of Stories: 1
Current Primary Type of Use: Picnic
Wheelchair Accessible: Yes

<u>2012</u>	<u>2013</u>	<u>2014</u>	<u>2015</u>	<u>2016</u>	<u>Sum 1-5</u>	<u>2017-2021</u>	<u>Estimated Cost</u>
Kesler Shelter	\$800	\$2,500	\$0	\$0	\$0	\$3,300	\$0	\$3,300

<u>ELECTRICAL/LIGHTING</u>	<u>General Information</u>	<u>Item in Need of Maintenance/ Repair/Replacement</u>	<u>2012</u>	<u>2013</u>	<u>2014</u>	<u>2015</u>	<u>2016</u>	<u>Sum 1-5</u>	<u>2017-2021</u>	<u>Estimated Cost</u>
Type:	100 AMP/4 Outlets/MH Lighting	Electrical Upgrades GFI/Timer		\$2,500				\$2,500	\$0	\$2,500
Age:	17							\$0	\$0	\$0
General Condition:	2							\$0	\$0	\$0
Estimated Replacement \$:	\$4,000							\$0	\$0	\$0
<u>SANITARY/CUSTODIAL</u>										
Type:	None							\$0	\$0	\$0
Age:								\$0	\$0	\$0
General Condition:								\$0	\$0	\$0
Estimated Replacement \$:								\$0	\$0	\$0
<u>STRUCTURE/FOUNDATION</u>										
Type:	Concrete Footing, Floor/Steel Frame							\$0	\$0	\$0
Age:	2							\$0	\$0	\$0
General Condition:	2							\$0	\$0	\$0
Estimated Replacement \$:	\$30,000							\$0	\$0	\$0

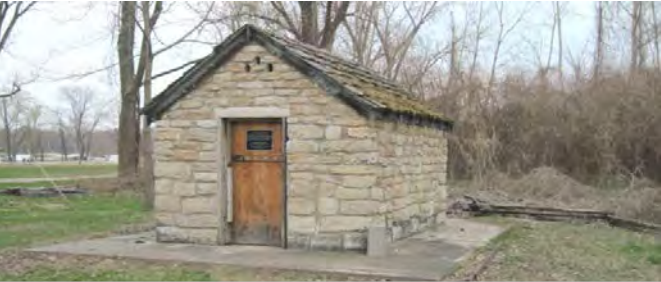
Facility Audit
General Information
 Facility Name: Log Cabin Village Smoke House
 Location: 1009 Quinsippi Island Road
 Approximate Sq. Ft.: 150 15'x10'
 General Condition: 2
 Seasons: Sp, Su, Fa
 Hours: 24/7 - April-October
 Year Built: 1850
 Year(s) of Major Renovations: None
 Type of Construction: Limestone Masonry
 Estimated Replacement \$: \$82,000
 Number of Stories: 1
 Current Primary Type of Use: Historical
 Wheelchair Accessible: No

<u>ROOF</u>	<u>General Information</u>	<u>Item in Need of Maintenance/ Repair/Replacement</u>	<u>2012</u>	<u>2013</u>	<u>2014</u>	<u>2015</u>	<u>2016</u>	<u>Sum 1-5</u>	<u>2017-2021</u>	<u>Estimated Cost</u>
Type:	Wood Frame/Wood Shingles							\$0	\$0	\$0
Age:	150							\$0	\$0	\$0
General Condition:	3							\$0	\$0	\$0
Estimated Replacement \$:	\$2,000							\$0	\$0	\$0
<u>STRUCTURE/FOUNDATION</u>										
Type:	Concrete Foundation/Stone Walls							\$0	\$0	\$0
Age:	150							\$0	\$0	\$0
General Condition:	2							\$0	\$0	\$0
Estimated Replacement \$:	\$80,000							\$0	\$0	\$0

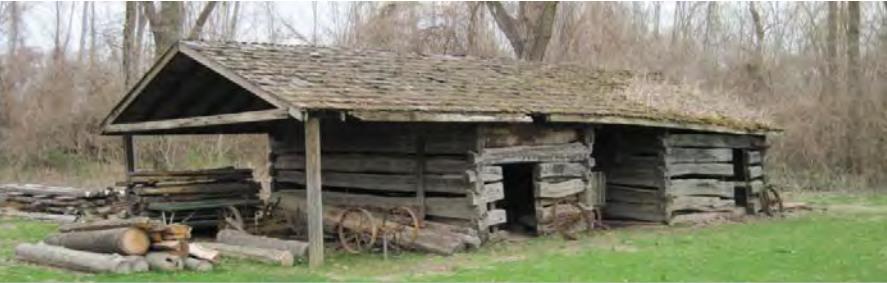
Facility Audit
General Information
 Facility Name: Log Cabin Village Corn Crib
 Location: 1009 Quinsippi Island Road
 Approximate Sq. Ft.: 800 40'x20'
 General Condition: 3
 Seasons: Sp, Su, Fa
 Hours: 24/7 - April-October
 Year Built: 1850
 Year(s) of Major Renovations: None
 Type of Construction: Log Construction
 Estimated Replacement \$: \$92,000
 Number of Stories: 1
 Current Primary Type of Use: Historical
 Wheelchair Accessible: No

<u>2012</u>	<u>2013</u>	<u>2014</u>	<u>2015</u>	<u>2016</u>	<u>Sum 1-5</u>	<u>2017-2020</u>	<u>Estimated Cost</u>
Log Cabin Village Corn Crib	\$0	\$0	\$0	\$0	\$0	\$0	\$0	\$0

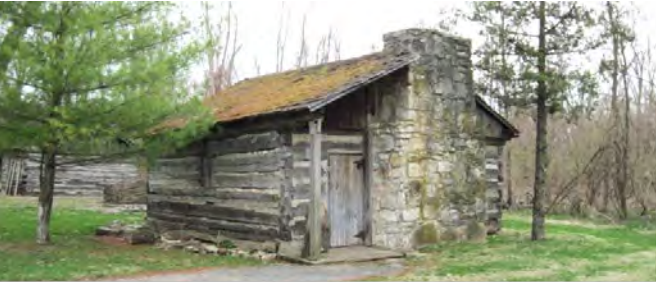
Facility Audit
General Information
 Facility Name: Log Cabin Village Call Cabin
 Location: 1009 Quinsippi Island Road
 Approximate Sq. Ft.: 400 20'x20'
 General Condition: 3
 Seasons: Sp, Su, Fa
 Hours: 24/7 - April-October
 Year Built: 1850
 Year(s) of Major Renovations: None
 Type of Construction: Log Cabin
 Estimated Replacement \$: \$92,000
 Number of Stories: 1
 Current Primary Type of Use: Historical
 Wheelchair Accessible: No

<u>ROOF</u>	<u>General Information</u>	<u>Item in Need of Maintenance/ Repair/Replacement</u>	<u>2012</u>	<u>2013</u>	<u>2014</u>	<u>2015</u>	<u>2016</u>	<u>Sum 1-5</u>	<u>2017-2021</u>	<u>Estimated Cost</u>
Type:	Wood Frame/Wood Shingles							\$0	\$0	\$0
Age:	150							\$0	\$0	\$0
General Condition:	3							\$0	\$0	\$0
Estimated Replacement \$:	\$2,000							\$0	\$0	\$0

<u>STRUCTURE/FOUNDATION</u>	<u>General Information</u>	<u>Item in Need of Maintenance/ Repair/Replacement</u>	<u>2012</u>	<u>2013</u>	<u>2014</u>	<u>2015</u>	<u>2016</u>	<u>Sum 1-5</u>	<u>2017-2021</u>	<u>Estimated Cost</u>
Type:	Wood Logs							\$0	\$0	\$0
Age:	150							\$0	\$0	\$0
General Condition:	3							\$0	\$0	\$0
Estimated Replacement \$:	\$90,000							\$0	\$0	\$0

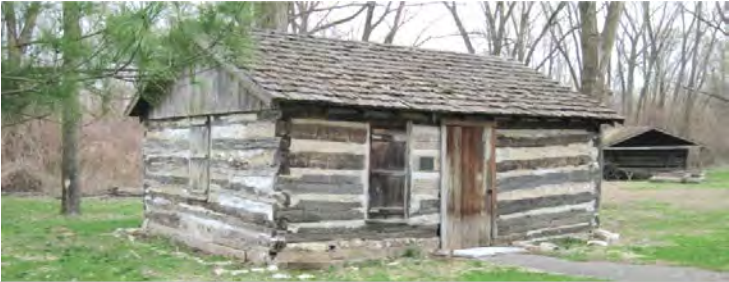
Facility Audit
General Information
 Facility Name: Log Cabin Village Herleman Cabin
 Location: 1009 Quinsippi Island Road
 Approximate Sq. Ft.: 400 20'x20'
 General Condition: 3
 Seasons: Sp, Su, Fa
 Hours: 24/7 - April-October
 Year Built: 1850
 Year(s) of Major Renovations: None
 Type of Construction: Log Cabin
 Estimated Replacement \$: \$92,000
 Number of Stories: 1
 Current Primary Type of Use: Historical
 Wheelchair Accessible: No

<u>ROOF</u>	<u>General Information</u>	<u>Item in Need of Maintenance/ Repair/Replacement</u>	<u>2012</u>	<u>2013</u>	<u>2014</u>	<u>2015</u>	<u>2016</u>	<u>Sum 1-5</u>	<u>2017-2021</u>	Estimated <u>Cost</u>
Type:	Wood Frame/Wood Shingles							\$0	\$0	\$0
Age:	150							\$0	\$0	\$0
General Condition:	3							\$0	\$0	\$0
Estimated Replacement \$:	\$2,000							\$0	\$0	\$0
<u>STRUCTURE/FOUNDATION</u>										
Type:	Wood Logs							\$0	\$0	\$0
Age:	150							\$0	\$0	\$0
General Condition:	3							\$0	\$0	\$0
Estimated Replacement \$:	\$90,000							\$0	\$0	\$0

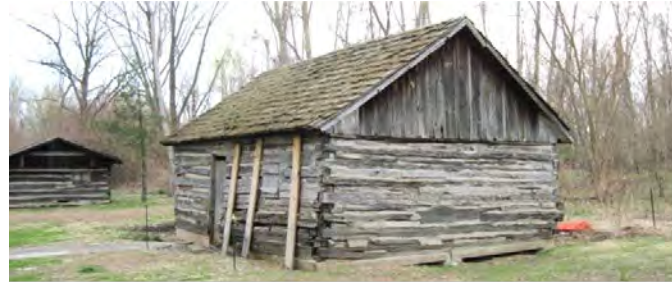
Facility Audit
General Information
 Facility Name: Log Cabin Village Clat Adams Cabin
 Location: 1009 Quinsippi Island Road
 Approximate Sq. Ft.: 400 20'x20'
 General Condition: 3
 Seasons: Sp, Su, Fa
 Hours: 24/7 - April-October
 Year Built: 1850
 Year(s) of Major Renovations: None
 Type of Construction: Log Cabin
 Estimated Replacement \$: \$92,000
 Number of Stories: 1
 Current Primary Type of Use: Historical
 Wheelchair Accessible: No

<u>ROOF</u>	<u>General Information</u>	<u>Item in Need of Maintenance/ Repair/Replacement</u>	<u>2012</u>	<u>2013</u>	<u>2014</u>	<u>2015</u>	<u>2016</u>	<u>Sum 1-5</u>	<u>2017-2021</u>	<u>Estimated Cost</u>
Type:	Wood Frame/Wood Shingles							\$0	\$0	\$0
Age:	150							\$0	\$0	\$0
General Condition:	3							\$0	\$0	\$0
Estimated Replacement \$:	\$2,000							\$0	\$0	\$0
<u>STRUCTURE/FOUNDATION</u>										
Type:	Wood Logs							\$0	\$0	\$0
Age:	150							\$0	\$0	\$0
General Condition:	3							\$0	\$0	\$0
Estimated Replacement \$:	\$90,000							\$0	\$0	\$0

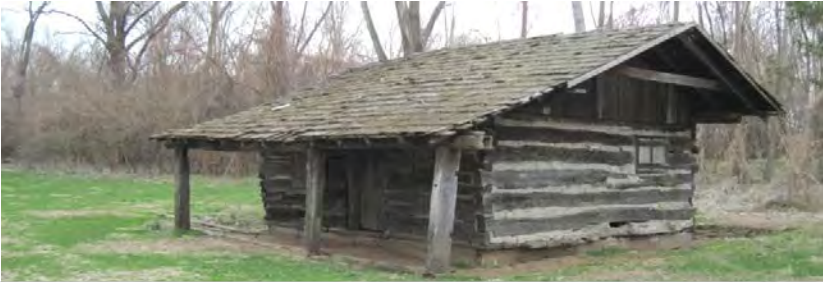
Facility Audit
General Information
 Facility Name: Log Cabin Village Fraser Cabin
 Location: 1009 Quinsippi Island Road
 Approximate Sq. Ft.: 400 20'x20'
 General Condition: 3
 Seasons: Sp, Su, Fa
 Hours: 24/7 - April-October
 Year Built: 1850
 Year(s) of Major Renovations: None
 Type of Construction: Log Cabin
 Estimated Replacement \$: \$92,000
 Number of Stories: 1
 Current Primary Type of Use: Historical
 Wheelchair Accessible: No

<u>ROOF</u>	<u>General Information</u>	<u>Item in Need of Maintenance/ Repair/Replacement</u>	<u>2012</u>	<u>2013</u>	<u>2014</u>	<u>2015</u>	<u>2016</u>	<u>Sum 1-5</u>	<u>2017-2021</u>	<u>Estimated Cost</u>
Type:	Wood Frame/Wood Shingles							\$0	\$0	\$0
Age:	150							\$0	\$0	\$0
General Condition:	3							\$0	\$0	\$0
Estimated Replacement \$:	\$2,000							\$0	\$0	\$0

<u>STRUCTURE/FOUNDATION</u>	<u>General Information</u>	<u>Item in Need of Maintenance/ Repair/Replacement</u>	<u>2012</u>	<u>2013</u>	<u>2014</u>	<u>2015</u>	<u>2016</u>	<u>Sum 1-5</u>	<u>2017-2021</u>	<u>Estimated Cost</u>
Type:	Wood Logs							\$0	\$0	\$0
Age:	150							\$0	\$0	\$0
General Condition:	3							\$0	\$0	\$0
Estimated Replacement \$:	\$90,000							\$0	\$0	\$0

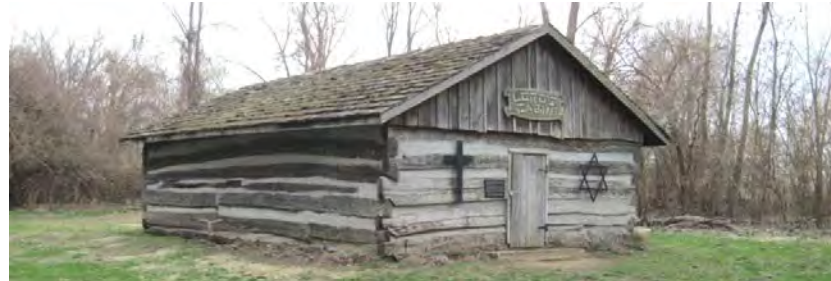
Facility Audit
General Information
 Facility Name: Log Cabin Village Church
 Location: 1009 Quinsippi Island Road
 Approximate Sq. Ft.: 600 30'x20'
 General Condition: 3
 Seasons: Sp, Su, Fa
 Hours: 24/7 - April-October
 Year Built: 1850
 Year(s) of Major Renovations: None
 Type of Construction: Log Cabin
 Estimated Replacement \$: \$102,000
 Number of Stories: 1
 Current Primary Type of Use: Historical
 Wheelchair Accessible: No

<u>ROOF</u>	<u>General Information</u>	<u>Item in Need of Maintenance/ Repair/Replacement</u>	<u>2012</u>	<u>2013</u>	<u>2014</u>	<u>2015</u>	<u>2016</u>	<u>Sum 1-5</u>	<u>2017-2021</u>	<u>Estimated Cost</u>
Type:	Wood Frame/Wood Shingles							\$0	\$0	\$0
Age:	150							\$0	\$0	\$0
General Condition:	3							\$0	\$0	\$0
Estimated Replacement \$:	\$2,000							\$0	\$0	\$0
<u>STRUCTURE/FOUNDATION</u>										
Type:	Wood Logs							\$0	\$0	\$0
Age:	150							\$0	\$0	\$0
General Condition:	3							\$0	\$0	\$0
Estimated Replacement \$:	\$100,000							\$0	\$0	\$0

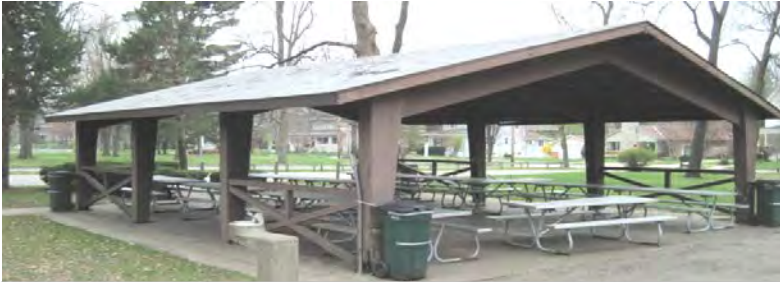
Facility Audit
General Information
 Facility Name: Madison Park Shelter
 Location: 2400 Maine Street
 Approximate Sq. Ft.: 1,400 (40' x 35')
 General Condition: 2
 Seasons: Spring, Summer, Fall
 Hours: 30 Min. before SR -11:00 pm
 Year Built: 1975
 Year(s) of Major Renovations: None
 Type of Construction: Wood Frame/Slab/Metal Roof
 Estimated Replacement \$: \$65,000
 Number of Stories: 1
 Current Primary Type of Use: Picnic Shelter
 Wheelchair Accessible: Yes

<u>ROOF</u>	<u>General Information</u>	<u>Item in Need of Maintenance/ Repair/Replacement</u>	<u>2012</u>	<u>2013</u>	<u>2014</u>	<u>2015</u>	<u>2016</u>	<u>Sum 1-5</u>	<u>2017-2021</u>	<u>Estimated Cost</u>
Type:	Fiberglass Shingle/Wood Rafters							\$0	\$0	\$0
Age:	37							\$0	\$0	\$0
General Condition:	2							\$0	\$0	\$0
Estimated Replacement \$:	\$4,000							\$0	\$0	\$0
<u>EXTERIOR/WINDOWS</u>										
Type:	Stained Wood							\$0	\$0	\$0
Age:	20							\$0	\$0	\$0
General Condition:	2							\$0	\$0	\$0
Estimated Replacement \$:	\$1,000							\$0	\$0	\$0
<u>INTERIOR/FINISHES</u>										
Type:	Stained Wood							\$0	\$0	\$0
Age:	20							\$0	\$0	\$0
General Condition:	2							\$0	\$0	\$0
Estimated Replacement \$:	\$1,000							\$0	\$0	\$0

Item in Need of Maintenance/ Repair/Replacement	2012	2013	2014	2015	2016	Sum 1-5	2017-2021	Estimated Cost
<u>ELECTRICAL/LIGHTING</u>										
Type:	100 Amp Service 2 Lt, 6 outlets	Update Electric - Timer/CFI				\$4,000		\$4,000	\$0	\$4,000
Age:	37							\$0	\$0	\$0
General Condition:	2							\$0	\$0	\$0
Estimated Replacement \$:	\$4,000							\$0	\$0	\$0
<u>SANITARY/CUSTODIAL</u>										
Type:	None							\$0	\$0	\$0
Age:								\$0	\$0	\$0
General Condition:								\$0	\$0	\$0
Estimated Replacement \$:	\$0							\$0	\$0	\$0
<u>STRUCTURE/FOUNDATION</u>										
Type:	Concrete Slab/Wood Frame							\$0	\$0	\$0
Age:	36							\$0	\$0	\$0
General Condition:	2							\$0	\$0	\$0
Estimated Replacement \$:	\$55,000							\$0	\$0	\$0
<u>SECURITY</u>										
Type:								\$0	\$0	\$0
Age:								\$0	\$0	\$0
General Condition:								\$0	\$0	\$0
Estimated Replacement \$:	\$0							\$0	\$0	\$0
<u>OTHER</u>

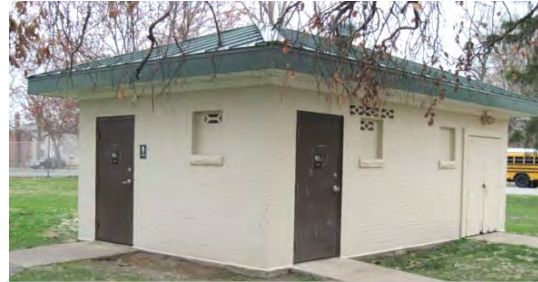
Facility Audit
General Information
 Facility Name: Madison Restroom
 Location: 2400 Maine Street
 Approximate Sq. Ft.: 600 (40' x 15')
 General Condition: 2
 Seasons: All
 Hours: 30 Min. before SR -11:00 pm Spr,Su,Fall.
 Year Built: 1975
 Year(s) of Major Renovations: None
 Type of Construction: Brick/Block/Asphalt Shingle Roof
 Estimated Replacement \$: \$97,000
 Number of Stories: 1
 Current Primary Type of Use: Restroom & Maintenance Storage
 Wheelchair Accessible: Yes

<u>Item in Need of Maintenance/ Repair/Replacement</u>	<u>2012</u>	<u>2013</u>	<u>2014</u>	<u>2015</u>	<u>2016</u>	<u>Sum 1-5</u>	<u>2017-2021</u>	<u>Estimated Cost</u>
<u>PLUMBING</u>										
Type:	City Water							\$0	\$0	\$0
Age:	37							\$0	\$0	\$0
General Condition:	3							\$0	\$0	\$0
Estimated Replacement \$:	\$15,000							\$0	\$0	\$0
<u>RESTROOMS</u>										
Type:	2 Toilet, 2 Lav (1 each side m/w)							\$0	\$0	\$0
Age:	37							\$0	\$0	\$0
General Condition:	2							\$0	\$0	\$0
Estimated Replacement \$:	\$8,000							\$0	\$0	\$0
<u>ROOF</u>										
Type:	Metal Roof							\$0	\$0	\$0
Age:	2							\$0	\$0	\$0
General Condition:	3							\$0	\$0	\$0
Estimated Replacement \$:	\$10,000							\$0	\$0	\$0

Item in Need of Maintenance/ Repair/Replacement	2012	2013	2014	2015	2016	Sum 1-5	2017-2021	Estimated Cost
<u>EXTERIOR/WINDOWS</u>										
Type:	Painted Brick							\$0	\$0	\$0
Age:	37							\$0	\$0	\$0
General Condition:	2							\$0	\$0	\$0
Estimated Replacement \$:	\$2,000							\$0	\$0	\$0
<u>INTERIOR/FINISHES</u>										
Type:	Painted Concrete Block							\$0	\$0	\$0
Age:	37							\$0	\$0	\$0
General Condition:	2							\$0	\$0	\$0
Estimated Replacement \$:	\$2,000							\$0	\$0	\$0
<u>ELECTRICAL/LIGHTING</u>										
Type:	100 Amp Service/2 CFL Lights							\$0		\$0
Age:	37							\$0	\$0	\$0
General Condition:	2							\$0	\$0	\$0
Estimated Replacement \$:	\$6,000							\$0	\$0	\$0
<u>SANITARY/CUSTODIAL</u>										
Type:	City Sewer							\$0	\$0	\$0
Age:	37							\$0	\$0	\$0
General Condition:	2							\$0	\$0	\$0
Estimated Replacement \$:	\$15,000							\$0	\$0	\$0
Type:	Maint. Storage 10 x 15							\$0	\$0	\$0

Age:	37							\$0	\$0	\$0
General Condition:	2							\$0	\$0	\$0
Estimated Replacement \$:	\$8,000							\$0	\$0	\$0
<u>STRUCTURE/FOUNDATION</u>										
Type:	Concrete Slab/Brick/Concrete Block							\$0	\$0	\$0
Age:	37							\$0	\$0	\$0
General Condition:	2							\$0	\$0	\$0
Estimated Replacement \$:	\$25,000							\$0	\$0	\$0
<u>SECURITY</u>										
Type:	Steel Doors w/locks (2)							\$0	\$0	\$0
Age:	37							\$0	\$0	\$0
General Condition:	2							\$0	\$0	\$0
Estimated Replacement \$:	\$6,000							\$0	\$0	\$0

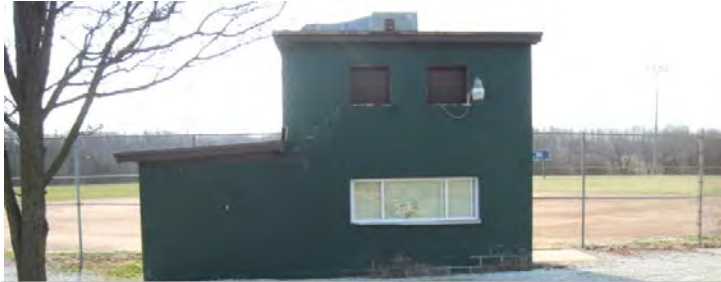
Facility Name: Moorman Main Concession
Location: 1215 N. 39th Street
Approximate Sq. Ft.: 200 (20' x 10')
General Condition: 2
Seasons: All
Hours: 30 Min. before SR -11:00 pm Spr,Su,Fall.
Year Built: 1985
Year(s) of Major Renovations: None
Type of Construction: Concrete Block/Concrete Slab
Estimated Replacement \$: \$41,000
Number of Stories: 2
Current Primary Type of Use: Concession/Field Scoring
Wheelchair Accessible: Unknown

<u>HVAC</u>	<u>General Information</u>	<u>Item in Need of Maintenance/Repair/Replacement</u>	<u>2012</u>	<u>2013</u>	<u>2014</u>	<u>2015</u>	<u>2016</u>	<u>Sum 1-5</u>	<u>2017-2020</u>	<u>Estimated Cost</u>
Type:	A/C Roof Mounted							\$0	\$0	\$0
Age:	27							\$0	\$0	\$0
General Condition:	2							\$0	\$0	\$0
Estimated Replacement \$:	\$2,000							\$0	\$0	\$0

<u>ROOF</u>										
Type:	Flat Roof							\$0	\$0	\$0
Age:	27							\$0	\$0	\$0
General Condition:	2							\$0	\$0	\$0
Estimated Replacement \$:	\$1,000							\$0	\$0	\$0

<u>EXTERIOR/WINDOWS</u>										
Type:	Painted Block							\$0	\$0	\$0
Age:	27							\$0	\$0	\$0
General Condition:	2							\$0	\$0	\$0
Estimated Replacement \$:	\$1,000							\$0	\$0	\$0

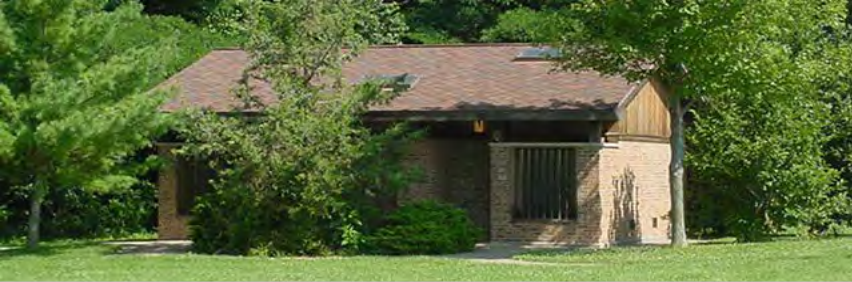
Facility Name: Moorman North Restroom
Location: 1608 Moorman Park Road
Approximate Sq. Ft.: 750 (30' x 25')
General Condition: 2
Seasons: All
Hours: 30 Min. before SR -11:00 pm Spr,Su,Fall.
Year Built: 1985
Year(s) of Major Renovations: None
Type of Construction: Brick/Fiberglass shingle
Estimated Replacement \$: \$113,000
Number of Stories: 1
Current Primary Type of Use: Restroom
Wheelchair Accessible: Yes

<u>Item in Need of Maintenance/ Repair/Replacement</u>	<u>2012</u>	<u>2013</u>	<u>2014</u>	<u>2015</u>	<u>2016</u>	<u>Sum 1-5</u>	<u>2017-2021</u>	Estimated Cost
<u>PLUMBING</u>										
Type:	City Water							\$0	\$0	\$0
Age:	27							\$0	\$0	\$0
General Condition:	2							\$0	\$0	\$0
Estimated Replacement \$:	\$15,000							\$0	\$0	\$0

<u>ROOF</u>										
Type:	Asphalt Shingles/Wood Frame/4 skylights							\$0	\$0	\$0
Age:	27							\$0	\$0	\$0
General Condition:	2							\$0	\$0	\$0
Estimated Replacement \$:	\$4,000							\$0	\$0	\$0

<u>RESTROOMS</u>										
Type:	4 T, 1 L (W), 2 T, 2 U, 1 L (M), 1 T, 1 L (ADA)	Replace Flush Valves	\$4,000					\$4,000	\$0	\$4,000
Age:	27							\$0	\$0	\$0
General Condition:	2							\$0	\$0	\$0
Estimated Replacement \$:	\$10,000							\$0	\$0	\$0

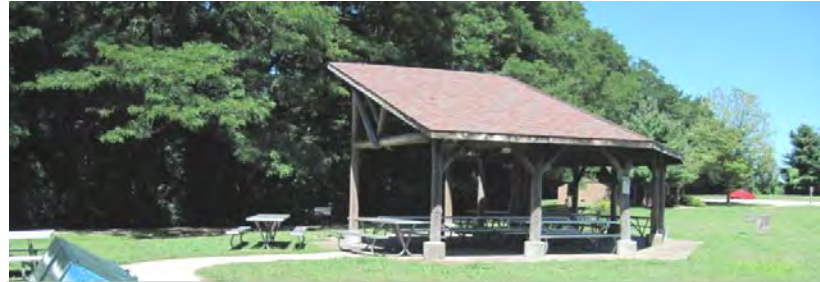
Facility Name: Moorman Small Shelter
Location: 790 Moorman Park Road
Approximate Sq. Ft.: 3100 (Irregular)
General Condition: 2
Seasons: All
Hours: 30 Min. before SR -11:00 pm Spr,Su,Fall.
Year Built: 1985
Year(s) of Major Renovations: None
Type of Construction: Timber Frame/Concrete Slab
Estimated Replacement \$: \$63,000
Number of Stories: 1
Current Primary Type of Use: Picnic Shelter
Wheelchair Accessible: Unknown

<u>ROOF</u>		<u>General Information</u>	<u>Item in Need of Maintenance/ Repair/Replacement</u>	<u>2012</u>	<u>2013</u>	<u>2014</u>	<u>2015</u>	<u>2016</u>	<u>Sum 1-5</u>	<u>2016-2020</u>	<u>Estimated Cost</u>
Type:	Wood Rafters/Asphalt Shingles								\$0	\$0	\$0
Age:	2								\$0	\$0	\$0
General Condition:	2								\$0	\$0	\$0
Estimated Replacement \$:	\$10,000								\$0	\$0	\$0
<u>EXTERIOR/WINDOWS</u>											
Type:	Wood/Stained								\$0	\$0	\$0
Age:	27								\$0	\$0	\$0
General Condition:	2								\$0	\$0	\$0
Estimated Replacement \$:	\$2,000								\$0	\$0	\$0
<u>INTERIOR/FINISHES</u>											
Type:	Wood/Stained								\$0	\$0	\$0
Age:	27								\$0	\$0	\$0
General Condition:	2								\$0	\$0	\$0
Estimated Replacement \$:	\$2,000								\$0	\$0	\$0

<u>2012</u>	<u>2013</u>	<u>2014</u>	<u>2015</u>	<u>2016</u>	<u>Sum 1-5</u>	<u>2017-2020</u>	<u>Estimated Cost</u>
Moorman Small Shelter	\$0	\$70,000	\$0	\$0	\$0	\$70,000	\$0	\$70,000

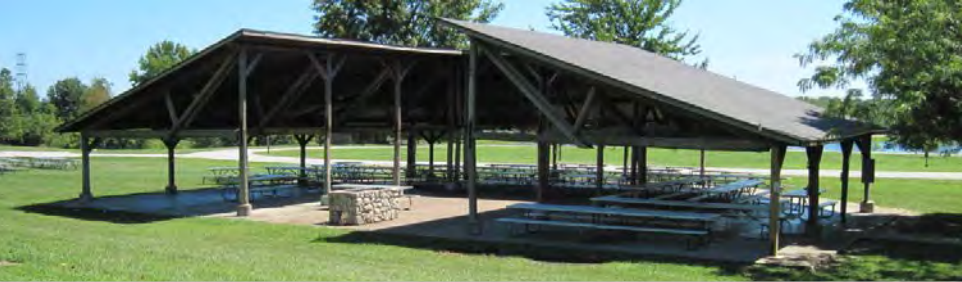
Facility Name: Moorman Large Shelter
Location: 1608 Moorman Park Road
Approximate Sq. Ft.: 3100 (Irregular)
General Condition: 2
Seasons: All
Hours: 30 Min. before SR -11:00 pm Spr,Su,Fall.
Year Built: 1985
Year(s) of Major Renovations: None
Type of Construction: Timber Frame/Concrete Slab
Estimated Replacement \$: \$125,000
Number of Stories: 1
Current Primary Type of Use: Storage
Wheelchair Accessible: Unknown

Type:	Timber Frame/Concrete Footing/Slab	Replace Shelter			\$120,000			\$120,000	\$0	\$120,000
Age:	27							\$0	\$0	\$0
General Condition:	2							\$0	\$0	\$0
Estimated Replacement \$:	\$85,000							\$0	\$0	\$0

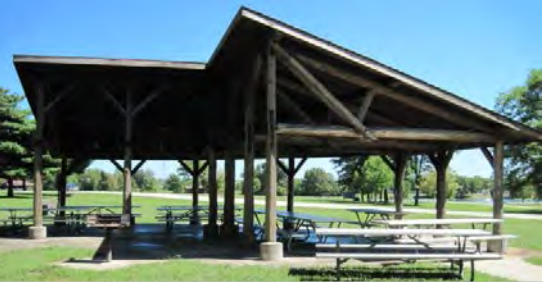
Facility Name: Moorman Medium Shelter
Location: 1608 Moorman Park Road
Approximate Sq. Ft.: 1646 (Irregular)
General Condition: 2
Seasons: All
Hours: 30 Min. before SR -11:00 pm Spr,Su,Fall.
Year Built: 1985
Year(s) of Major Renovations: None
Type of Construction: Timber Frame/Concrete Slab
Estimated Replacement \$: \$72,000
Number of Stories: 1
Current Primary Type of Use: Storage
Wheelchair Accessible: Unknown

<u>2012</u>	<u>2013</u>	<u>2014</u>	<u>2015</u>	<u>2016</u>	<u>Sum 1-5</u>	<u>2017-2020</u>	<u>Estimated Cost</u>
Moorman Medium Shelter	\$70,000	\$0	\$0	\$0	\$0	\$70,000	\$0	\$70,000

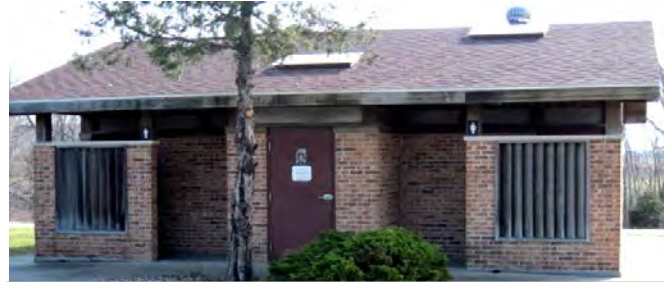
Facility Name: Moorman Upper East Restroom
Location: 1608 Moorman Park Road
Approximate Sq. Ft.: 750 (30' x 25')
General Condition: 2
Seasons: All
Hours: 30 Min. before SR -11:00 pm Spr,Su,Fall.
Year Built: 1985
Year(s) of Major Renovations: None
Type of Construction: Brick/Fiberglass shingle
Estimated Replacement \$: \$113,000
Number of Stories: 1
Current Primary Type of Use: Restroom
Wheelchair Accessible: Yes

<u>RESTROOMS</u>										
Type:	4 T, 1 L (W), 2 T, 2 U, 1 L (M), 1 T, 1 L (ADA)	Replace Flush Valves	\$4,000					\$4,000	\$0	\$4,000
Age:	27							\$0	\$0	\$0
General Condition:	2							\$0	\$0	\$0
Estimated Replacement \$:	\$10,000							\$0	\$0	\$0

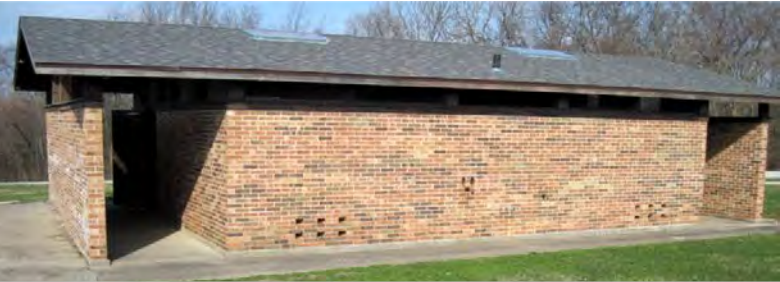
Facility Audit
General Information
 Facility Name: Moorman Ballfield Restroom
 Location: 1215 N. 39th Street
 Approximate Sq. Ft.: 1000 (40' x 25')
 General Condition: 2
 Seasons: All
 Hours: 30 Min. before SR -11:00 pm Spr,Su,Fall.
 Year Built: 1985
 Year(s) of Major Renovations: None
 Type of Construction: Brick/Fiberglass shingle
 Estimated Replacement \$: \$125,000
 Number of Stories: 1
 Current Primary Type of Use: Restroom & Maintenance Storage
 Wheelchair Accessible: Yes

<u>2012</u>	<u>2013</u>	<u>2014</u>	<u>2015</u>	<u>2016</u>	<u>Sum 1-5</u>	<u>2017-2021</u>	<u>Estimated Cost</u>	
Moorman Ballfield Restroom	\$0	\$4,000	\$0	\$0	\$0	\$4,000	\$0	\$0	\$4,000

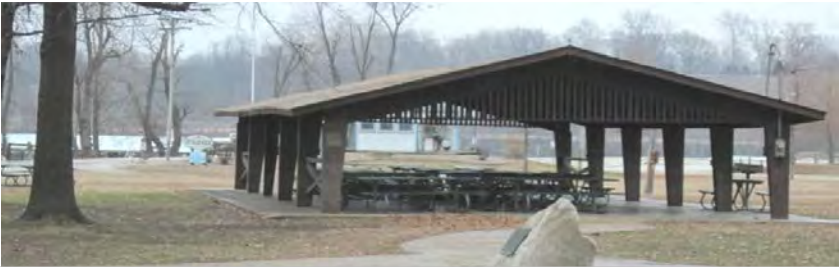
Facility Name: Q-Island Large Shelter
Location: 1100 Quinsippi Island Road
Approximate Sq. Ft.: 2,275 (65' x 35')
General Condition: 2
Seasons: Spring, Summer, Fall
Hours: 30 Minute before Sunrise - 11:00 p.m.
Year Built: 1975
Year(s) of Major Renovations: None
Type of Construction: Wood Frame/Asphalt Shingle Roof
Estimated Replacement \$: \$102,000
Number of Stories: 1
Current Primary Type of Use: Picnic Shelter
Wheelchair Accessible:

<u>INTERIOR/FINISHES</u>										
Type:	Stained Wood Frame/Truss							\$0	\$0	\$0
Age:	2							\$0	\$0	\$0
General Condition:	3							\$0	\$0	\$0
Estimated Replacement \$:	\$2,000							\$0	\$0	\$0

Item in Need of Maintenance/ Repair/Replacement	2012	2013	2014	2015	2016	Sum 1-5	2017-2021	Estimated Cost
ELECTRICAL/LIGHTING										
Type:	100 amp, 5 GFI outlets, 6 CFL Lights	Electrical Upgrade						\$0	\$5,000	\$5,000
Age:	37							\$0	\$0	\$0
General Condition:	3							\$0	\$0	\$0
Estimated Replacement \$:	\$8,000							\$0	\$0	\$0

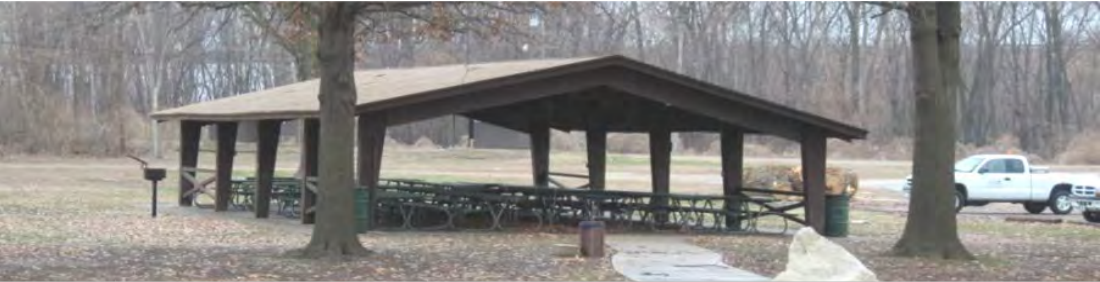
Facility Name: Q-Island Small Shelter
Location: 1100 Quinsippi Island Road
Approximate Sq. Ft.: 1,750 (50' x 35')
General Condition: 2
Seasons: Spring, Summer, Fall
Hours: 30 Minute before Sunrise - 11:00 p.m.
Year Built: 1975
Year(s) of Major Renovations: None
Type of Construction: Wood Frame/Asphalt Shingle Roof
Estimated Replacement \$: \$81,000
Number of Stories: 1
Current Primary Type of Use: Picnic Shelter
Wheelchair Accessible:

INTERIOR/FINISHES										
Type:	Stained Wood Frame/Truss							\$0	\$0	\$0
Age:	2							\$0	\$0	\$0
General Condition:	3							\$0	\$0	\$0
Estimated Replacement \$:	\$2,000							\$0	\$0	\$0

Item in Need of Maintenance/ Repair/Replacement	2012	2013	2014	2015	2016	Sum 1-5	2017-2021	Estimated Cost
ELECTRICAL/LIGHTING										
Type:	100 amp, 7 GFI outlets, 4 CFL Lights	Electrical Upgrade						\$0	\$5,000	2017 \$5,000
Age:	37							\$0	\$0	\$0
General Condition:	3							\$0	\$0	\$0
Estimated Replacement \$:	\$6,000							\$0	\$0	\$0
STRUCTURE/FOUNDATION										
Type:	Wood Support/Truss							\$0	\$0	\$0
Age:	37							\$0	\$0	\$0
General Condition:	2							\$0	\$0	\$0
Estimated Replacement \$:	\$50,000							\$0	\$0	\$0
Type:	Reinforced Concrete Slab/Footing	Replace Floor						\$0	\$20,000	2017 \$20,000
Age:	37							\$0	\$0	\$0
General Condition:	2							\$0	\$0	\$0
Estimated Replacement \$:	\$15,000							\$0	\$0	\$0
SECURITY										
Type:								\$0	\$0	\$0
Age:								\$0	\$0	\$0
General Condition:								\$0	\$0	\$0
Estimated Replacement \$:								\$0	\$0	\$0
OTHER										
Type:								\$0	\$0	\$0

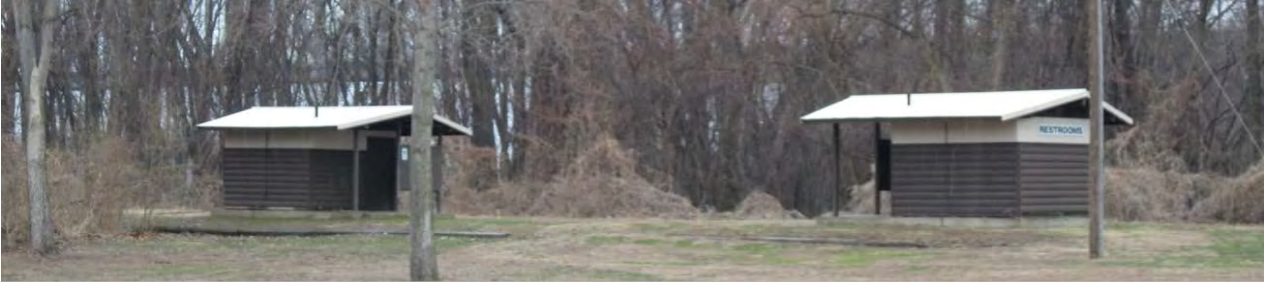
Facility Name: Q-Island Restrooms
Location: 1100 Quinsippi Island Road
Approximate Sq. Ft.: 150 (15' x 10') 2 Structures M/W
General Condition: 2
Seasons: Spring, Summer, Fall
Hours: 30 Minute before Sunrise - 11:00 p.m.
Year Built: 1975
Year(s) of Major Renovations: None
Type of Construction: Wood Frame/Asphalt Shingle Roof
Estimated Replacement \$: \$96,500
Number of Stories: 1
Current Primary Type of Use: Picnic Shelter
Wheelchair Accessible: No

<u>2012</u>	<u>2013</u>	<u>2014</u>	<u>2015</u>	<u>2016</u>	<u>Sum 1-5</u>	<u>2017-2021</u>	<u>Estimated Cost</u>
Q-Island Restrooms	\$0	\$0	\$0	\$0	\$0	\$0	\$5,000	\$5,000

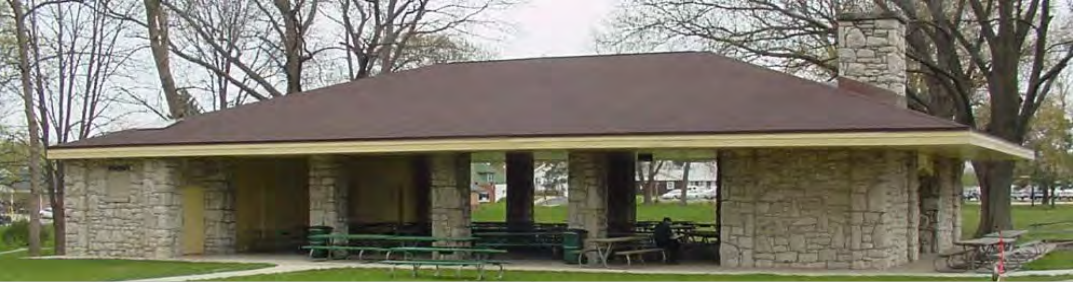
Facility Name: Reservoir Shelter
Location: 2230 Cedar Street
Approximate Sq. Ft.: 4,400 (80' x 55')
General Condition: 2
Seasons: All
Hours: 30 Min. before SR -11:00 pm Spr,Su,Fall.
Year Built: 1936
Year(s) of Major Renovations: None
Type of Construction: Stone Structure/Shingle Roof/Slab
Estimated Replacement \$: \$381,000
Number of Stories: 1
Current Primary Type of Use: Picnic Shelter
Wheelchair Accessible: Yes

<u>2012</u>	<u>2013</u>	<u>2014</u>	<u>2015</u>	<u>2016</u>	<u>Sum 1-5</u>	<u>2017-2021</u>	<u>Estimated Cost</u>
Reservoir Shelter	\$3,500	\$0	\$0	\$0	\$0	\$3,500	\$0	\$3,500

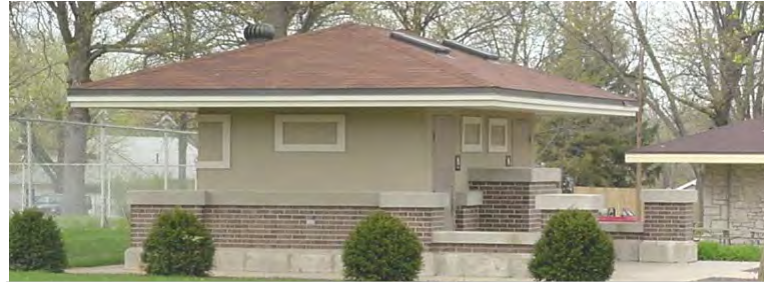
Facility Audit
General Information
 Facility Name: Reservoir Restroom
 Location: 2249 Chestnut
 Approximate Sq. Ft.: 560 (28' x 20')
 General Condition: 2
 Seasons: All
 Hours: 30 Min. before SR -11:00 pm Spr,Su,Fall.
 Year Built: 1998
 Year(s) of Major Renovations: None
 Type of Construction: Stone Structure/Shingle Roof/Slab
 Estimated Replacement \$: \$71,000
 Number of Stories: 1
 Current Primary Type of Use: Restroom & Maintenance Storage
 Wheelchair Accessible: Yes

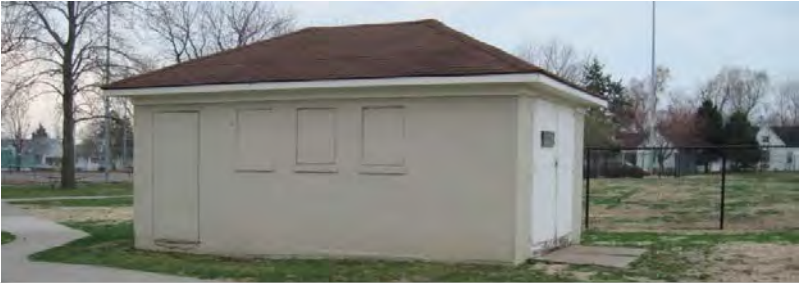
Facility Name: Reservoir Maintenance Shed
Location: 2249 Chestnut
Approximate Sq. Ft.: 300 (20' x 15')
General Condition: 2
Seasons: All
Hours: 30 Min. before SR -11:00 pm Spr,Su,Fall.
Year Built: 1970
Year(s) of Major Renovations: None
Type of Construction: Concrete Block/Slab
Estimated Replacement \$: \$28,000
Number of Stories: 1
Current Primary Type of Use: Maintenance Storage
Wheelchair Accessible: Yes

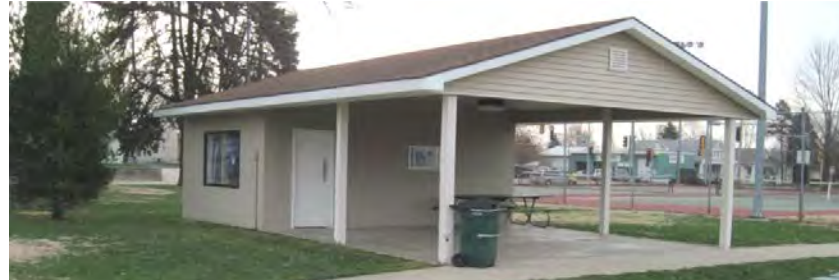
Facility Audit
General Information
 Facility Name: Reservoir Tennis Building
 Location: 2230 Cedar Street
 Approximate Sq. Ft.: 828 (36' x 23')
 General Condition: 2
 Seasons: All
 Hours: 30 Min. before SR -11:00 pm Spr,Su,Fall.
 Year Built: 1990
 Year(s) of Major Renovations: None
 Type of Construction: Wood Frame/Concrete Slab
 Estimated Replacement \$: \$35,000
 Number of Stories: 1
 Current Primary Type of Use: Storage
 Wheelchair Accessible: Unknown

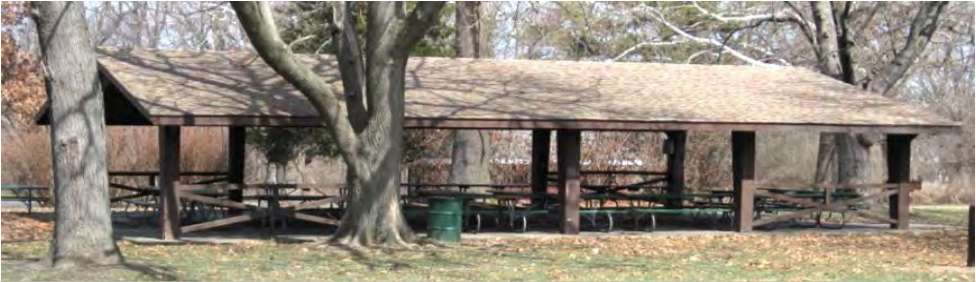
Facility Name: Riverview Shelter
Location: 1001 N. 2nd Street
Approximate Sq. Ft.: 1,750 (50' x 35')
General Condition: 2
Seasons: Spring, Summer, Fall
Hours: 30 Min. before SR -11:00 pm
Year Built: 1975
Year(s) of Major Renovations: None
Type of Construction: Wood Frame/Slab/Metal Roof
Estimated Replacement \$: \$90,000
Number of Stories: 1
Current Primary Type of Use: Picnic Shelter
Wheelchair Accessible:

Item in Need of Maintenance/ Repair/Replacement	2012	2013	2014	2015	2016	2017-2021	Estimated Cost
<u>ELECTRICAL/LIGHTING</u>									
Type:	100 Amp Service 4 outlet 2 CFLight	Update Electric - Timer/CFI				\$4,000		\$4,000	\$0
Age:	37							\$0	\$0
General Condition:	2							\$0	\$0
Estimated Replacement \$:	\$8,000							\$0	\$0
<u>SANITARY/CUSTODIAL</u>									
Type:	None							\$0	\$0
Age:								\$0	\$0
General Condition:								\$0	\$0
Estimated Replacement \$:	\$0							\$0	\$0
<u>STRUCTURE/FOUNDATION</u>									
Type:	Wood Frame/Truss							\$0	\$0
Age:	36							\$0	\$0
General Condition:	2							\$0	\$0
Estimated Replacement \$:	\$50,000							\$0	\$0
Type:	Concrete Footing/Floor							\$0	\$0
Age:	36							\$0	\$0
General Condition:	2							\$0	\$0
Estimated Replacement \$:	\$20,000							\$0	\$0
<u>SECURITY</u>									
Type:								\$0	\$0
Age:								\$0	\$0
General Condition:								\$0	\$0
Estimated Replacement \$:	\$0							\$0	\$0

<u>2012</u>	<u>2013</u>	<u>2014</u>	<u>2015</u>	<u>2016</u>	<u>Sum 1-5</u>	<u>2017-2021</u>	<u>Estimated Cost</u>
Riverview Shelter	\$0	\$0	\$0	\$4,000		\$4,000	\$0	\$4,000

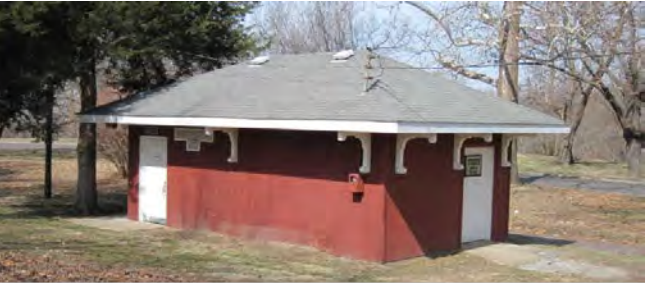
Facility Name: Riverview Restroom
Location: 1001 N. 2nd Street
Approximate Sq. Ft.: 504 (28' x 18')
General Condition: 2
Seasons: All
Hours: 30 Min. before SR -11:00 pm Spr,Su,Fall.
Year Built: 1975
Year(s) of Major Renovations: None
Type of Construction: Wood Frame/Asphalt Shingle Roof
Estimated Replacement \$: \$73,000
Number of Stories: 1
Current Primary Type of Use: Restroom & Maintenance Storage
Wheelchair Accessible: Yes

<u>PLUMBING</u>		<u>Item in Need of Maintenance/Repair/Replacement</u>	<u>2012</u>	<u>2013</u>	<u>2014</u>	<u>2015</u>	<u>2016</u>	<u>Sum 1-5</u>	<u>2017-2021</u>	<u>Estimated Cost</u>
Type:	City Water							\$0	\$0	\$0
Age:	37							\$0	\$0	\$0
General Condition:	3							\$0	\$0	\$0
Estimated Replacement \$:	\$15,000							\$0	\$0	\$0

<u>2012</u>	<u>2013</u>	<u>2014</u>	<u>2015</u>	<u>2016</u>	<u>Sum 1-5</u>	<u>2017-2021</u>	<u>Estimated Cost</u>	
Riverview Restroom	\$0	\$0	\$0	\$0	\$0	\$0	\$4,000	\$0	\$4,000

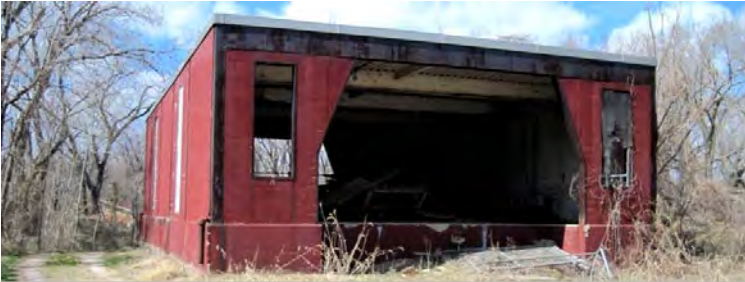
Facility Audit
General Information
 Facility Name: Skyride Shed
 Location: 1009 Quinsippi Island Road
 Approximate Sq. Ft.: 1800, 30'x60'
 General Condition: 2
 Seasons: Sp, Su, Fa
 Hours: 24/7 - April-October
 Year Built: 1968
 Year(s) of Major Renovations: None
 Type of Construction: Metal Frame/Roof
 Estimated Replacement \$: \$127,000
 Number of Stories: 1
 Current Primary Type of Use: Storage
 Wheelchair Accessible: No

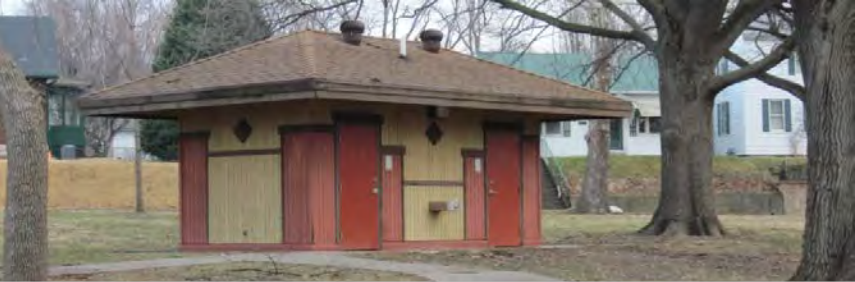
Facility Audit
General Information
 Facility Name: South Park Tennis Restroom
 Location: 1331 S. 11th Street
 Approximate Sq. Ft.: 375 (25' x 15')
 General Condition: 2
 Seasons: All
 Hours: 30 Min. before SR -11:00 pm Spr,Su,Fall.
 Year Built: 1998
 Year(s) of Major Renovations: None
 Type of Construction: Wood Frame/Asphalt Shingle Roof
 Estimated Replacement \$: \$68,500
 Number of Stories: 1
 Current Primary Type of Use: Restroom
 Wheelchair Accessible: Yes

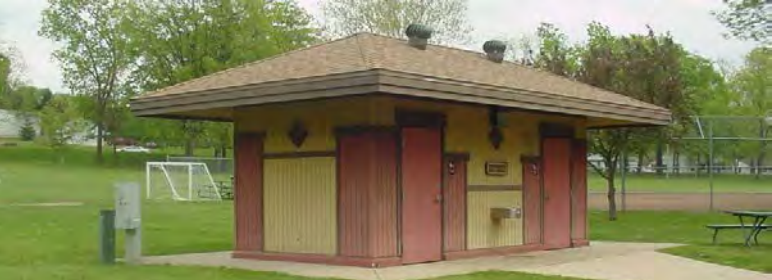
Facility Audit
General Information
 Facility Name: South Park Ballfield Restroom
 Location: 1500 S. 12th Street
 Approximate Sq. Ft.: 375 (25' x 15')
 General Condition: 2
 Seasons: All
 Hours: 30 Min. before SR -11:00 pm Spr,Su,Fall.
 Year Built: 1998
 Year(s) of Major Renovations: None
 Type of Construction: Wood Frame/Asphalt Shingle Roof
 Estimated Replacement \$: \$68,500
 Number of Stories: 1
 Current Primary Type of Use: Restroom
 Wheelchair Accessible: Yes

Item in Need of Maintenance/ Repair/Replacement	2012	2013	2014	2015	2016	Sum 1-5	2017-2021	Estimated Cost
PLUMBING										
Type:	City Water							\$0	\$0	\$0
Age:	13							\$0	\$0	\$0
General Condition:	3							\$0	\$0	\$0
Estimated Replacement \$:	\$10,000							\$0	\$0	\$0
RESTROOMS										
Type:	2 Toilets, 2 Lav's (1 Each Side M/W)							\$0	\$0	\$0
Age:	13							\$0	\$0	\$0
General Condition:	2							\$0	\$0	\$0
Estimated Replacement \$:	\$6,000							\$0	\$0	\$0
Type:	Electric Hot Water (tank)							\$0	\$0	\$0
Age:	13							\$0	\$0	\$0
General Condition:	2							\$0	\$0	\$0
Estimated Replacement \$:	\$1,500							\$0	\$0	\$0

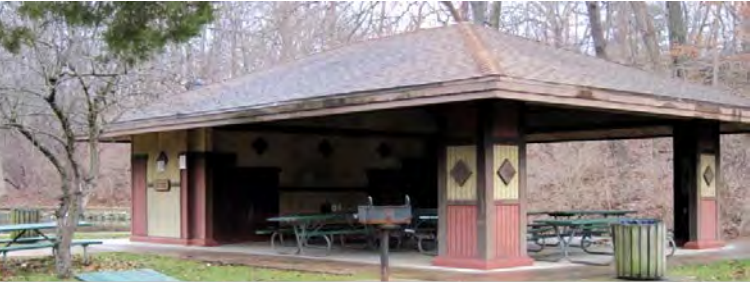
Facility Audit
General Information
 Facility Name: South Park Pond Shelter/Restroom
 Location: 8th & R.J. Peters Drive
 Approximate Sq. Ft.: 1,350 (45' x 30')
 General Condition: 2
 Seasons: Spring, Summer, Fall
 Hours: 30 Min. before SR -11:00 pm Spr, Su, Fall.
 Year Built: 1998
 Year(s) of Major Renovations: None
 Type of Construction: Wood Frame/Asphalt Shingle Roof
 Estimated Replacement \$: \$96,000
 Number of Stories: 1
 Current Primary Type of Use: Picnic Shelter/Restroom
 Wheelchair Accessible: Yes

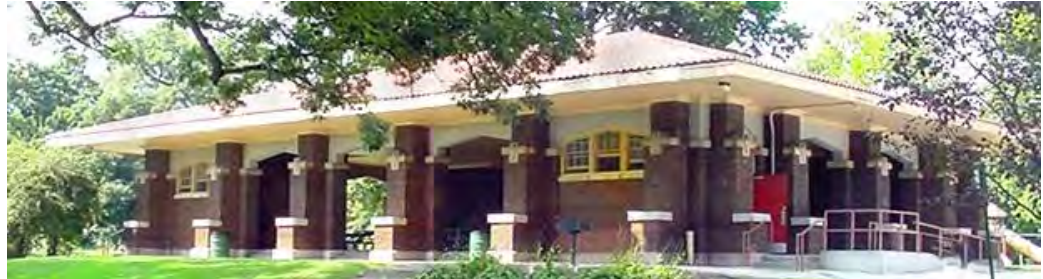
Facility Audit
General Information
 Facility Name: South Park Large Shelter/Restroom
 Location: 1500 S. 12th Street
 Approximate Sq. Ft.: 6,650 (95' x 70')
 General Condition: 2
 Seasons: Spring, Summer, Fall
 Hours: 30 Min. before SR -11:00 pm Spr, Su, Fall.
 Year Built: 1917
 Year(s) of Major Renovations: None
 Type of Construction: Brick/Tile Roof
 Estimated Replacement \$: \$676,000
 Number of Stories: 1
 Current Primary Type of Use: Picnic Shelter/Restroom
 Wheelchair Accessible: Yes

Estimated		
	<u>2012</u>	<u>2013</u>	<u>2014</u>	<u>2015</u>	<u>2016</u>	<u>Sum 1-5</u>	<u>2017-2021</u>	<u>Cost</u>	
South Park Large Shelter/Restroom	\$0	\$6,000	\$0	\$0	\$0	\$6,000	\$0	\$6,000

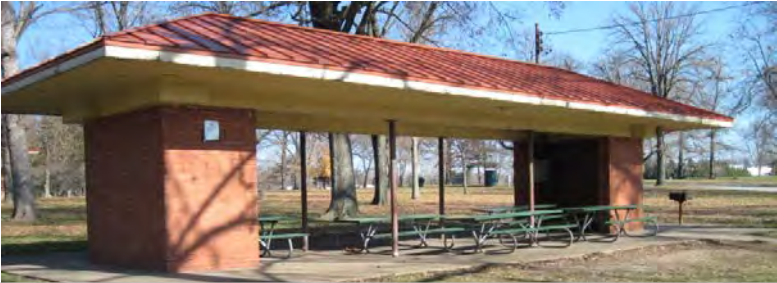
Facility Audit
General Information
 Facility Name: South Park Small Shelter
 Location: 1500 S. 12th Street
 Approximate Sq. Ft.: 1,000 (50' x 20')
 General Condition: 2
 Seasons: Spring, Summer, Fall
 Hours: 30 Min. before SR -11:00 pm
 Year Built: 1955
 Year(s) of Major Renovations: None
 Type of Construction: Brick Frame/Slab/Metal Roof
 Estimated Replacement \$: \$60,000
 Number of Stories: 1
 Current Primary Type of Use: Picnic Shelter
 Wheelchair Accessible:

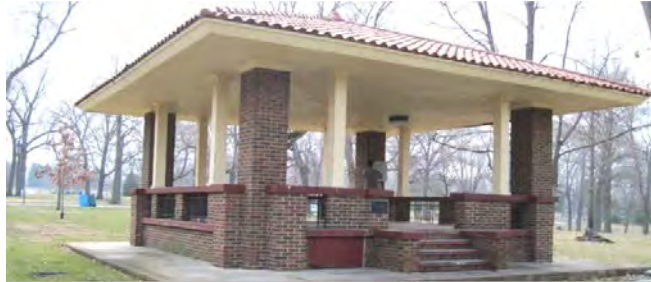
Facility Audit
General Information
 Facility Name: South Park Band Stand
 Location: 1500 S. 12th Street
 Approximate Sq. Ft.: 900 (30' x 30')
 General Condition: 2
 Seasons: Spring, Summer, Fall
 Hours: 30 Min. before SR -11:00 pm
 Year Built: 1919
 Year(s) of Major Renovations: None
 Type of Construction: Brick /Tile Roof
 Estimated Replacement \$: \$152,000
 Number of Stories: 1
 Current Primary Type of Use: Picnic Shelter
 Wheelchair Accessible:

<u>2012</u>	<u>2013</u>	<u>2014</u>	<u>2015</u>	<u>2016</u>	<u>Sum 1-5</u>	<u>2017-2021</u>	<u>Estimated Cost</u>
South Park Band Stand	\$30,000	\$0	\$0	\$0	\$0	\$30,000	\$0	\$30,000

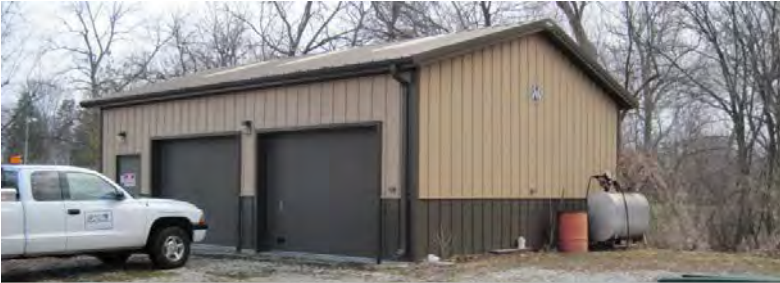
Facility Audit
General Information
 Facility Name: South Park Maintenance Building (#2)
 Location: 1331 S. 11th Street
 Approximate Sq. Ft.: 750 (30' x 25')
 General Condition: 2
 Seasons: Spring, Summer, Fall
 Hours: 30 Min. before SR -11:00 pm Spr, Su, Fall.
 Year Built: 1998
 Year(s) of Major Renovations: None
 Type of Construction: Wood Frame/Asphalt Shingle Roof
 Estimated Replacement \$: \$82,500
 Number of Stories: 1
 Current Primary Type of Use: Maintenance
 Wheelchair Accessible: Yes

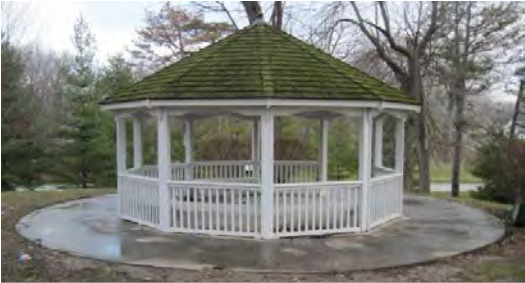
Facility Audit
General Information
 Facility Name: South Park Gazebo
 Location: 1500 S. 12th Street
 Approximate Sq. Ft.: 150 (16' x 16') 10 Sides
 General Condition: 2
 Seasons: Spring, Summer, Fall
 Hours: 30 Min. before SR -11:00 pm
 Year Built: 1998
 Year(s) of Major Renovations: None
 Type of Construction: Brick Frame/Slab/Tile Roof
 Estimated Replacement \$: \$24,000
 Number of Stories: 1
 Current Primary Type of Use: Picnic Shelter
 Wheelchair Accessible:

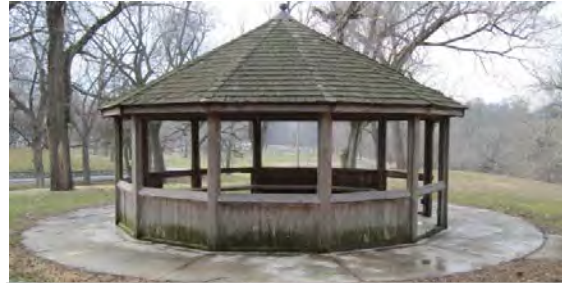
Facility Audit
General Information
 Facility Name: South Park Warming Hut
 Location: 1500 S. 12th Street
 Approximate Sq. Ft.: 400 (20' x 20') 12 Sides
 General Condition: 2
 Seasons: Spring, Summer, Fall
 Hours: 30 Min. before SR -11:00 pm
 Year Built: 1998
 Year(s) of Major Renovations: None
 Type of Construction: Wood Frame/Slab/Wood Roof
 Estimated Replacement \$: \$25,000
 Number of Stories: 1
 Current Primary Type of Use: Picnic Shelter
 Wheelchair Accessible:

<u>ROOF</u>	<u>General Information</u>	<u>Item in Need of Maintenance/ Repair/Replacement</u>	<u>2012</u>	<u>2013</u>	<u>2014</u>	<u>2015</u>	<u>2016</u>	<u>2017-2021</u>	<u>Estimated Cost</u>
Type:	Wood							\$0	\$0
Age:	13							\$0	\$0
General Condition:	2							\$0	\$0
Estimated Replacement \$:	\$2,000							\$0	\$0

Type:	Stained Wood/11 Windows							\$0	\$0
Age:	13							\$0	\$0
General Condition:	3							\$0	\$0
Estimated Replacement \$:	\$2,000							\$0	\$0

Type:	Stained Wood							\$0	\$0
Age:	13							\$0	\$0
General Condition:	3							\$0	\$0
Estimated Replacement \$:	\$1,000							\$0	\$0

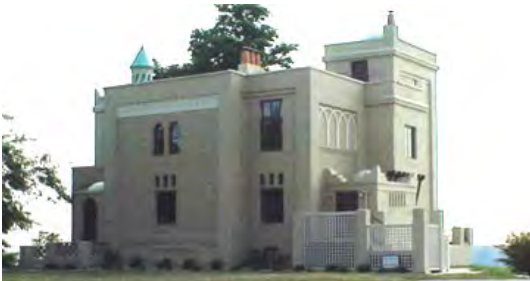
Facility Audit
General Information
 Facility Name: Villa Kathrine
 Location: 532 Gardner Expressway
 Approximate Sq. Ft.: 2600
 General Condition: 2
 Seasons: All
 Hours: 9 a.m. - 4 p.m. M-Sat, 1-4 Sun.
 Year Built: 1900
 Year(s) of Major Renovations: Various
 Type of Construction: Wood Frame/Stucco
 Estimated Replacement \$: \$997,000
 Number of Stories: 2
 Current Primary Type of Use: Visitor Center/Museum/Offices
 Wheelchair Accessible: Yes

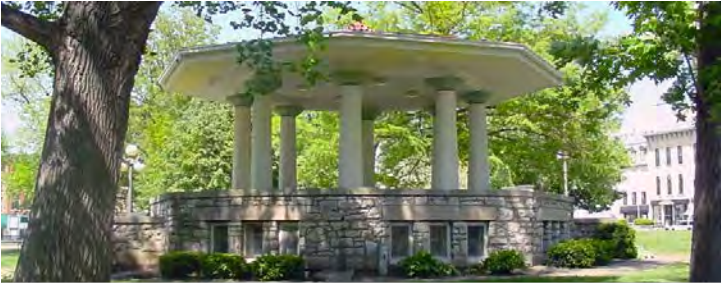
Facility Audit
General Information
 Facility Name: Washington Park Bandstand
 Location: 101 N. 5th Street
 Approximate Sq. Ft.: 2400 sq ft. (35'x35')
 General Condition: 2
 Seasons: Summer
 Hours: 30 Min. before SR -11:00 pm
 Year Built: 1920
 Year(s) of Major Renovations: None
 Type of Construction: Concrete
 Estimated Replacement \$: \$393,000
 Number of Stories: 2
 Current Primary Type of Use: Events/Performances
 Wheelchair Accessible: Yes

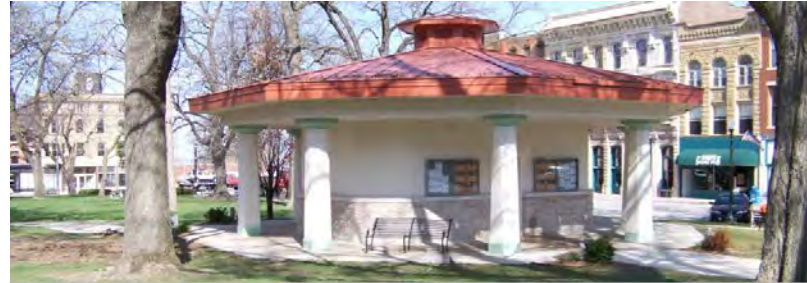
Facility Audit
General Information
 Facility Name: Washington Park Restroom
 Location: 101 N. 5th Street
 Approximate Sq. Ft.: 1700 sq ft. Concession (42'x42')
 General Condition: 2
 Seasons: Summer
 Hours: 30 Min. before SR -11:00 pm
 Year Built: 2007
 Year(s) of Major Renovations: None
 Type of Construction: Wood Frame/Masonry Veneer/Metal Rf
 Estimated Replacement \$: \$301,500
 Number of Stories: 1
 Current Primary Type of Use: Restroom/Information Kiosk
 Wheelchair Accessible: Yes

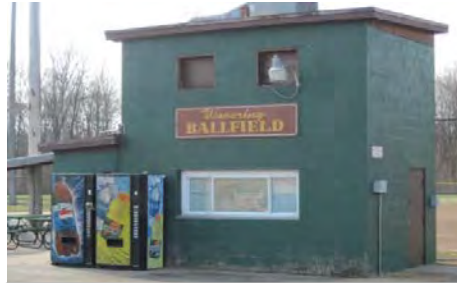
Facility Name: Wavering Ballfield Concession
Location: 1215 N. 39th Street
Approximate Sq. Ft.: 200 (20' x 10')
General Condition: 2
Seasons: All
Hours: 30 Min. before SR -11:00 pm Spr,Su,Fall.
Year Built: 1985
Year(s) of Major Renovations: None
Type of Construction: Concrete Block/Concrete Slab
Estimated Replacement \$: \$43,000
Number of Stories: 2
Current Primary Type of Use: Concession/Field Scoring
Wheelchair Accessible: Unknown

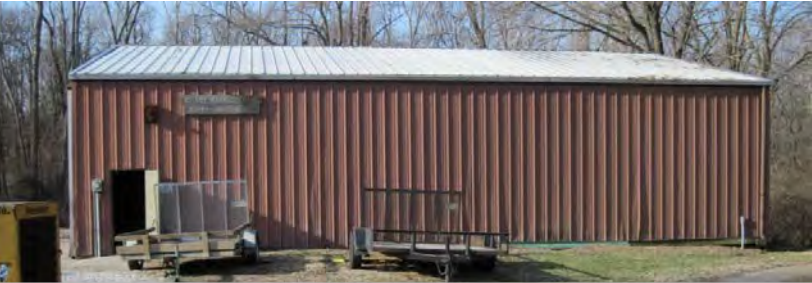
Facility Audit
General Information
 Facility Name: Wavering Maintenance 3 Building
 Location: 3710 Wavering Park Road
 Approximate Sq. Ft.: 2475 (45' x 55')
 General Condition: 2
 Seasons: All
 Hours: 30 Min. before SR -11:00 pm Spr,Su,Fall.
 Year Built: 1995
 Year(s) of Major Renovations: None
 Type of Construction: Wood Frame/Metal Siding/Concrete Slab
 Estimated Replacement \$: \$86,000
 Number of Stories: 1
 Current Primary Type of Use: Storage
 Wheelchair Accessible: Unknown

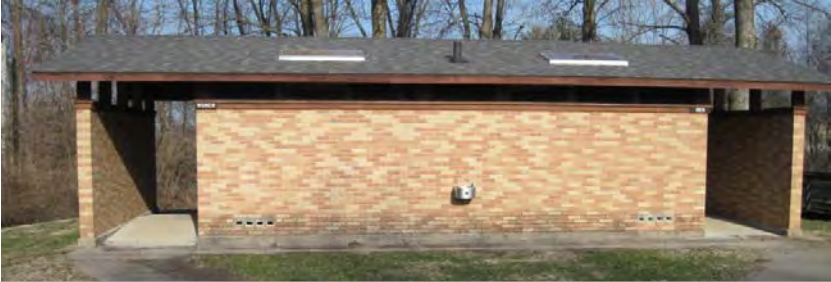
Facility Audit
General Information
 Facility Name: Wavering Restroom
 Location: 1215 N. 39th Street
 Approximate Sq. Ft.: 700 (35' x 20')
 General Condition: 2
 Seasons: All
 Hours: 30 Min. before SR -11:00 pm Spr,Su,Fall.
 Year Built: 1985
 Year(s) of Major Renovations: None
 Type of Construction: Brick/Fiberglass shingle
 Estimated Replacement \$: \$125,000
 Number of Stories: 1
 Current Primary Type of Use: Restroom & Maintenance Storage
 Wheelchair Accessible: Yes

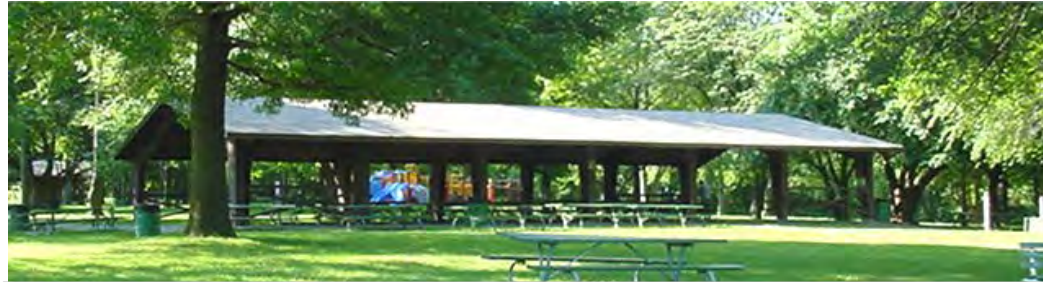
Facility Name: Wavering Large Shelter
Location: 3710 Wavering Park Road
Approximate Sq. Ft.: 2800 (70' x 40')
General Condition: 2
Seasons: All
Hours: 30 Min. before SR -11:00 pm Spr,Su,Fall.
Year Built: 1975
Year(s) of Major Renovations: None
Type of Construction: Wood Frame/Concrete Slab
Estimated Replacement \$: \$110,000
Number of Stories: 1
Current Primary Type of Use: Storage
Wheelchair Accessible: Unknown

ROOF	General Information	Item in Need of Maintenance/ Repair/Replacement	2012	2013	2014	2015	2016		2017-2020	Estimated Cost
Type:	Wood Rafters/Asphalt Shingles	Replace Shingles					\$6,000	\$6,000	\$0	\$6,000
Age:	15							\$0	\$0	\$0
General Condition:	2							\$0	\$0	\$0
Estimated Replacement \$:	\$10,000							\$0	\$0	\$0
<u>EXTERIOR/WINDOWS</u>										
Type:	Wood/Stained							\$0	\$0	\$0
Age:	37							\$0	\$0	\$0
General Condition:	2							\$0	\$0	\$0
Estimated Replacement \$:	\$2,000							\$0	\$0	\$0
<u>INTERIOR/FINISHES</u>										
Type:	Wood/Painted							\$0	\$0	\$0
Age:	37							\$0	\$0	\$0
General Condition:	2							\$0	\$0	\$0
Estimated Replacement \$:	\$2,000							\$0	\$0	\$0
<u>ELECTRICAL/LIGHTING</u>										
Type:	100 Amp, 16 GFI outlets, 3 MH Lights							\$0	\$0	\$0
Age:	5							\$0	\$0	\$0
General Condition:	2							\$0	\$0	\$0
Estimated Replacement \$:	\$6,000							\$0	\$0	\$0
<u>SANITARY/CUSTODIAL</u>

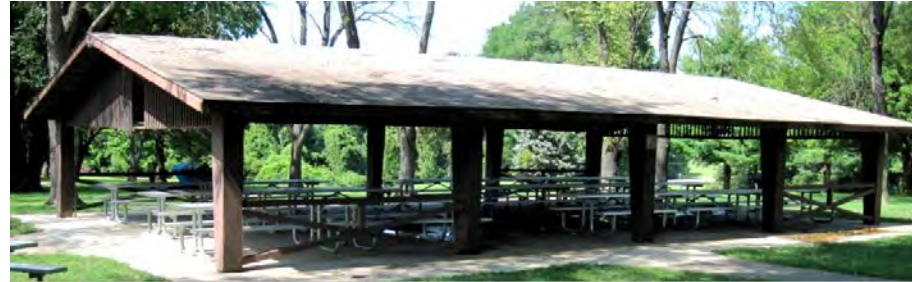
Facility Audit
General Information
 Facility Name: Wavering Small Shelter
 Location: 1215 N. 39th Street
 Approximate Sq. Ft.: 1440 (45' x 32')
 General Condition: 2
 Seasons: All
 Hours: 30 Min. before SR -11:00 pm Spr,Su,Fall.
 Year Built: 1980
 Year(s) of Major Renovations: None
 Type of Construction: Wood Frame/Concrete Slab
 Estimated Replacement \$: \$70,000
 Number of Stories: 1
 Current Primary Type of Use: Picnic Shelter
 Wheelchair Accessible: Unknown

ROOF	General Information	Item in Need of Maintenance/ Repair/Replacement	2012	2013	2014	2015	2016	Sum 1-5	2017-2020	Estimated Cost
Type:	Asphalt Shingles	Replace Shingles					\$3,000	\$3,000	\$0	\$3,000
Age:	32							\$0	\$0	\$0
General Condition:	2							\$0	\$0	\$0
Estimated Replacement \$:	\$4,000							\$0	\$0	\$0

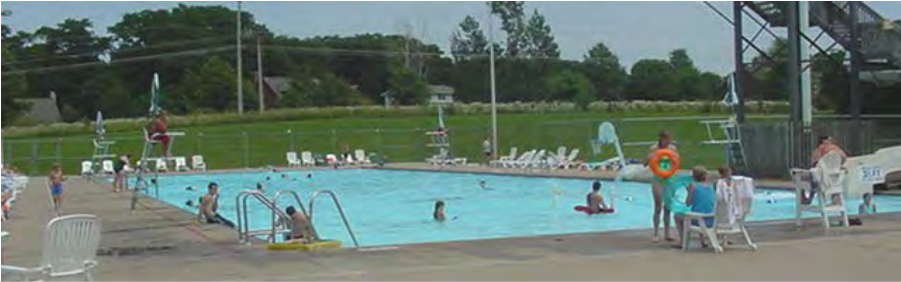
Facility Name: Wavering Aquatic Center
Location: 1410 Wavering Park Road
Approximate Sq. Ft.: 7600 Basin, 3700 Bathhouse, 1200 Filter
General Condition: 2
Seasons: Summer
Hours: 11:00 - 7:00
Year Built: 2002
Year(s) of Major Renovations: None
Type of Construction: Concrete
Estimated Replacement \$: \$3,344,000
Number of Stories: 1
Current Primary Type of Use: Swimming
Wheelchair Accessible: Yes

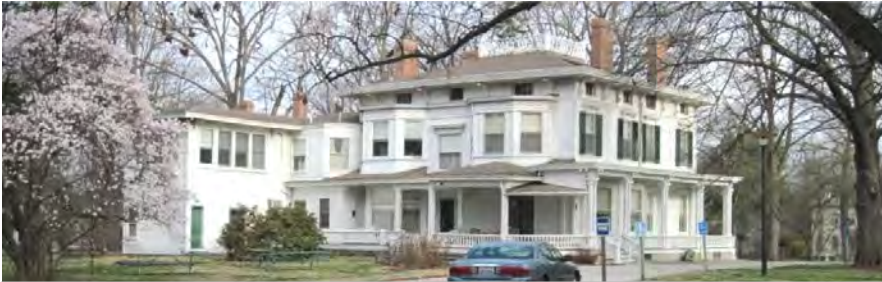
Facility Name: Women's City Club
 Location: 1550 Maine Street
 Approximate Sq. Ft.: 8000
 General Condition: 2
 Seasons: All
 Hours: No Public Hours
 Year Built: 1867
 Year(s) of Major Renovations: Various
 Type of Construction: Wood Frame/Siding
 Estimated Replacement \$: \$812,000
 Number of Stories: 2
 Current Primary Type of Use: Club Functions
 Wheelchair Accessible:

2012	2013	2014	2015	2016	Sum 1-5	2017-2021	Estimated Cost
Women's City Club	\$0	\$0	\$30,000	\$0	\$0	\$30,000	\$0	\$30,000

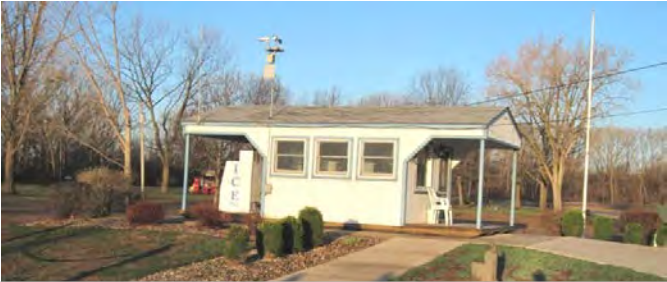
Facility Name: Art Keller Guard House
Location: 1009 Quinsippi Island Road
Approximate Sq. Ft.: 144 (12'x12') 20' x 12' w/Covered Decks
General Condition: 2
Seasons: Sp, Su, Fa
Hours: 24/7 - April-October
Year Built: 2001
Year(s) of Major Renovations: None
Type of Construction: Wood Frame/Wood Skids
Estimated Replacement \$: \$31,500
Number of Stories: 1
Current Primary Type of Use: Marina Office/Attendant Station
Wheelchair Accessible: Unknown

ROOF	General Information	Item in Need of Maintenance/ Repair/Replacement	2012	2013	2014	2015	2016	Sum 1-5	2017-2020	Estimated Cost
Type:	Wood Rafters/Fiberglass Shingles	Replace						\$0	\$1,500	\$1,500
Age:	10							\$0	\$0	\$0
General Condition:	2							\$0	\$0	\$0
Estimated Replacement \$:	\$1,500							\$0	\$0	\$0
EXTERIOR/WINDOWS										
Type:	Painted Wood Siding/6 Window							\$0	\$0	\$0
Age:	10							\$0	\$0	\$0
General Condition:	2							\$0	\$0	\$0
Estimated Replacement \$:	\$1,000							\$0	\$0	\$0
INTERIOR/FINISHES										
Type:	Drywall/Paint							\$0	\$0	\$0
Age:	10							\$0	\$0	\$0
General Condition:	2							\$0	\$0	\$0
Estimated Replacement \$:	\$1,000							\$0	\$0	\$0
ELECTRICAL/LIGHTING										
Type:	100 Amp Sub-Panel, 2' FL L int, 6 outlets							\$0	\$0	\$0
Age:	10							\$0	\$0	\$0
General Condition:	2							\$0	\$0	\$0
Estimated Replacement \$:	\$1,500							\$0	\$0	\$0
SANITARY/CUSTODIAL
