Appendix A: Community Input

Focus Group Summary Report

Quincy Park District ***Quincy, Illinois***

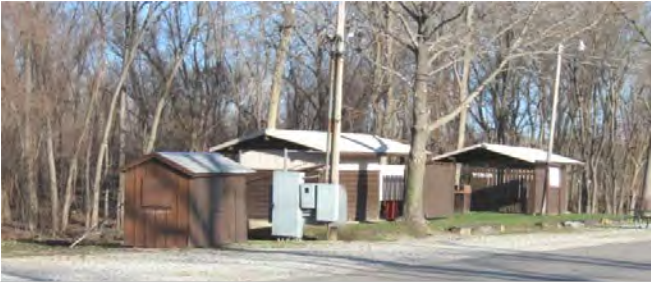
Facility Audit
General Information
 Facility Name: Art Keller Restrooms
 Location: 1009 Quinsippi Island Road
 Approximate Sq. Ft.: 216 (18'x12') 2 units M/W
 General Condition: 2
 Seasons: Sp, Su, Fa
 Hours: 24/7 - April-October
 Year Built: 1975
 Year(s) of Major Renovations: None
 Type of Construction: Wood Frame/Concrete Floor
 Estimated Replacement \$: \$52,000
 Number of Stories: 1
 Current Primary Type of Use: Restroom
 Wheelchair Accessible: Unknown

ROOF	General Information	Item in Need of Maintenance/ Repair/Replacement	2012	2013	2014	2015	2016	Sum 1-5	2017-2020	Estimated Cost
Type:	Wood Rafters/Fiberglass Panel	Replace						\$0	\$1,500	\$1,500
Age:	37							\$0	\$0	\$0
General Condition:	2							\$0	\$0	\$0
Estimated Replacement \$:	\$4,000							\$0	\$0	\$0
EXTERIOR/WINDOWS										
Type:	Painted Wood Siding							\$0	\$0	\$0
Age:	37							\$0	\$0	\$0
General Condition:	2							\$0	\$0	\$0
Estimated Replacement \$:	\$2,000							\$0	\$0	\$0
INTERIOR/FINISHES										
Type:	Painted Wood							\$0	\$0	\$0
Age:	37							\$0	\$0	\$0
General Condition:	2							\$0	\$0	\$0
Estimated Replacement \$:	\$2,000							\$0	\$0	\$0
ELECTRICAL/LIGHTING										
Type:	100 Amp Sub, 2 FL, Lights, 2 E. W. Heaters							\$0	\$0	\$0
Age:	37							\$0	\$0	\$0
General Condition:	2							\$0	\$0	\$0
Estimated Replacement \$:	\$4,000							\$0	\$0	\$0
SANITARY/CUSTODIAL

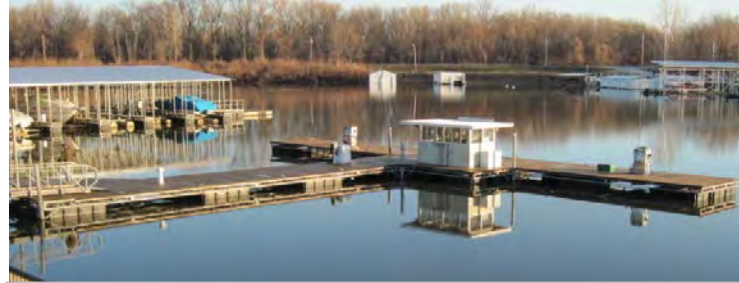
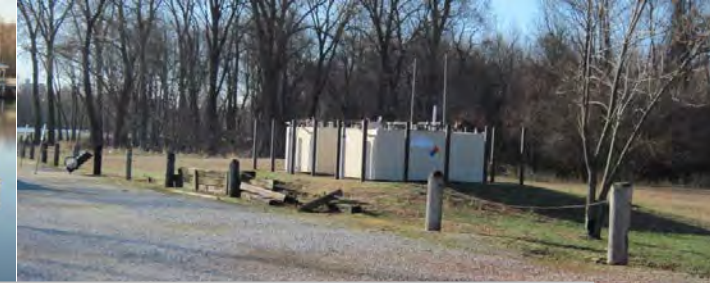
Facility Audit
General Information
 Facility Name: Art Keller Gas Dock
 Location: 1009 Quinsippi Island Road
 Approximate Sq. Ft.: 126 (14'x 9')
 General Condition: 2
 Seasons: Sp, Su, Fa
 Hours: 24/7 - April-October
 Year Built: 2000
 Year(s) of Major Renovations: None
 Type of Construction: Wood Frame/Concrete Floor
 Estimated Replacement \$: \$232,500
 Number of Stories: 1
 Current Primary Type of Use: Boat Fueling
 Wheelchair Accessible: Unknown

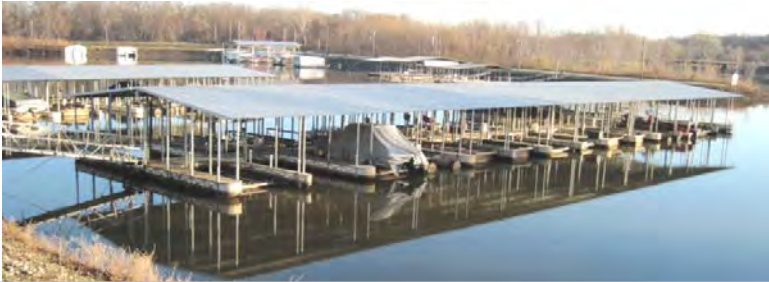
Facility Name: Art Keller AA Dock
Location: 1009 Quinsippi Island Road
Approximate Sq. Ft.: 7650, 170'x45' 28 20'x10' covered slips
General Condition: 2
Seasons: Sp, Su, Fa
Hours: 24/7 - April-October
Year Built: 1985
Year(s) of Major Renovations: None
Type of Construction: Metal Frame/Roof/Floats
Estimated Replacement \$: \$192,000
Number of Stories: 1
Current Primary Type of Use: Boat Slips
Wheelchair Accessible: No

<u>2012</u>	<u>2013</u>	<u>2014</u>	<u>2015</u>	<u>2016</u>	<u>Sum 1-5</u>	<u>2017-2020</u>	<u>Estimated Cost</u>
Art Keller AA Dock	\$10,000	\$0	\$0	\$0	\$0	\$10,000	\$0 \$0	\$10,000

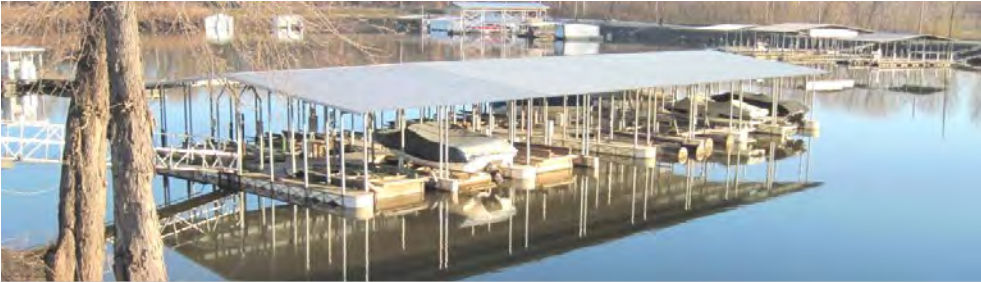
Facility Audit
General Information
 Facility Name: Art Keller BB Dock
 Location: 1009 Quinsippi Island Road
 Approximate Sq. Ft.: 4500, 100'x45' 16 20'x10' covered slips
 General Condition: 2
 Seasons: Sp, Su, Fa
 Hours: 24/7 - April-October
 Year Built: 1985
 Year(s) of Major Renovations: None
 Type of Construction: Metal Frame/Roof/Floats
 Estimated Replacement \$: \$150,000
 Number of Stories: 1
 Current Primary Type of Use: Boat Slips
 Wheelchair Accessible: No

ELECTRICAL/LIGHTING		Item in Need of Maintenance/ Repair/Replacement	2012	2013	2014	2015	2016	Sum 1-5	2017-2020	Estimated Cost
<u>General Information</u>										
Type:	100 Amp Sub, 3 Lt, 3 GFI outlets	Replace Lighting			\$2,000			\$2,000	\$0	\$2,000
Age:	27							\$0	\$0	\$0
General Condition:	2							\$0	\$0	\$0
Estimated Replacement \$:	\$2,000							\$0	\$0	\$0
STRUCTURE/FOUNDATION										
Type:	Metal Frame/Foam Floats	Replace Floats				\$45,000		\$45,000	\$0	\$45,000
Age:	27							\$0	\$0	\$0
General Condition:	2							\$0	\$0	\$0
Estimated Replacement \$:	\$120,000							\$0	\$0	\$0
OTHER										
Type:	Wood Access Stairs/Ramp	Replace	\$10,000					\$10,000	\$0	\$10,000
Age:	27							\$0	\$0	\$0
General Condition:	3							\$0	\$0	\$0
Estimated Replacement \$:	\$10,000							\$0	\$0	\$0
Type:	Aluminum Gangway							\$0	\$0	\$0
Age:	27							\$0	\$0	\$0
General Condition:	2							\$0	\$0	\$0
Estimated Replacement \$:	\$4,000							\$0	\$0	\$0

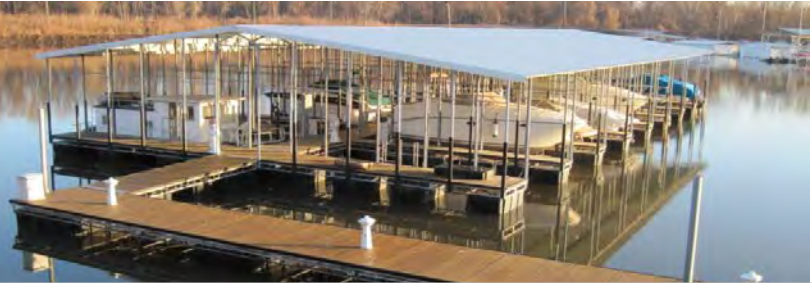
Facility Name: Art Keller CC Dock
Location: 1009 Quinsippi Island Road
Approximate Sq. Ft.: 9450, 135'x70' 16 30'x13' covered slips
General Condition: 2
Seasons: Sp, Su, Fa
Hours: 24/7 - April-October
Year Built: 2001
Year(s) of Major Renovations: None
Type of Construction: Metal Frame/Roof/Floats
Estimated Replacement \$: \$188,000
Number of Stories: 1
Current Primary Type of Use: Boat Slips
Wheelchair Accessible: Yes

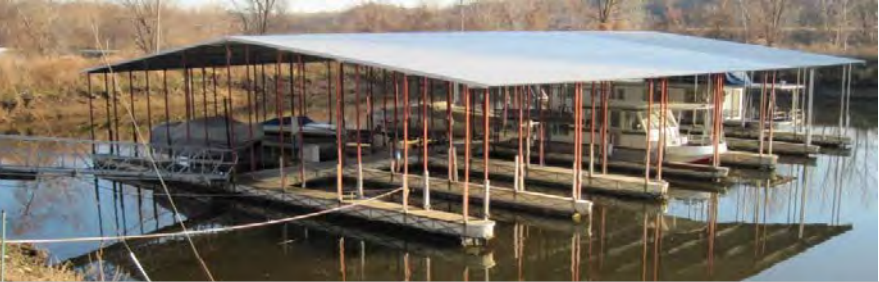
Facility Audit
General Information
 Facility Name: Art Keller A Dock
 Location: 1009 Quinsippi Island Road
 Approximate Sq. Ft.: 7600, 95'x80' 6 14'x35', 6 14'x40' cov. slips
 General Condition: 2
 Seasons: Sp, Su, Fa
 Hours: 24/7 - April-October
 Year Built: 1970
 Year(s) of Major Renovations: None
 Type of Construction: Metal Frame/Roof/Floats
 Estimated Replacement \$: \$181,000
 Number of Stories: 1
 Current Primary Type of Use: Boat Slips
 Wheelchair Accessible: No

ELECTRICAL/LIGHTING		Item in Need of Maintenance/ Repair/Replacement	2012	2013	2014	2015	2016	Sum 1-5	2017-2020	Estimated Cost
<u>General Information</u>										
Type:	200 Amp, 2 Lt, 12 Meters/Outlets	Replace Lighting			\$2,000			\$2,000	\$0	\$2,000
Age:	30							\$0	\$0	\$0
General Condition:	2							\$0	\$0	\$0
Estimated Replacement \$:	\$12,000							\$0	\$0	\$0
STRUCTURE/FOUNDATION										
Type:	Metal Frame/Foam Floats							\$0	\$0	\$0
Age:	42/10							\$0	\$0	\$0
General Condition:	2							\$0	\$0	\$0
Estimated Replacement \$:	\$140,000							\$0	\$0	\$0
OTHER										
Type:	Wood Access Stairs/Ramp	Replace			\$10,000			\$10,000	\$0	\$10,000
Age:	42							\$0	\$0	\$0
General Condition:	3							\$0	\$0	\$0
Estimated Replacement \$:	\$10,000							\$0	\$0	\$0
Type:	Aluminum Gangway							\$0	\$0	\$0
Age:	20							\$0	\$0	\$0
General Condition:	2							\$0	\$0	\$0
Estimated Replacement \$:	\$4,000							\$0	\$0	\$0

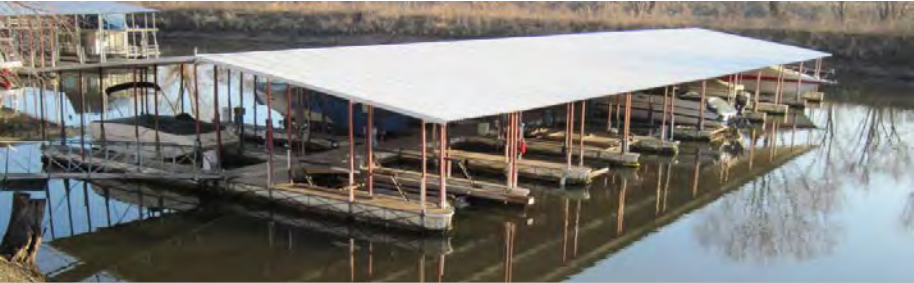
Facility Name: Art Keller B Dock
Location: 1009 Quinsippi Island Road
Approximate Sq. Ft.: 8700, 145'x60' 10 13'x25', 10 13'x30' cov. slips
General Condition: 2
Seasons: Sp, Su, Fa
Hours: 24/7 - April-October
Year Built: 1970
Year(s) of Major Renovations: None
Type of Construction: Metal Frame/Roof/Floats
Estimated Replacement \$: \$190,000
Number of Stories: 1
Current Primary Type of Use: Boat Slips
Wheelchair Accessible: No

<u>2012</u>	<u>2013</u>	<u>2014</u>	<u>2015</u>	<u>2016</u>	<u>Sum 1-5</u>	<u>2017-2020</u>	Estimated <u>Cost</u>
Art Keller B Dock	\$0	\$0	\$0	\$10,000	\$0	\$10,000	\$0	\$10,000

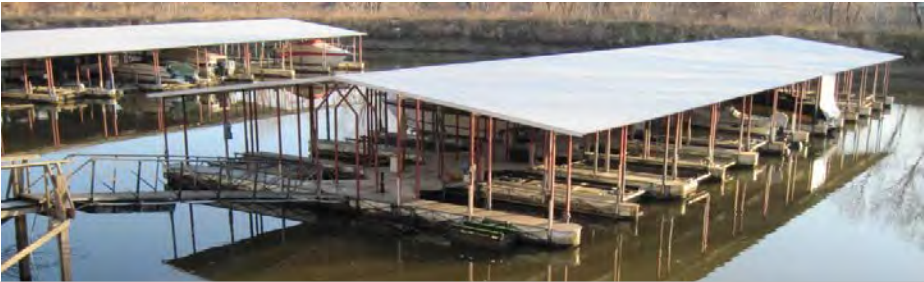
Facility Name: Art Keller C Dock
Location: 1009 Quinsippi Island Road
Approximate Sq. Ft.: 8400, 140'x60' 12 10'x25', 12 10'x23' cov. slips
General Condition: 2
Seasons: Sp, Su, Fa
Hours: 24/7 - April-October
Year Built: 1970
Year(s) of Major Renovations: None
Type of Construction: Metal Frame/Roof/Floats
Estimated Replacement \$: \$184,500
Number of Stories: 1
Current Primary Type of Use: Boat Slips
Wheelchair Accessible: No

<u>2012</u>	<u>2013</u>	<u>2014</u>	<u>2015</u>	<u>2016</u>	<u>Sum 1-5</u>	<u>2017-2020</u>	Estimated <u>Cost</u>
Art Keller C Dock	\$0	\$0	\$0	\$10,000	\$0	\$10,000	\$0	\$10,000

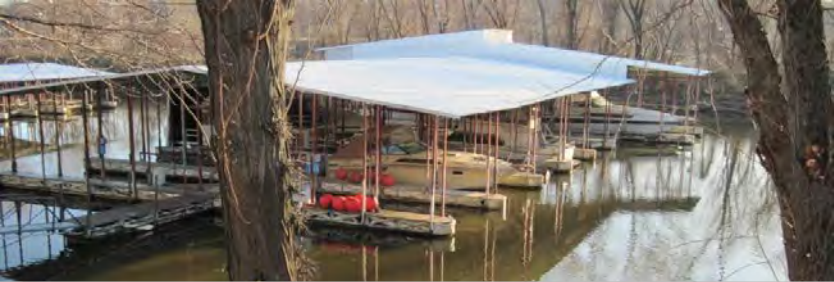
Facility Name: Art Keller D Dock
Location: 1009 Quinsippi Island Road
Approximate Sq. Ft.: 8400, 120'x70' 7 15'x30', 7 15'x35' cov. slips
General Condition: 2
Seasons: Sp, Su, Fa
Hours: 24/7 - April-October
Year Built: 1970
Year(s) of Major Renovations: None
Type of Construction: Metal Frame/Roof/Floats
Estimated Replacement \$: \$193,000
Number of Stories: 1
Current Primary Type of Use: Boat Slips
Wheelchair Accessible: No

2012	2013	2014	2015	2016	Sum 1-5	2017-2020	Estimated Cost
Art Keller D Dock	\$0	\$0	\$0	\$10,000	\$0	\$10,000	\$0	\$10,000

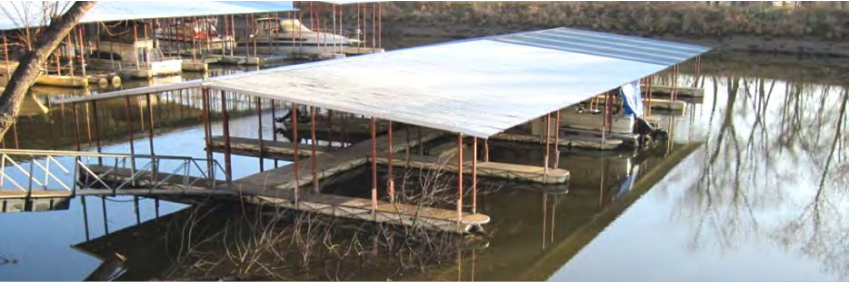
Facility Name: Art Keller E Dock
Location: 1009 Quinsippi Island Road
Approximate Sq. Ft.: 5000, 100'x50' 10 9'x20', 10 9'x23' cov. slips
General Condition: 2
Seasons: Sp, Su, Fa
Hours: 24/7 - April-October
Year Built: 1970
Year(s) of Major Renovations: None
Type of Construction: Metal Frame/Roof/Floats
Estimated Replacement \$: \$140,000
Number of Stories: 1
Current Primary Type of Use: Boat Slips
Wheelchair Accessible: No

Item in Need of Maintenance/ Repair/Replacement	<u>2012</u>	<u>2013</u>	<u>2014</u>	<u>2015</u>	<u>2016</u>	<u>Sum 1-5</u>	<u>2017-2020</u>	Estimated <u>Cost</u>
PLUMBING										
Type:	City Water							\$0	\$0	\$0
Age:	42							\$0	\$0	\$0
General Condition:	2							\$0	\$0	\$0
Estimated Replacement \$:	\$1,000							\$0	\$0	\$0
ROOF										
Type:	Metal							\$0	\$0	\$0
Age:	42							\$0	\$0	\$0
General Condition:	2							\$0	\$0	\$0
Estimated Replacement \$:	\$4,000							\$0	\$0	\$0
INTERIOR/FINISHES										
Type:	Concrete Deck							\$0	\$0	\$0
Age:	42							\$0	\$0	\$0
General Condition:	2							\$0	\$0	\$0
Estimated Replacement \$:	\$6,000							\$0	\$0	\$0

<u>ELECTRICAL/LIGHTING</u>		Item in Need of Maintenance/ <u>Repair/Replacement</u>	<u>2012</u>	<u>2013</u>	<u>2014</u>	<u>2015</u>	<u>2016</u>	<u>Sum 1-5</u>	<u>2017-2020</u>	Estimated <u>Cost</u>
Type:	100 Amp, 3 Lts, 2 Curt. Outlets							\$0	\$0	\$0
Age:	42							\$0	\$0	\$0
General Condition:	2							\$0	\$0	\$0
Estimated Replacement \$:	\$5,000							\$0	\$0	\$0
<u>STRUCTURE/FOUNDATION</u>										
Type:	Metal Frame/Foam Floats	Replace Dock			\$320,000			\$320,000	\$0	\$320,000
Age:	42							\$0	\$0	\$0
General Condition:	2							\$0	\$0	\$0
Estimated Replacement \$:	\$110,000							\$0	\$0	\$0
<u>OTHER</u>										
Type:	Wood Access Stairs/Ramp	Replace Access						\$0	\$0	\$0
Age:	42							\$0	\$0	\$0
General Condition:	3							\$0	\$0	\$0
Estimated Replacement \$:	\$10,000							\$0	\$0	\$0
Type:	Steel Gangway							\$0	\$0	\$0
Age:	42							\$0	\$0	\$0
General Condition:	2							\$0	\$0	\$0
Estimated Replacement \$:	\$4,000							\$0	\$0	\$0

<u>2012</u>	<u>2013</u>	<u>2014</u>	<u>2015</u>	<u>2016</u>	<u>Sum 1-5</u>	<u>2017-2020</u>	Estimated <u>Cost</u>
Art Keller E Dock	\$0	\$0	\$320,000	\$0	\$0	\$320,000	\$0	\$320,000

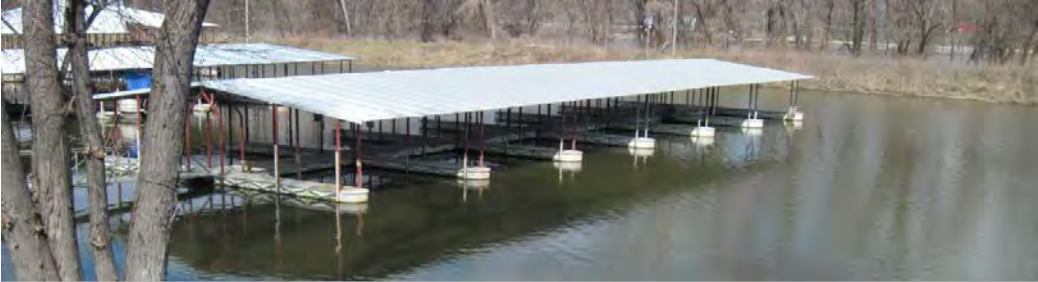
Facility Name: Art Keller F Dock
Location: 1009 Quinsippi Island Road
Approximate Sq. Ft.: 4800, 120'x40' 24 9'x18' (irreg) cov. slips
General Condition: 2
Seasons: Sp, Su, Fa
Hours: 24/7 - April-October
Year Built: 1970
Year(s) of Major Renovations: None
Type of Construction: Metal Frame/Roof/Floats
Estimated Replacement \$: \$140,000
Number of Stories: 1
Current Primary Type of Use: Boat Slips
Wheelchair Accessible: No

Item in Need of Maintenance/ Repair/Replacement	2012	2013	2014	2015	2016	Sum 1-5	2017-2020	Estimated Cost
PLUMBING		General Information								
Type:	City Water							\$0	\$0	\$0
Age:	42							\$0	\$0	\$0
General Condition:	2							\$0	\$0	\$0
Estimated Replacement \$:	\$1,000							\$0	\$0	\$0
ROOF										
Type:	Metal							\$0	\$0	\$0
Age:	42							\$0	\$0	\$0
General Condition:	2							\$0	\$0	\$0
Estimated Replacement \$:	\$5,000							\$0	\$0	\$0
INTERIOR/FINISHES										
Type:	Concrete Deck							\$0	\$0	\$0
Age:	42							\$0	\$0	\$0
General Condition:	2							\$0	\$0	\$0
Estimated Replacement \$:	\$5,000							\$0	\$0	\$0

ELECTRICAL/LIGHTING		Item in Need of Maintenance/ Repair/Replacement	2012	2013	2014	2015	2016	Sum 1-5	2017-2020	Estimated Cost
Type:	100 Amp, 4 Lts, 4 Curt. Outlets							\$0	\$0	\$0
Age:	42							\$0	\$0	\$0
General Condition:	2							\$0	\$0	\$0
Estimated Replacement \$:	\$5,000							\$0	\$0	\$0
STRUCTURE/FOUNDATION										
Type:	Metal Frame/Foam Floats	Dock Eliminated in 2014						\$0	\$0	\$0
Age:	42							\$0	\$0	\$0
General Condition:	2							\$0	\$0	\$0
Estimated Replacement \$:	\$110,000							\$0	\$0	\$0
OTHER										
Type:	Wood Access Stairs/Ramp							\$0	\$0	\$0
Age:	42							\$0	\$0	\$0
General Condition:	3							\$0	\$0	\$0
Estimated Replacement \$:	\$10,000							\$0	\$0	\$0
Type:	Steel Gangway							\$0	\$0	\$0
Age:	42							\$0	\$0	\$0
General Condition:	2							\$0	\$0	\$0
Estimated Replacement \$:	\$4,000							\$0	\$0	\$0

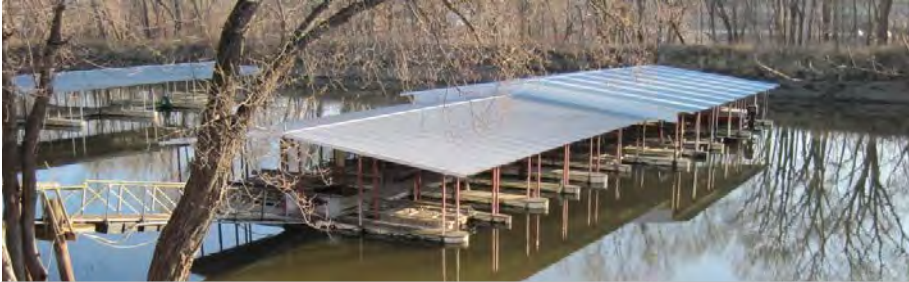
Facility Name: Art Keller G Dock
Location: 1009 Quinsippi Island Road
Approximate Sq. Ft.: 5400, 120'x45' 24 9'x20' (irreg) cov. slips
General Condition: 2
Seasons: Sp, Su, Fa
Hours: 24/7 - April-October
Year Built: 1970
Year(s) of Major Renovations: None
Type of Construction: Metal Frame/Roof/Floats
Estimated Replacement \$: \$152,000
Number of Stories: 1
Current Primary Type of Use: Boat Slips
Wheelchair Accessible: No

Item in Need of Maintenance/		2012	2013	2014	2015	2016	Sum 1-5	2017-2020	Estimated Cost
General Information		Repair/Replacement							
PLUMBING	Type:	City Water					\$0	\$0	\$0
	Age:	42					\$0	\$0	\$0
	General Condition:	2					\$0	\$0	\$0
	Estimated Replacement \$:	\$1,000					\$0	\$0	\$0
ROOF									
	Type:	Metal					\$0	\$0	\$0
	Age:	42					\$0	\$0	\$0
	General Condition:	2					\$0	\$0	\$0
	Estimated Replacement \$:	\$5,000					\$0	\$0	\$0
INTERIOR/FINISHES									
	Type:	Concrete Deck					\$0	\$0	\$0
	Age:	42					\$0	\$0	\$0
	General Condition:	2					\$0	\$0	\$0
	Estimated Replacement \$:	\$7,000					\$0	\$0	\$0

ELECTRICAL/LIGHTING		Item in Need of Maintenance/ Repair/Replacement	2012	2013	2014	2015	2016	Sum 1-5	2017-2020	Estimated Cost
Type:	100 Amp, 3 Lts, 4 Curt. Outlets							\$0	\$0	\$0
Age:	42							\$0	\$0	\$0
General Condition:	2							\$0	\$0	\$0
Estimated Replacement \$:	\$5,000							\$0	\$0	\$0
STRUCTURE/FOUNDATION										
Type:	Metal Frame/Foam Floats	Refloat		\$45,000				\$45,000	\$0	\$45,000
Age:	42							\$0	\$0	\$0
General Condition:	2							\$0	\$0	\$0
Estimated Replacement \$:	\$120,000							\$0	\$0	\$0
OTHER										
Type:	Wood Access Stairs/Ramp	Replace				\$10,000		\$10,000	\$0	\$10,000
Age:	42							\$0	\$0	\$0
General Condition:	3							\$0	\$0	\$0
Estimated Replacement \$:	\$10,000							\$0	\$0	\$0
Type:	Steel Gangway							\$0	\$0	\$0
Age:	42							\$0	\$0	\$0
General Condition:	2							\$0	\$0	\$0
Estimated Replacement \$:	\$4,000							\$0	\$0	\$0

2012	2013	2014	2015	2016	Sum 1-5	2017-2020	Estimated Cost
Art Keller G Dock	\$0	\$45,000	\$0	\$10,000	\$0	\$55,000	\$0	\$55,000

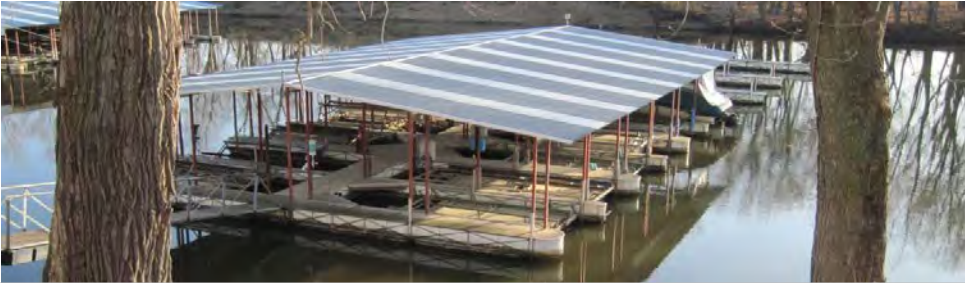
Facility Name: Art Keller H Dock
Location: 1009 Quinsippi Island Road
Approximate Sq. Ft.: 2700, 60'x45', 7 9'x20', 9'x23' cov. slips
General Condition: 2
Seasons: Sp, Su, Fa
Hours: 24/7 - April-October
Year Built: 1970
Year(s) of Major Renovations: None
Type of Construction: Metal Frame/Roof/Floats
Estimated Replacement \$: \$143,000
Number of Stories: 1
Current Primary Type of Use: Boat Slips
Wheelchair Accessible: No

Item in Need of Maintenance/ Repair/Replacement	<u>2012</u>	<u>2013</u>	<u>2014</u>	<u>2015</u>	<u>2016</u>	<u>Sum 1-5</u>	<u>2017-2020</u>	<u>Estimated Cost</u>
PLUMBING		<u>General Information</u>								
Type:	City Water							\$0	\$0	\$0
Age:	42							\$0	\$0	\$0
General Condition:	2							\$0	\$0	\$0
Estimated Replacement \$:	\$1,000							\$0	\$0	\$0
ROOF										
Type:	Metal							\$0	\$0	\$0
Age:	42							\$0	\$0	\$0
General Condition:	2							\$0	\$0	\$0
Estimated Replacement \$:	\$5,000							\$0	\$0	\$0
INTERIOR/FINISHES										
Type:	Concrete Deck							\$0	\$0	\$0
Age:	42							\$0	\$0	\$0
General Condition:	2							\$0	\$0	\$0
Estimated Replacement \$:	\$5,000							\$0	\$0	\$0

ELECTRICAL/LIGHTING		Item in Need of Maintenance/ Repair/Replacement	2012	2013	2014	2015	2016	Sum 1-5	2017-2020	Estimated Cost
<u>General Information</u>										
Type:	100 Amp, 6 meters, 3 Lts, 15 Curt. Outlets							\$0	\$0	\$0
Age:	42							\$0	\$0	\$0
General Condition:	2							\$0	\$0	\$0
Estimated Replacement \$:	\$8,000							\$0	\$0	\$0
STRUCTURE/FOUNDATION										
Type:	Metal Frame/Foam Floats							\$0	\$0	\$0
Age:	42							\$0	\$0	\$0
General Condition:	2							\$0	\$0	\$0
Estimated Replacement \$:	\$110,000							\$0	\$0	\$0
OTHER										
Type:	Wood Access Stairs/Ramp	Replace				\$10,000		\$10,000	\$0	\$10,000
Age:	42							\$0	\$0	\$0
General Condition:	3							\$0	\$0	\$0
Estimated Replacement \$:	\$10,000							\$0	\$0	\$0
Type:	Steel Gangway							\$0	\$0	\$0
Age:	42							\$0	\$0	\$0
General Condition:	2							\$0	\$0	\$0
Estimated Replacement \$:	\$4,000							\$0	\$0	\$0

<u>2012</u>	<u>2013</u>	<u>2014</u>	<u>2015</u>	<u>2016</u>	<u>Sum 1-5</u>	<u>2017-2020</u>	<u>Estimated Cost</u>
Art Keller H Dock	\$0	\$0	\$0	\$10,000	\$0	\$10,000	\$0	\$10,000

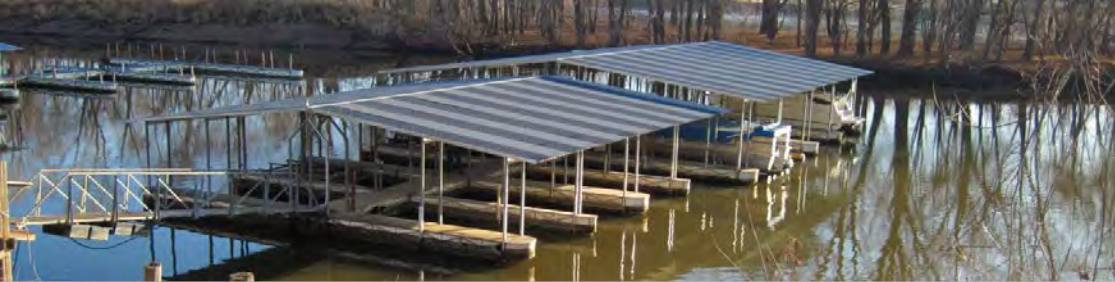
Facility Name: Art Keller I Dock
Location: 1009 Quinsippi Island Road
Approximate Sq. Ft.: 5000, 100'x50', 8 12'x24', 8 10'x20' cov. slips
General Condition: 2
Seasons: Sp, Su, Fa
Hours: 24/7 - April-October
Year Built: 1970
Year(s) of Major Renovations: None
Type of Construction: Metal Frame/Roof/Floats
Estimated Replacement \$: \$151,000
Number of Stories: 1
Current Primary Type of Use: Boat Slips
Wheelchair Accessible: No

Item in Need of Maintenance/		2012	2013	2014	2015	2016	Sum 1-5	2017-2020	Estimated Cost
Repair/Replacement									
PLUMBING	<u>General Information</u>								
Type:	City Water						\$0	\$0	\$0
Age:	42						\$0	\$0	\$0
General Condition:	2						\$0	\$0	\$0
Estimated Replacement \$:	\$1,000						\$0	\$0	\$0
<u>ROOF</u>									
Type:	Metal						\$0	\$0	\$0
Age:	42						\$0	\$0	\$0
General Condition:	2						\$0	\$0	\$0
Estimated Replacement \$:	\$5,000						\$0	\$0	\$0
<u>INTERIOR/FINISHES</u>									
Type:	Concrete Deck						\$0	\$0	\$0
Age:	42						\$0	\$0	\$0
General Condition:	2						\$0	\$0	\$0
Estimated Replacement \$:	\$6,000						\$0	\$0	\$0

Item in Need of Maintenance/ Repair/Replacement	2012	2013	2014	2015	2016	Sum 1-5	2017-2020	Estimated Cost
ELECTRICAL/LIGHTING		General Information								
Type:	100 Amp, 8 Lts, 4 Curt. Outlets							\$0	\$0	\$0
Age:	10							\$0	\$0	\$0
General Condition:	2							\$0	\$0	\$0
Estimated Replacement \$:	\$5,000							\$0	\$0	\$0
STRUCTURE/FOUNDATION										
Type:	Metal Frame/Foam Floats							\$0	\$0	\$0
Age:	42							\$0	\$0	\$0
General Condition:	2							\$0	\$0	\$0
Estimated Replacement \$:	\$120,000							\$0	\$0	\$0
OTHER										
Type:	Wood Access Stairs/Ramp	Replace				\$10,000		\$10,000	\$0	\$10,000
Age:	42							\$0	\$0	\$0
General Condition:	3							\$0	\$0	\$0
Estimated Replacement \$:	\$10,000							\$0	\$0	\$0
Type:	Steel Gangway							\$0	\$0	\$0
Age:	42							\$0	\$0	\$0
General Condition:	2							\$0	\$0	\$0
Estimated Replacement \$:	\$4,000							\$0	\$0	\$0

2012	2013	2014	2015	2016	Sum 1-5	2017-2020	Estimated Cost
Art Keller I Dock	\$0	\$0	\$0	\$10,000	\$0	\$10,000	\$0	\$10,000

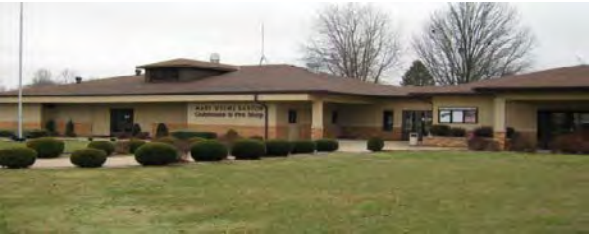
Facility Name: Mary Weems Barton Clubhouse/Proshop
Location: 2150 South 36th Street
Approximate Sq. Ft.: 8,500
General Condition: 2
Year Built: Early 1950's
Year(s) of Major Renovations: 2000
Type of Construction: Wood frame, brick/stucco siding shingle roof
Estimated Replacement \$: \$930,000
Wheelchair Accessible: Yes

<u>HVAC</u>	Item in Need of Maintenance/ Repair/Replacement	<u>2012</u>	<u>2013</u>	<u>2014</u>	<u>2015</u>	<u>2016</u>	<u>Sum 1-5</u>	<u>2017-2021</u>	Estimated Cost
Type:	5-Carrier down flo horizontal gas model 58ray						\$0	\$0	\$0
Age:	11						\$0	\$0	\$0
General Condition:	2						\$0	\$0	\$0
Estimated Replacement \$:	\$40,000		\$20,000	\$20,000			\$40,000	\$0	\$40,000

<u>PLUMBING</u>									
Type:	City water service						\$0	\$0	\$0
Age:	50+						\$0	\$0	\$0
General Condition:	4						\$0	\$0	\$0
Estimated Replacement \$:	\$30,000						\$0	\$0	\$0

<u>RESTROOMS/LOCKER ROOMS</u>									
Type:	2U/2T men's, 3T Women's, 2 Lav each side						\$0	\$0	\$0
Age:	50+						\$0	\$0	\$0
General Condition:	4						\$0	\$0	\$0
Estimated Replacement \$:	\$250,000			\$250,000			\$250,000	\$0	\$250,000

Item in Need of Maintenance/ Repair/Replacement	2012	2013	2014	2015	2016	Sum 1-5	2017-2021	Estimated Cost
ROOF										
Type:	Fiberglass shingles							\$0	\$0	\$0
Age:	7							\$0	\$0	\$0
General Condition:	1							\$0	\$0	\$0
Estimated Replacement \$:	\$35,000							\$0	\$0	\$0
STRUCTURE/FOUNDATION										
Type:	Brick/wood frame/stucco, concrete							\$0	\$0	\$0
Age:	50+							\$0	\$0	\$0
General Condition:	1							\$0	\$0	\$0
Estimated Replacement \$:	\$250,000							\$0	\$0	\$0
INTERIOR/FINISHES										
Type:	Carpet/tile flooring, paint, fixtures							\$0	\$0	\$0
Age:	Proshop - 11 yrs. Players Grill - 3 years							\$0	\$0	\$0
General Condition:	2							\$0	\$0	\$0
Estimated Replacement \$:	\$75,000							\$0	\$0	\$0
OTHER										
Type:	Interior painting	replacement				\$2,000		\$2,000	\$0	\$2,000
Age:	Carpet - partial	replacement		\$10,000				\$10,000	\$0	\$10,000
General Condition:								\$0	\$0	\$0

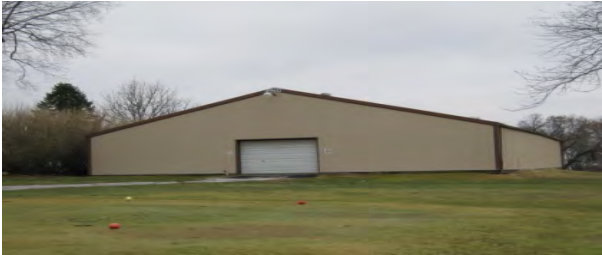
Building Name: Golf Car Barn
Approximate Sq. Ft.: 3,500
General Condition: 2
Year Built: 1981
Year(s) of Major Renovations: None
Type of Construction: Wood frame, metal siding
Estimated Replacement \$: \$82,000
Wheelchair Accessible: Yes

<u>PLUMBING</u>		<u>2012</u>	<u>2013</u>	<u>2014</u>	<u>2015</u>	<u>2016</u>	<u>Sum 1-5</u>	<u>2017-2021</u>	Estimated <u>Cost</u>
Type:	Non potable						\$0	\$0	\$0
Age:	30						\$0	\$0	\$0
General Condition:	2						\$0	\$0	\$0
Estimated Replacement \$:	\$2,000						\$0	\$0	\$0

Item in Need of Maintenance/ Repair/Replacement	2012	2013	2014	2015	2016	Sum 1-5	2017-2021	Estimated Cost
ROOF										
Type:	Metal roof							\$0	\$0	\$0
Age:	30							\$0	\$0	\$0
General Condition:	2							\$0	\$0	\$0
Estimated Replacement \$:	\$25,000							\$0	\$0	\$0
STRUCTURE/FOUNDATION										
Type:	Wood framing, concrete floor							\$0	\$0	\$0
Age:	30							\$0	\$0	\$0
General Condition:	2							\$0	\$0	\$0
Estimated Replacement \$:	\$30,000							\$0	\$0	\$0
EXTERIOR/WINDOWS										
Type:	Metal siding							\$0	\$0	\$0
Age:	30							\$0	\$0	\$0
General Condition:	2							\$0	\$0	\$0
Estimated Replacement \$:	\$25,000							\$0	\$0	\$0
OTHER										
Type:	2- Overhead doors & lighting	replacement		\$5,000				\$5,000	\$0	\$5,000
Age:								\$0	\$0	\$0
General Condition:								\$0	\$0	\$0
Estimated Replacement \$:								\$0	\$0	\$0

<u>2012</u>	<u>2013</u>	<u>2014</u>	<u>2015</u>	<u>2016</u>	<u>Sum 1-5</u>	<u>2017-2021</u>	Estimated <u>Cost</u>
Golf Car Barn	\$0	\$5,000	\$0	\$0	\$0	\$5,000	\$0	\$5,000

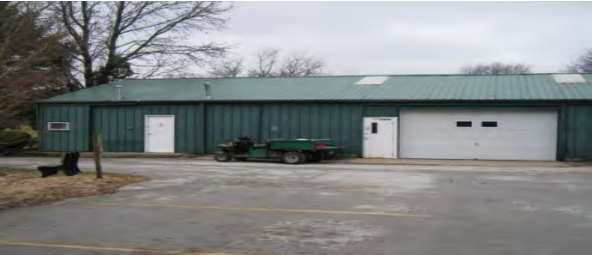
Building Name: Maintenance Shop
Approximate Sq. Ft.: 2,500
General Condition: 2
Year Built: 1976
Year(s) of Major Renovations: None
Type of Construction: Wood frame, metal siding
Estimated Replacement \$: \$150,000
Wheelchair Accessible: Yes

<u>HVAC</u>		Item in Need of Maintenance/ Repair/Replacement	<u>2012</u>	<u>2013</u>	<u>2014</u>	<u>2015</u>	<u>2016</u>	<u>Sum 1-5</u>	<u>2017-2021</u>	Estimated <u>Cost</u>
Type:	Ceiling mount gas heater							\$0	\$0	\$0
Age:	8							\$0	\$0	\$0
General Condition:	1							\$0	\$0	\$0
Estimated Replacement \$:	\$5,000							\$0	\$0	\$0

<u>PLUMBING</u>										
Type:	City water service							\$0	\$0	\$0
Age:	35							\$0	\$0	\$0
General Condition:	2							\$0	\$0	\$0
Estimated Replacement \$:	\$15,000							\$0	\$0	\$0

<u>RESTROOMS</u>										
Type:	1T & 1 Lav each for employees & public							\$0	\$0	\$0
Age:	35							\$0	\$0	\$0
General Condition:	2							\$0	\$0	\$0
Estimated Replacement \$:	\$50,000							\$0	\$0	\$0

Item in Need of Maintenance/ Repair/Replacement	2012	2013	2014	2015	2016	Sum 1-5	2017-2021	Estimated Cost
ROOF										
Type:	Metal roof							\$0	\$0	\$0
Age:	35							\$0	\$0	\$0
General Condition:	1							\$0	\$0	\$0
Estimated Replacement \$:	\$25,000							\$0	\$0	\$0
STRUCTURE/FOUNDATION										
Type:	Wood frame, metal siding, concrete floor, elect.							\$0	\$0	\$0
Age:	35							\$0	\$0	\$0
General Condition:	2							\$0	\$0	\$0
Estimated Replacement \$:	\$50,000							\$0	\$0	\$0
EXTERIOR/WINDOWS										
Type:	2-walk in doors & 1 - overhead							\$0	\$0	\$0
Age:	10							\$0	\$0	\$0
General Condition:	2							\$0	\$0	\$0
Estimated Replacement \$:	\$5,000							\$0	\$0	\$0
OTHER										
Type:	2- Entrance doors & electrical updates	replacement				\$10,000		\$10,000	\$0	\$10,000
Age:								\$0	\$0	\$0
General Condition:								\$0	\$0	\$0
Estimated Replacement \$:								\$0	\$0	\$0

<u>2012</u>	<u>2013</u>	<u>2014</u>	<u>2015</u>	<u>2016</u>	<u>Sum 1-5</u>	<u>2017-2021</u>	Estimated <u>Cost</u>
Maintenance Shop	\$0	\$0	\$0	\$10,000	\$0	\$10,000	\$0	\$10,000

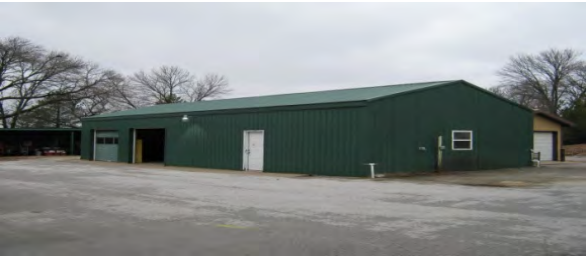
Building Name: Equipment Storage Shed
Approximate Sq. Ft.: 1,500
General Condition: 1
Year Built: 2005
Year(s) of Major Renovations: None
Type of Construction: Wood frame, metal siding
Estimated Replacement \$: \$50,000
Wheelchair Accessible: Yes

Item in Need of Maintenance/ Repair/Replacement	2012	2013	2014	2015	2016	Sum 1-5	2017-2021	Estimated Cost
ROOF										
Type:	Metal roof							\$0	\$0	\$0
Age:	6							\$0	\$0	\$0
General Condition:	1							\$0	\$0	\$0
Estimated Replacement \$:	\$15,000							\$0	\$0	\$0
STRUCTURE/FOUNDATION										
Type:	Wood frame, metal siding, concrete floor, elect.							\$0	\$0	\$0
Age:	6							\$0	\$0	\$0
General Condition:	1							\$0	\$0	\$0
Estimated Replacement \$:	\$25,000							\$0	\$0	\$0
EXTERIOR/WINDOWS										
Type:	1-walk in & 2 - overhead doors							\$0	\$0	\$0
Age:	6							\$0	\$0	\$0
General Condition:	1							\$0	\$0	\$0
Estimated Replacement \$:	\$10,000							\$0	\$0	\$0
OTHER										
Type:	1- Entrance door	replacement				\$1,000		\$1,000	\$0	\$1,000
Age:								\$0	\$0	\$0
General Condition:								\$0	\$0	\$0
Estimated Replacement \$:								\$0	\$0	\$0

<u>2012</u>	<u>2013</u>	<u>2014</u>	<u>2015</u>	<u>2016</u>	<u>Sum 1-5</u>	<u>2017-2021</u>	Estimated <u>Cost</u>
Equipment Storage Shed	\$0	\$0	\$0	\$1,000	\$0	\$1,000	\$0	\$1,000

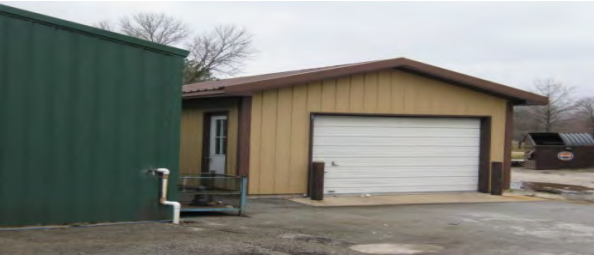
Building Name: Chemical Storage Shed
Approximate Sq. Ft.: 400
General Condition: 2
Year Built: 1993
Year(s) of Major Renovations: None
Type of Construction: Wood frame, metal siding
Estimated Replacement \$: \$45,000
Wheelchair Accessible: Yes

<u>PLUMBING</u>		<u>2012</u>	<u>2013</u>	<u>2014</u>	<u>2015</u>	<u>2016</u>	<u>Sum 1-5</u>	<u>2017-2021</u>	Estimated <u>Cost</u>
Type:	City water & non potable water						\$0	\$0	\$0
Age:	18						\$0	\$0	\$0
General Condition:	2						\$0	\$0	\$0
Estimated Replacement \$:	\$5,000						\$0	\$0	\$0

Item in Need of Maintenance/ Repair/Replacement	2012	2013	2014	2015	2016	Sum 1-5	2017-2021	Estimated Cost
ROOF										
Type:	Metal roof							\$0	\$0	\$0
Age:	18							\$0	\$0	\$0
General Condition:	1							\$0	\$0	\$0
Estimated Replacement \$:	\$5,000							\$0	\$0	\$0
STRUCTURE/FOUNDATION										
Type:	Wood frame, metal siding, concrete floor, elect.							\$0	\$0	\$0
Age:	18							\$0	\$0	\$0
General Condition:	1							\$0	\$0	\$0
Estimated Replacement \$:	\$30,000							\$0	\$0	\$0
EXTERIOR/WINDOWS										
Type:	1- Walk in & overhead door							\$0	\$0	\$0
Age:	6							\$0	\$0	\$0
General Condition:	2							\$0	\$0	\$0
Estimated Replacement \$:	\$10,000							\$0	\$0	\$0
OTHER										
Type:	1- Entrance door, timed ventilation	replacement	\$3,000					\$3,000	\$0	\$3,000
Age:								\$0	\$0	\$0
General Condition:								\$0	\$0	\$0
Estimated Replacement \$:								\$0	\$0	\$0

<u>2012</u>	<u>2013</u>	<u>2014</u>	<u>2015</u>	<u>2016</u>	<u>Sum 1-5</u>	<u>2017-2021</u>	Estimated <u>Cost</u>
Chemical Storage Shed	\$3,000	\$0	\$0	\$0	\$0	\$3,000	\$0	\$3,000

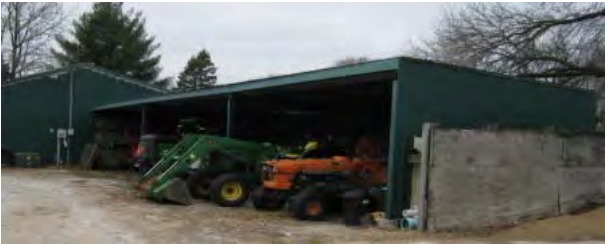
Building Name: Pole Barn Storage Shed
Approximate Sq. Ft.: 850
General Condition: 2
Year Built: 1970
Year(s) of Major Renovations: None
Type of Construction: Wood frame, metal siding
Estimated Replacement \$: \$20,000
Wheelchair Accessible: Yes

<u>2012</u>	<u>2013</u>	<u>2014</u>	<u>2015</u>	<u>2016</u>	<u>Sum 1-5</u>	<u>2017-2021</u>	Estimated <u>Cost</u>
Pole Barn Storage Shed	\$0	\$0	\$0	\$0	\$5,000	\$5,000	\$0	\$5,000

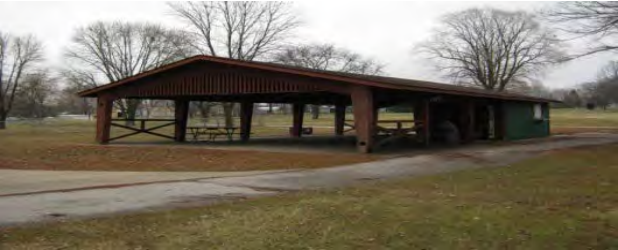
Building Name: #5 Shelter House
Approximate Sq. Ft.: 1,000
General Condition: 2
Year Built: 1971
Year(s) of Major Renovations: None
Type of Construction: Wood frame, fiberglass shingles
Estimated Replacement \$: \$36,000
Wheelchair Accessible: Yes

<u>2012</u>	<u>2013</u>	<u>2014</u>	<u>2015</u>	<u>2016</u>	<u>Sum 1-5</u>	<u>2017-2021</u>	Estimated <u>Cost</u>
#5 Shelter House	\$0	\$0	\$0	\$0	\$1,000	\$1,000	\$0	\$1,000

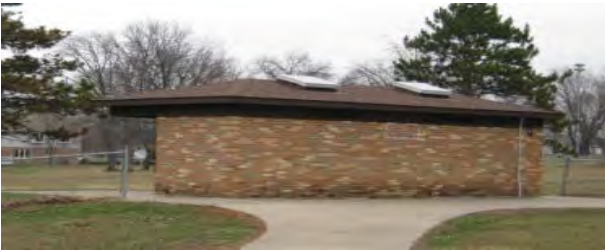
Building Name: #5 Restroom
Approximate Sq. Ft.: 1,000
General Condition: 2
Year Built: 1986
Year(s) of Major Renovations: None
Type of Construction: Brick, Shingle roof
Estimated Replacement \$: \$82,000
Wheelchair Accessible: Yes

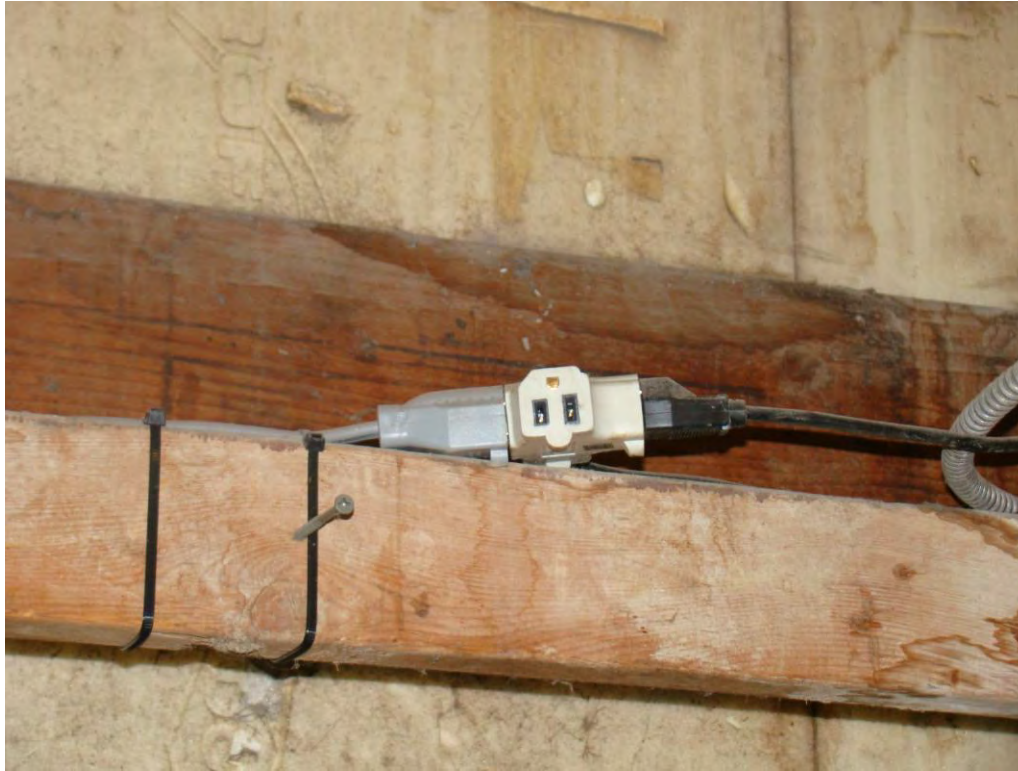
Extension cord used as permanent wiring

OSHA Standard Subpart S Electrical 1910.305, wiring methods, components and equipment for general use.

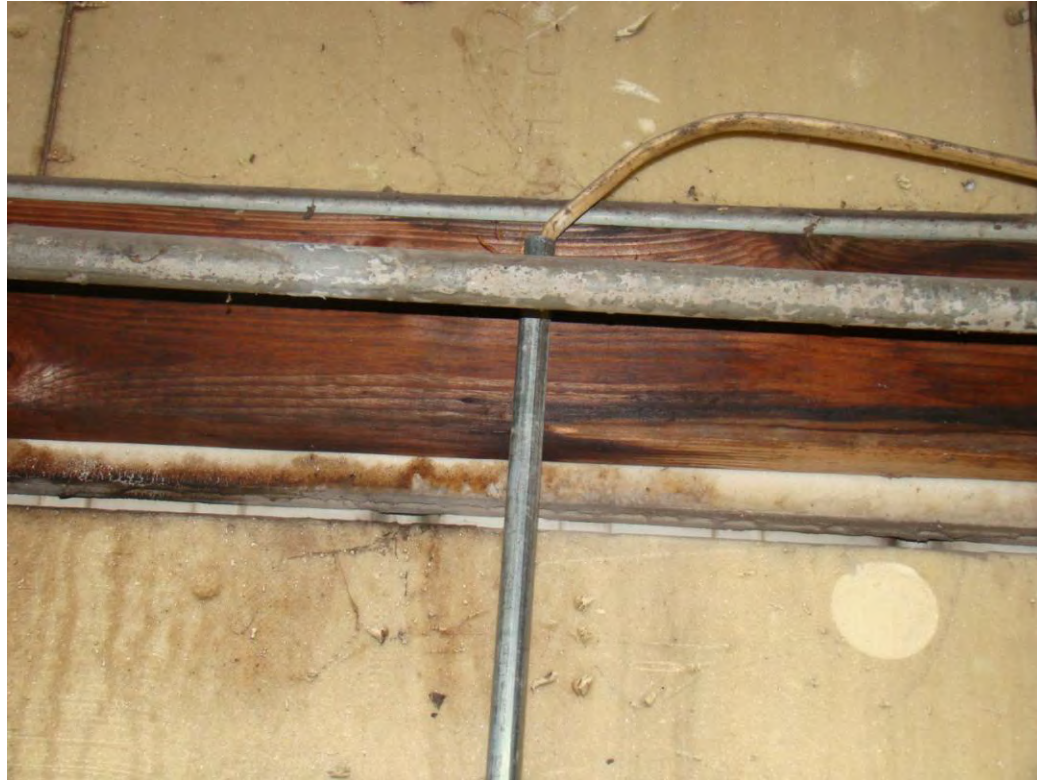
Romex coming out of conduit

National Electrical Codes (NEC) 334.10 non metallic sheathed cable, type NM, (romex) is only allowed in dwelling units, 1 and 2 family, and their attached garages and their storage units.

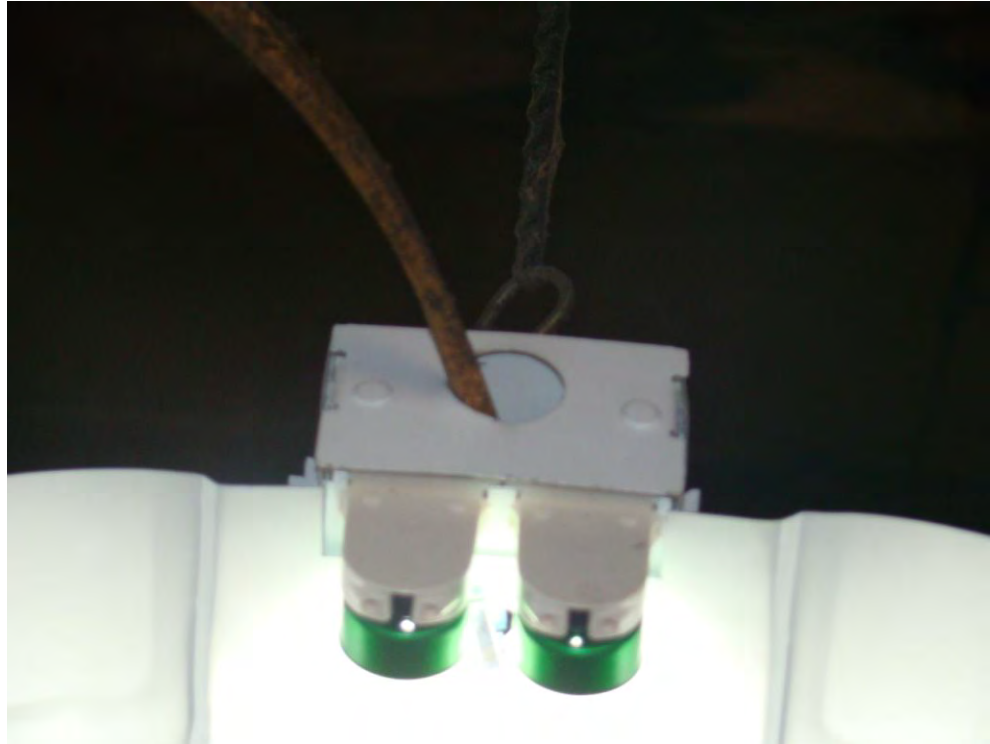
Romex going directly into lighting fixture

National Electrical Codes NEC 334.10 non metallic sheathed cable, type NM, (romex) is only allowed in dwelling units, 1 and 2 family, and their attached garages and their storage units.

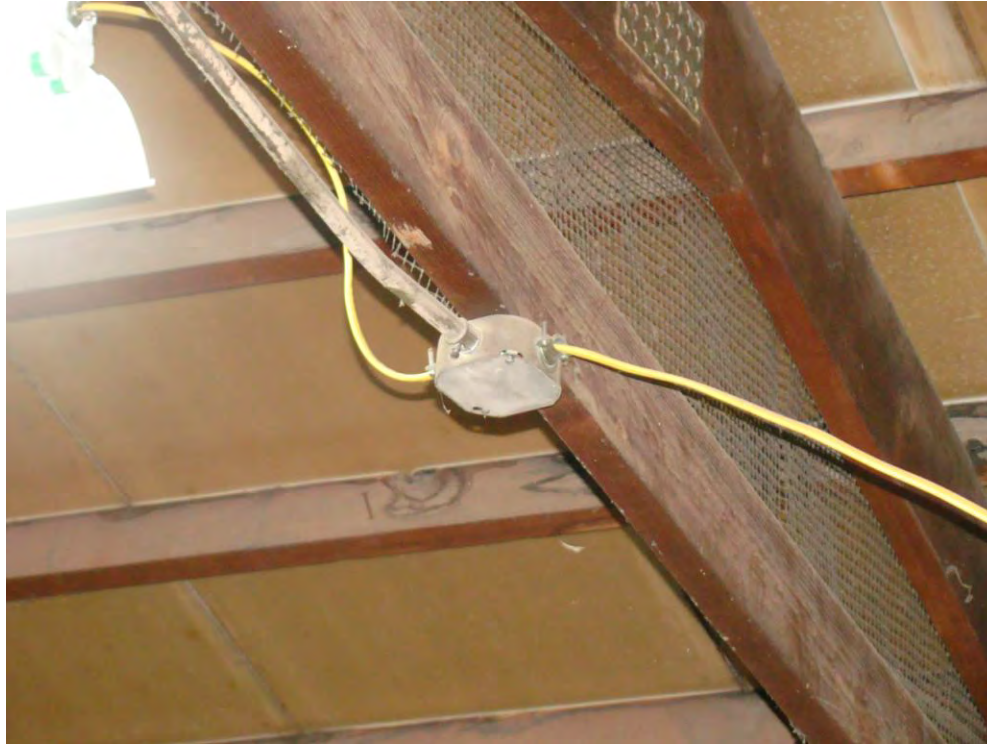
Romex wiring throughout building mainly for lighting

National Electrical Codes NEC 334.10 non metallic sheathed cable, type NM, (romex) is only allowed in dwelling units, 1and 2 family, and their attached garages and their storage units.

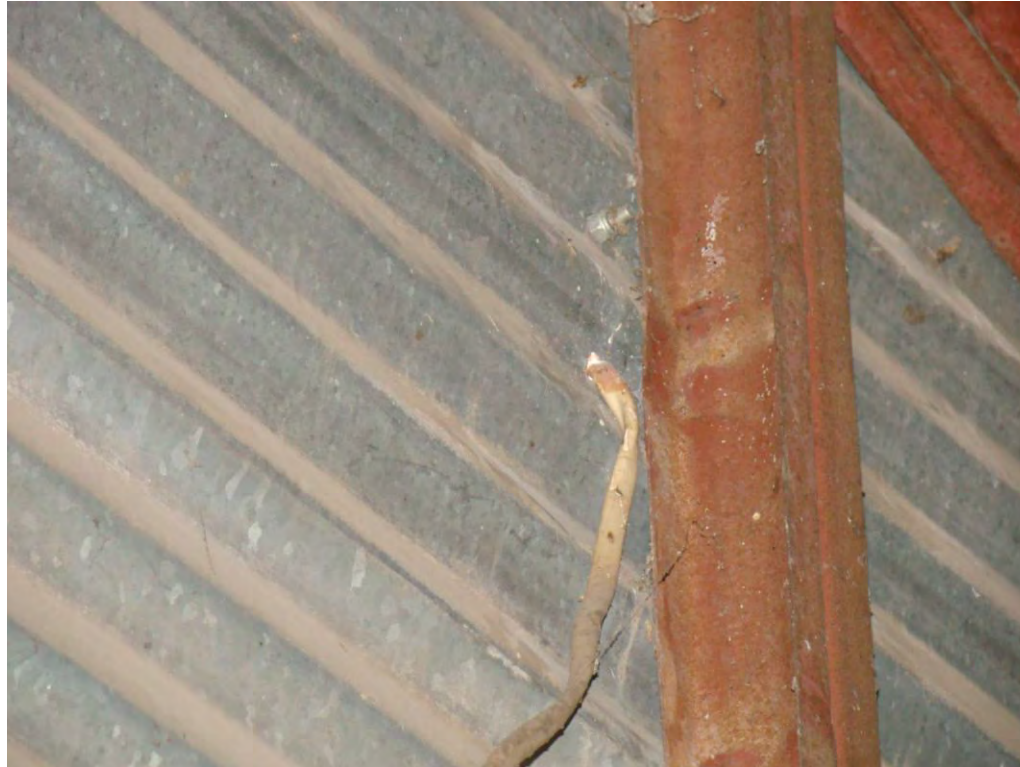
Electrical wiring unprotected running through steel siding in Tractor building.

1910.305 Wiring methods and components and equipment for general use

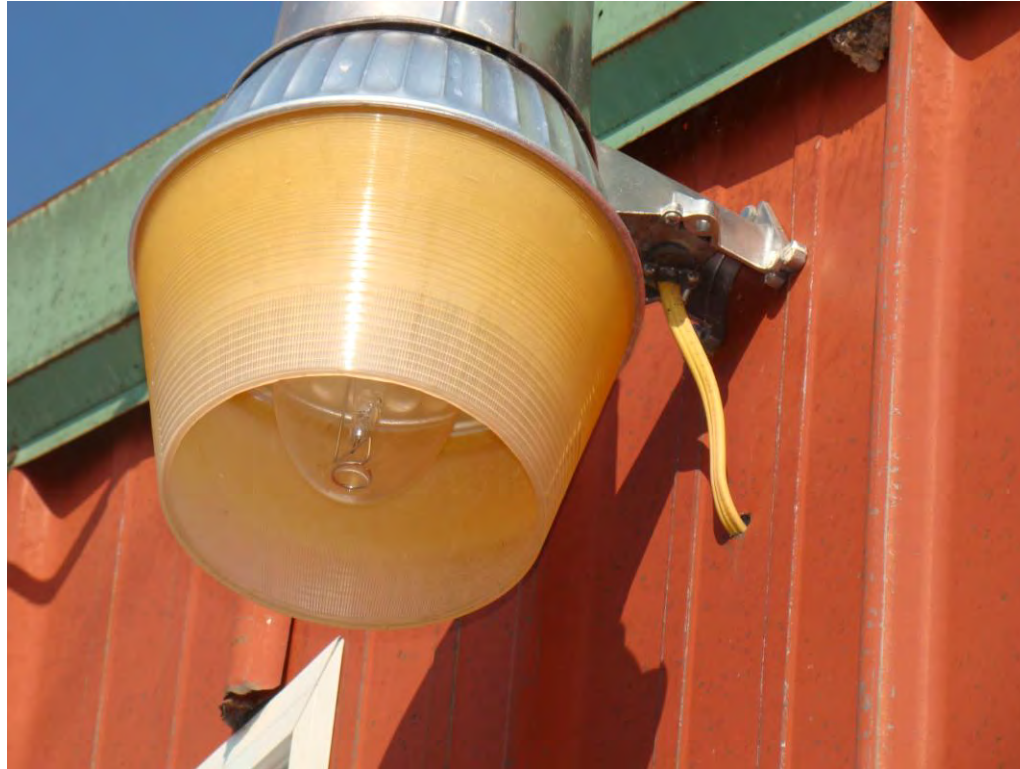
Romex wiring of light passing through steel siding

National Electrical Codes NEC 334.10 non metallic sheathed cable, type NM, (romex) is only allowed in dwelling units, 1 and 2 family, and their attached garages and their storage units.

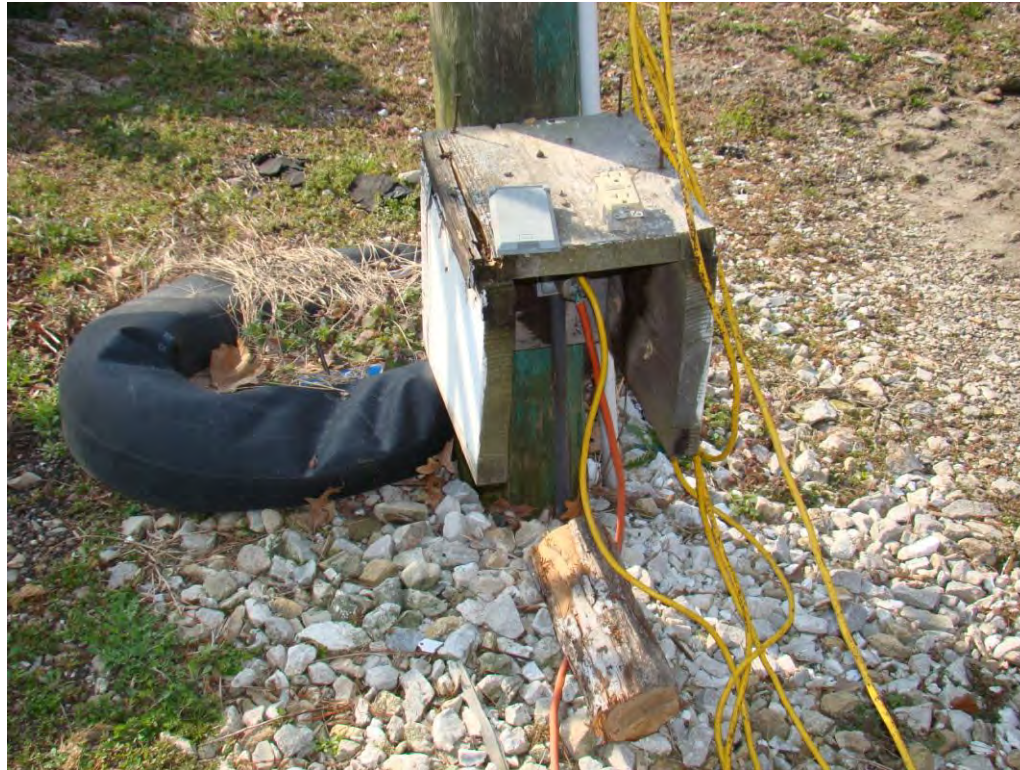
Outside receptacles without GFCI protection

OSHA Standard 1910.304 Subpart S Electrical (f) over current protection for outdoors.

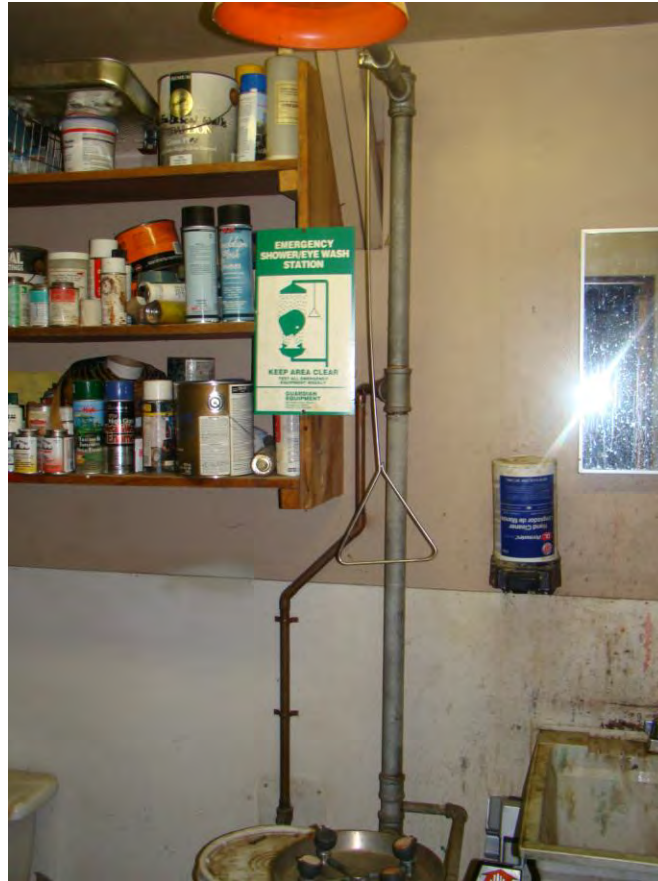
Emergency shower not inspected

OSHA Standard 1910.151 © Subpart K Medical services and first aid

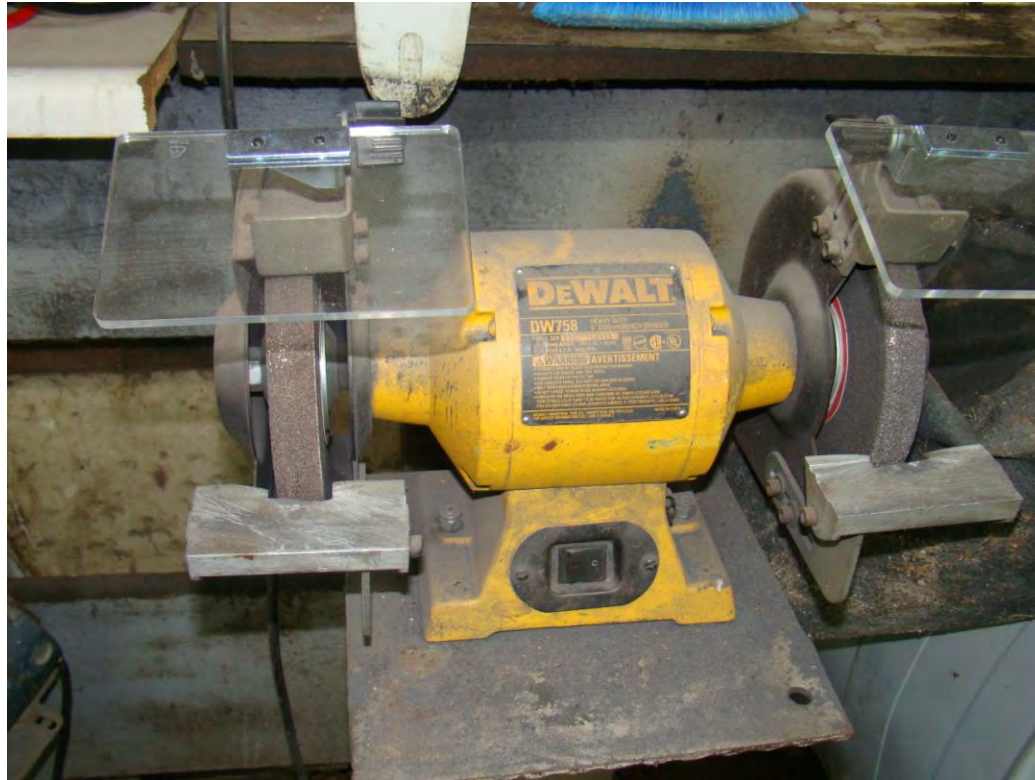
Bench grinder tool rest too far away from wheel work rest

OSHA Standard 1910.216 Subpart O Machinery and Machine Guarding

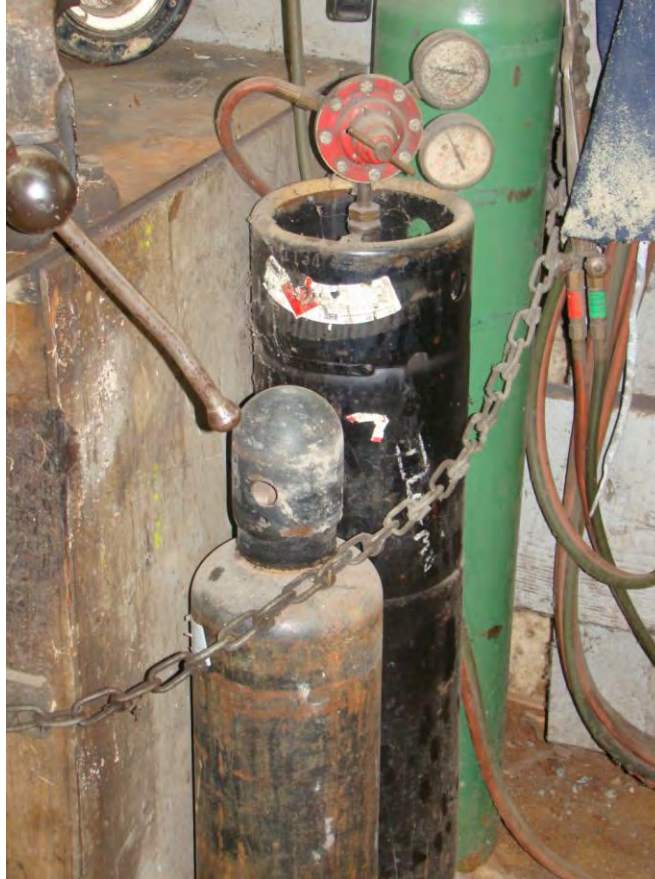
Two bottles of acetylene can not be stored together

OSHA Standard 1910.253 Subpart Q (2) storage of cylinders.

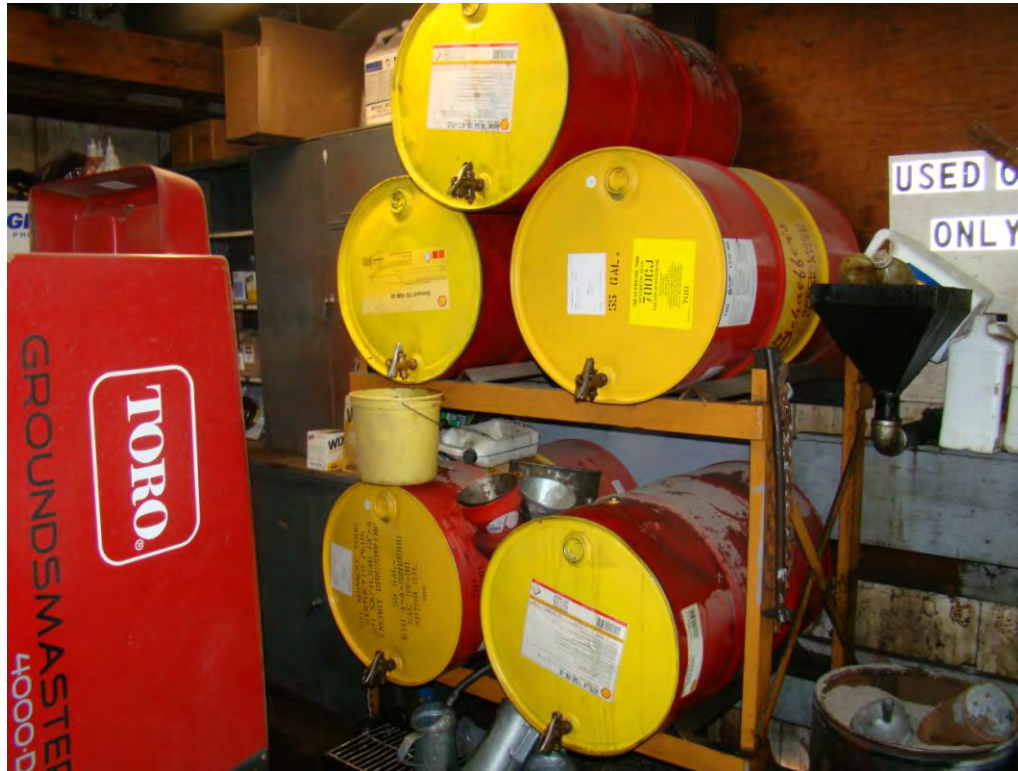
Check drum storage standard 5 drums of oil stored together

OSHA Standard 1910.106 (d) (4) (v) Subpart Flammable and Combustible liquids paragraph

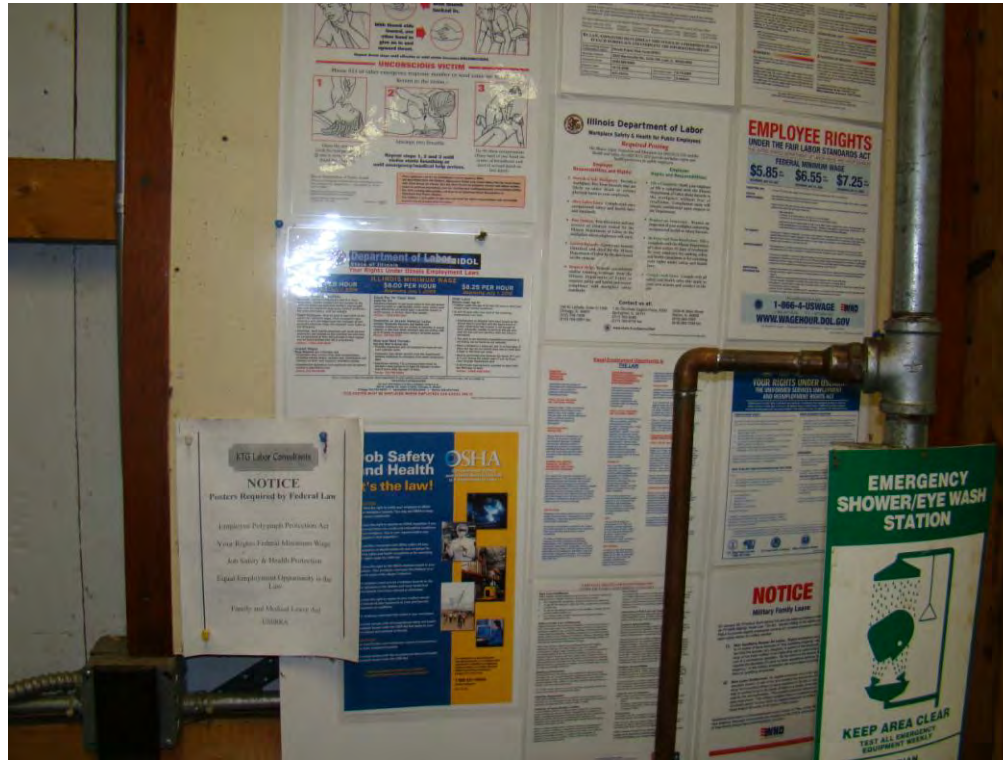
Posters out dated

OSHA Standard 1903.2 Posting of Notice
