Appendix A: Community Input

Focus Group Summary Report

Quincy Park District ***Quincy, Illinois***

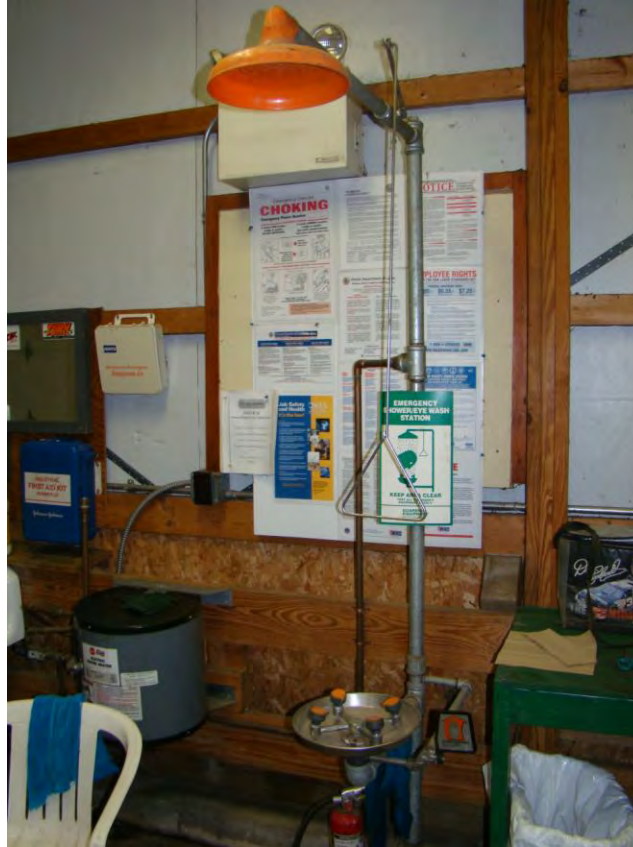
Emergency Shower not inspected

OSHA Standard 1910.151 Subpart K Medical services and First Aid

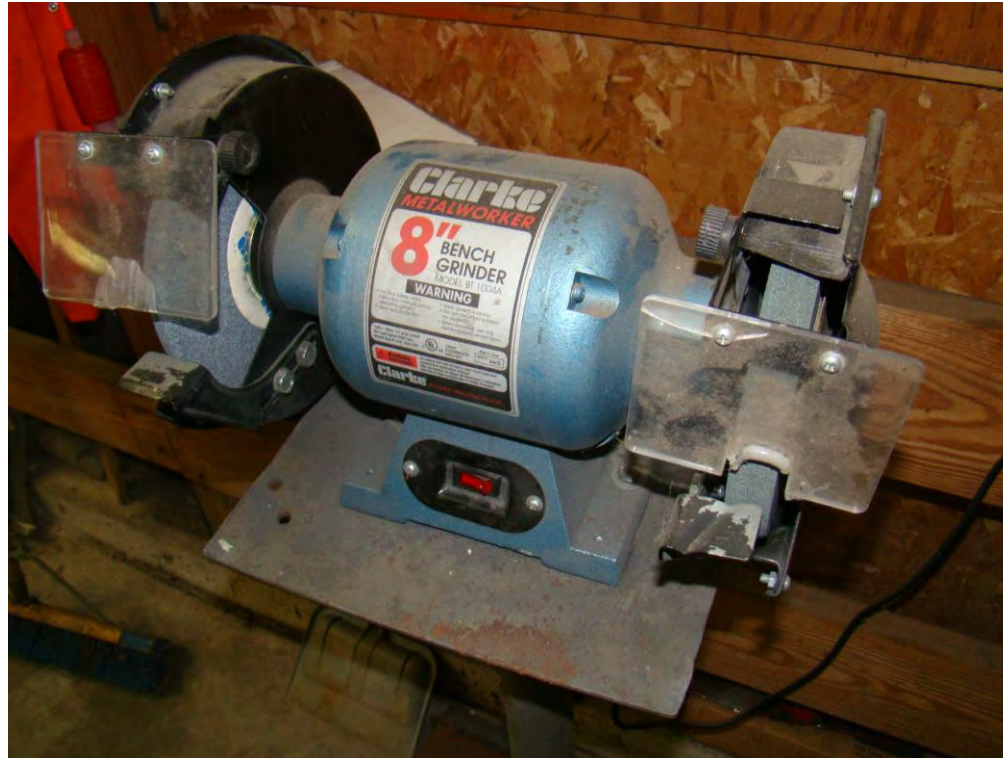
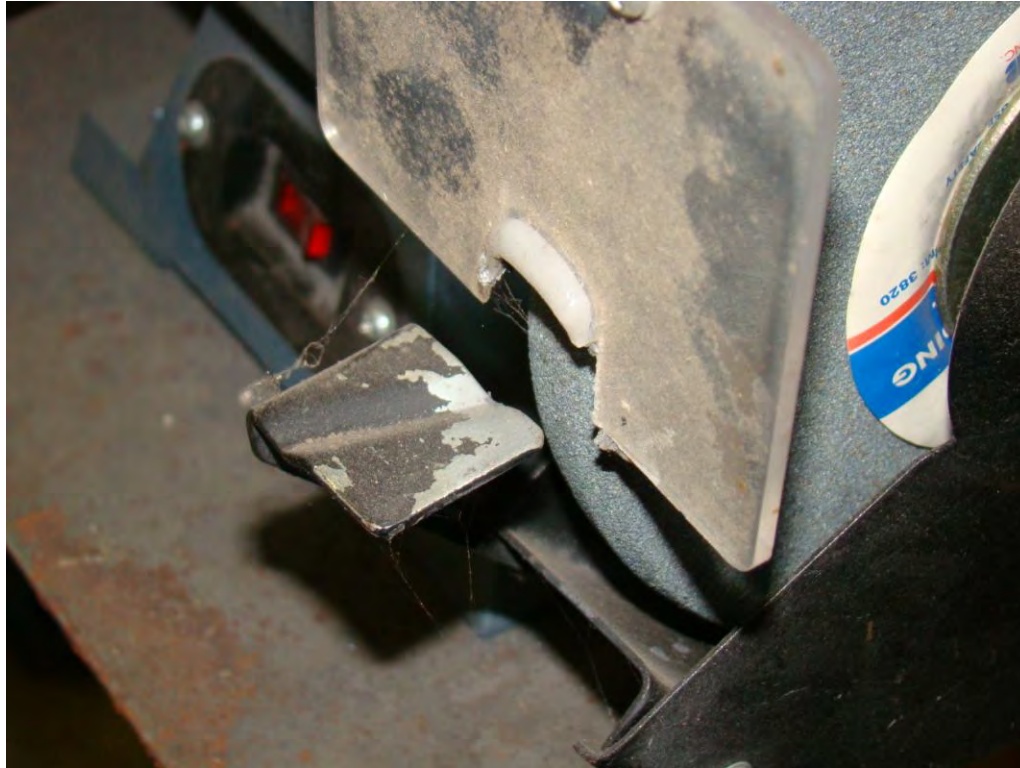
Bench Grinder Rest should be 1/8" from wheel not 1/4"
OSHA Standard 1910.219 Subpart O Machinery and Machine Guarding.

Close up of previous photo of Bench Grinder Rest

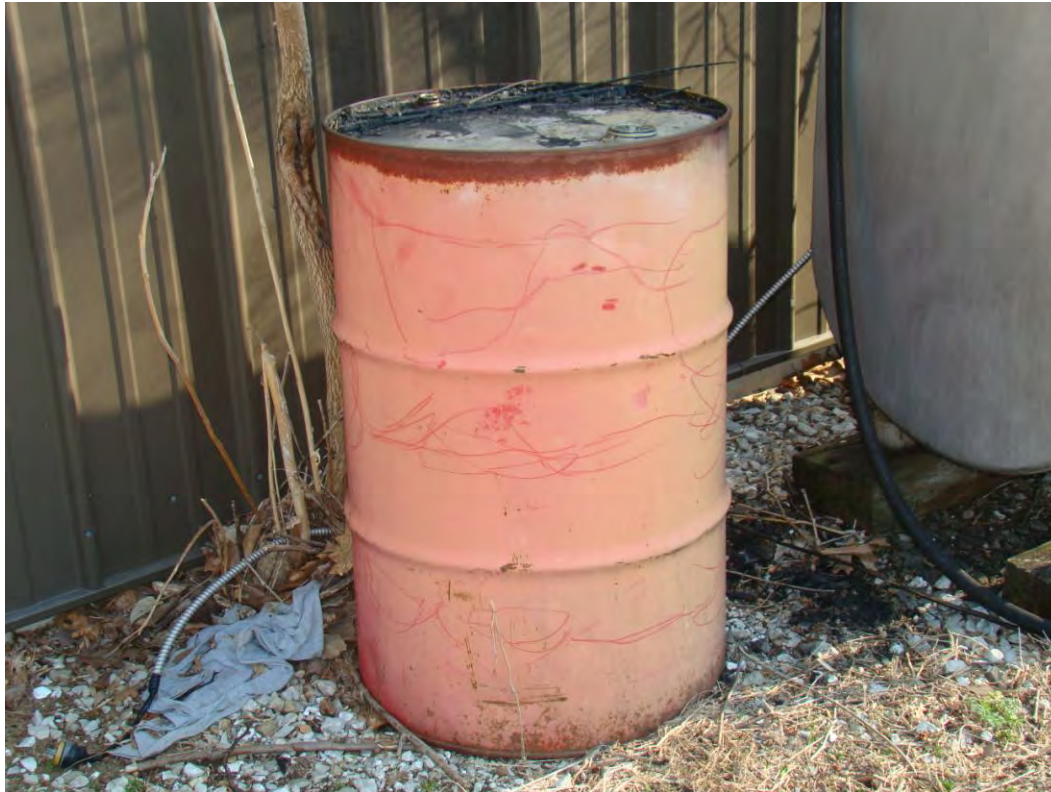
Unmarked 55 gallon steel drum

OSHA Standard 1910.1200 Subpart Z

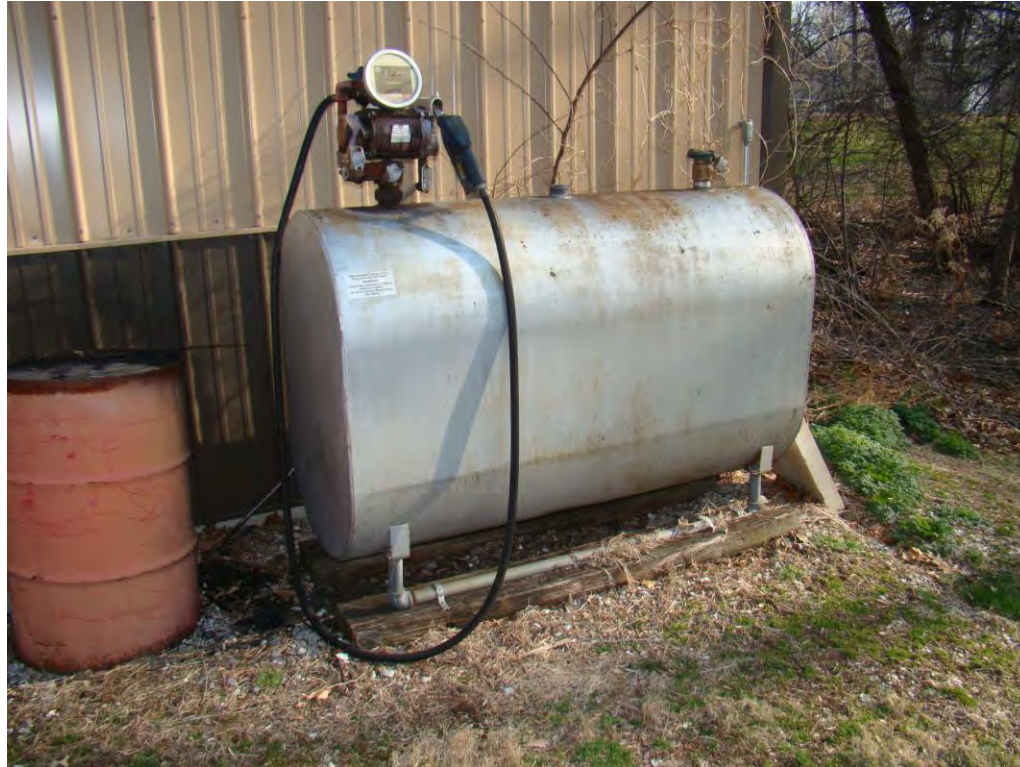
Unmarked fuel container

OSHA Standard 1910.1200 Subpart Z

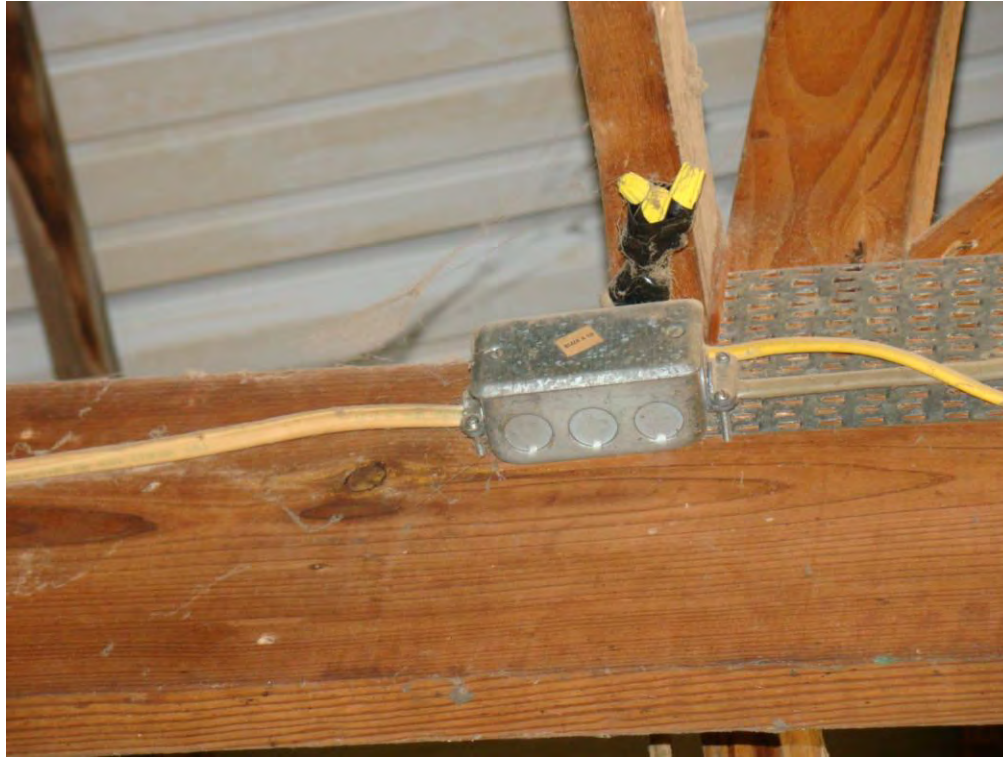
Open electrical box exposed wiring

OSHA Standard Subpart S electrical 1910.305 (b) Cabinets, boxes and fittings

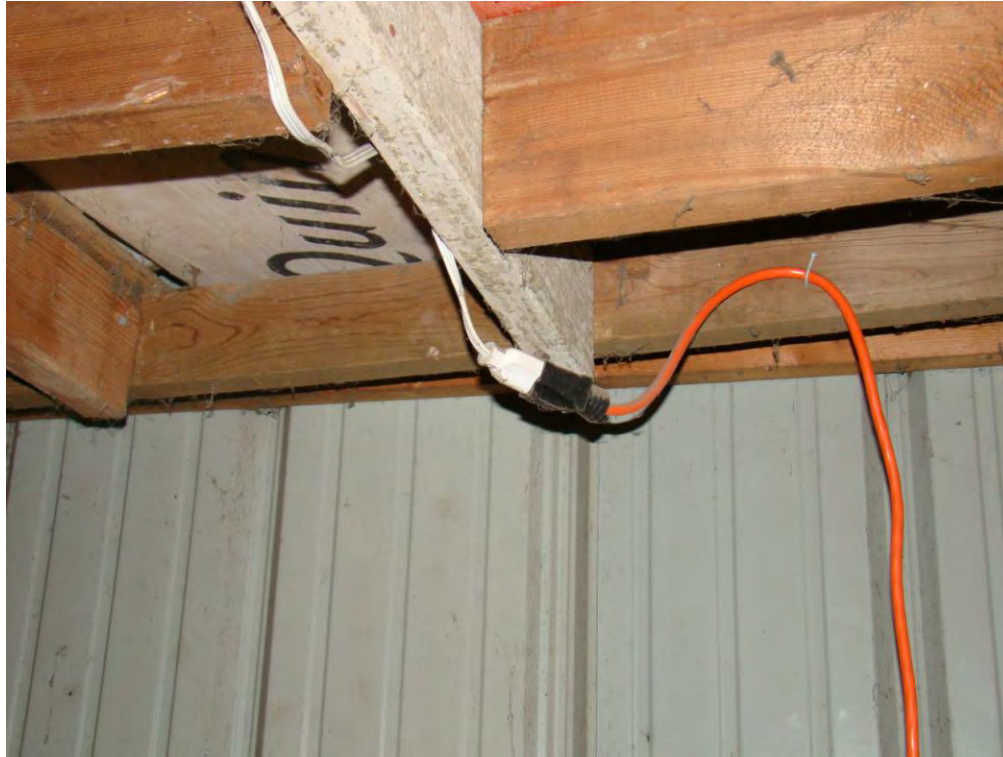
Extension cords used and permanent wiring

OSHA Standard Subpart S Electrical 1910.305, wiring methods, components and equipment for general use.

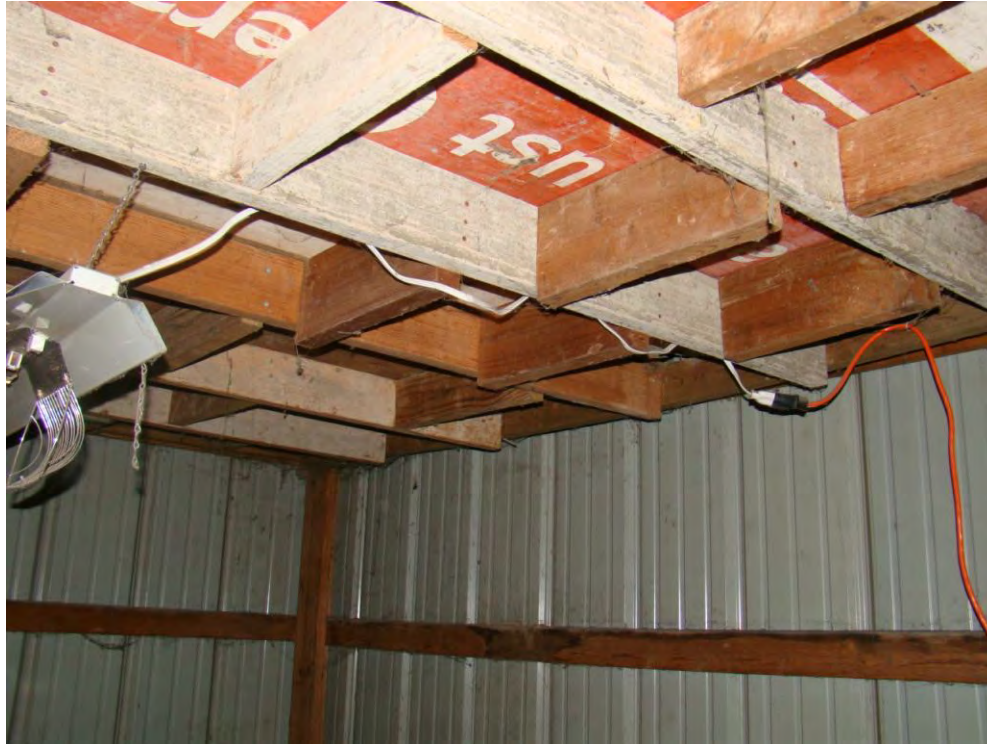
Extension cords used and permanent wiring

OSHA Standard Subpart S Electrical 1910.305, wiring methods, components and equipment for general use.

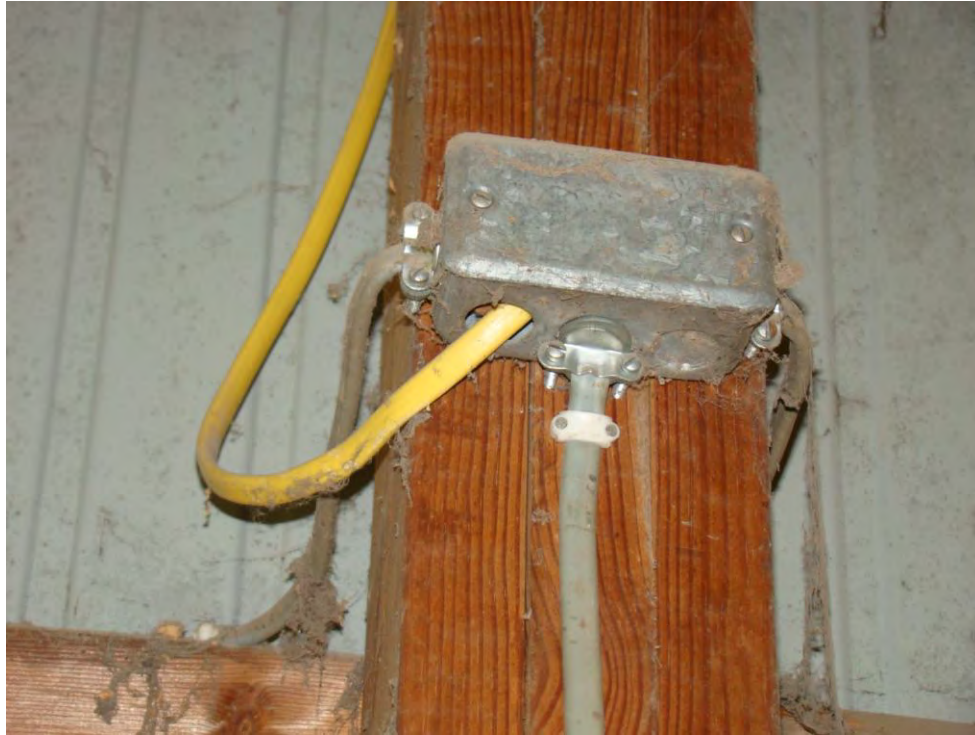
**Romex wiring going into box with no support fitting
and romex can not be used in industrial buildings**

National Electrical Code (NEC) 334.10 non metallic sheathed cable, type NM, romex is only allowed in dwelling units, 1 and 2 family, and their attached garages and their storage units.

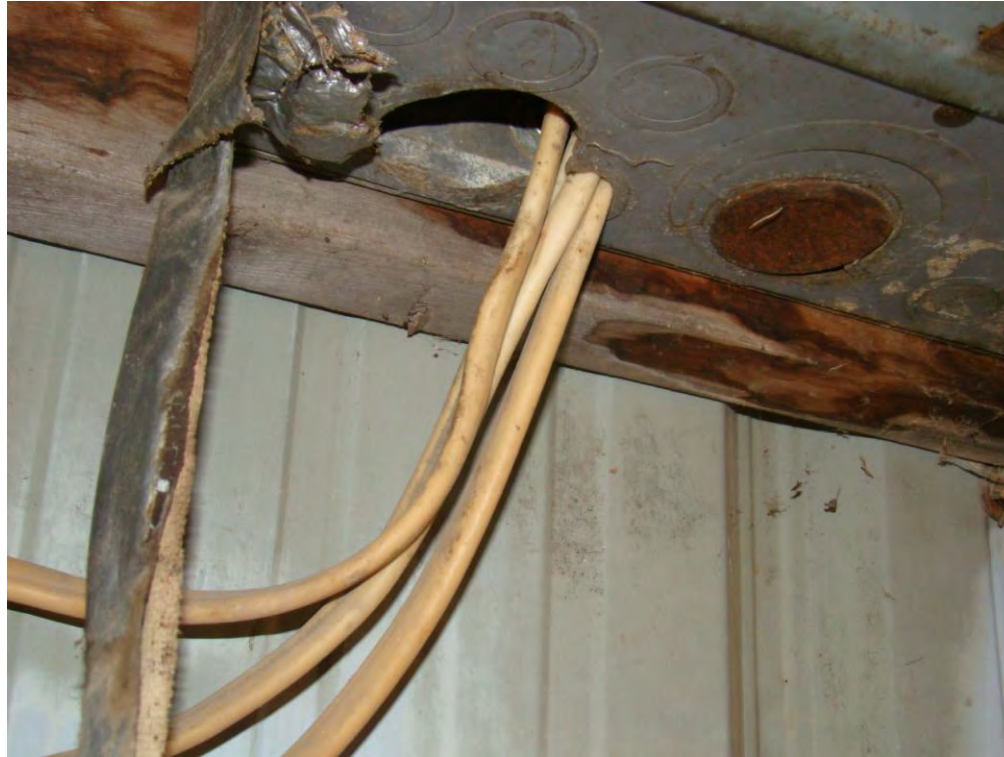
Romex running into main electrical box North East wall

National Electrical Code (NEC) 334.10 non metallic sheathed cable, type NM, romex is only allowed in dwelling units, 1 and 2 family, and their attached garages and their storage units.

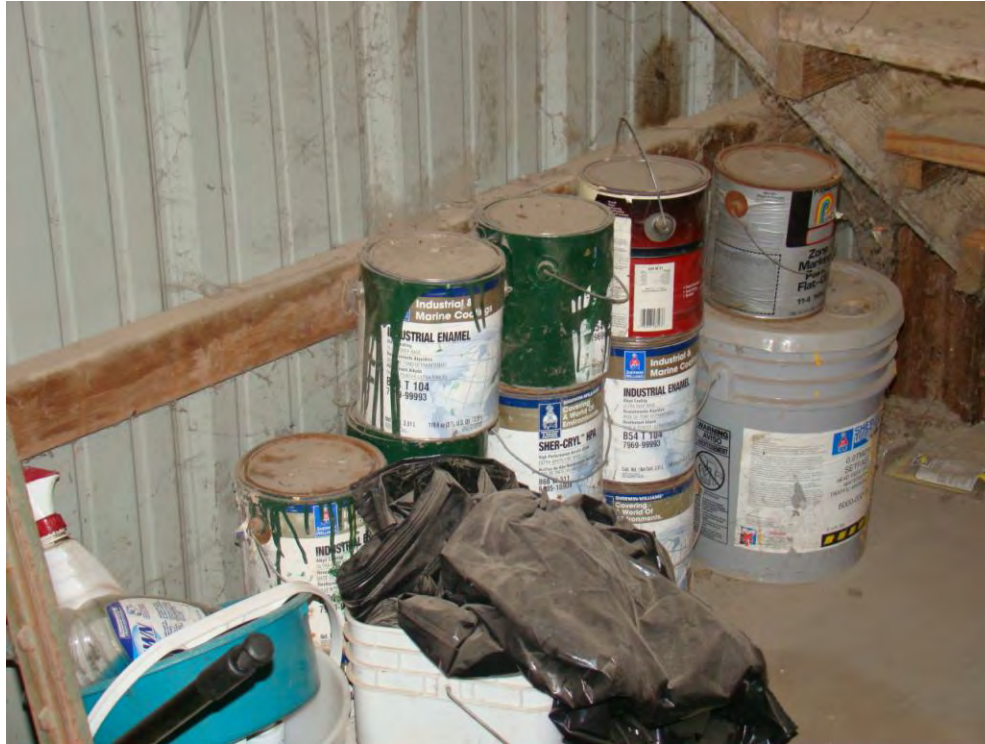
Paint not stored properly under stairs

OSHA Standard H Hazardous Material 1910.107 (d) (1) Storage of Containers

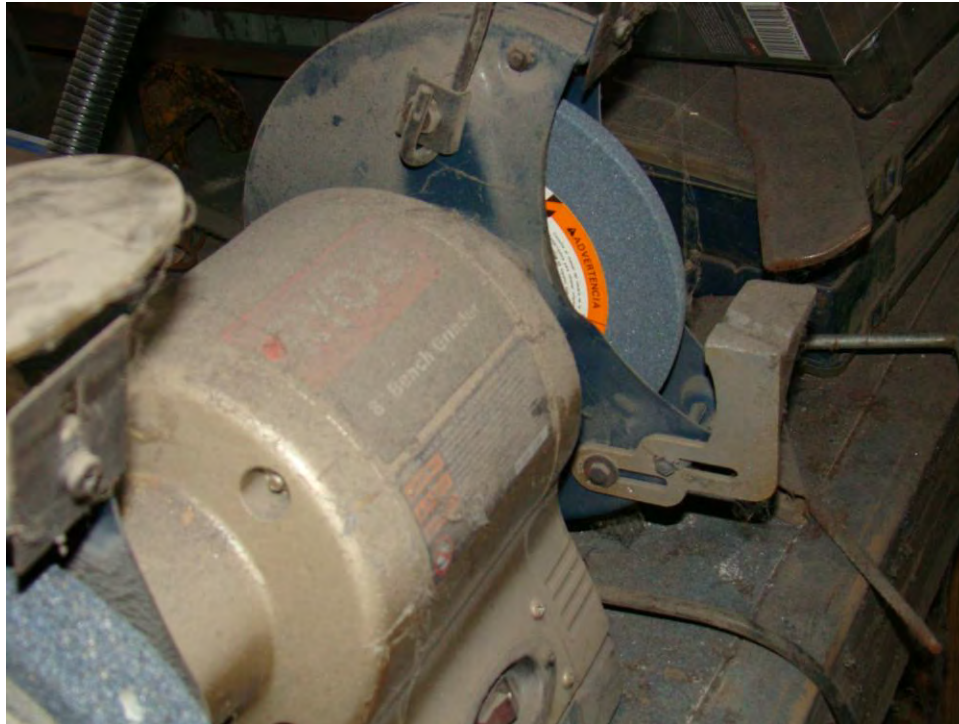
Bench Grinder Rest should be 1/8" from wheel not 1/4"
OSHA Standard Subpart O Machinery 1910.215 (a) (4)

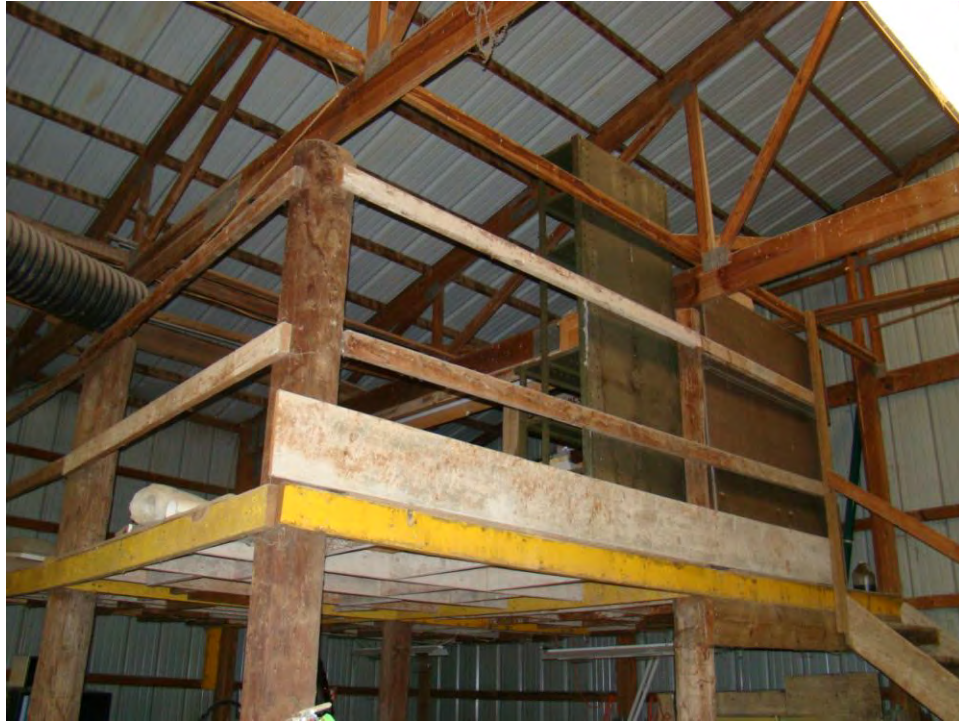
Unmarked weight of capacity of mezzanine

OSHA Standard Subpart H 1910.106 (d) (4) (i)

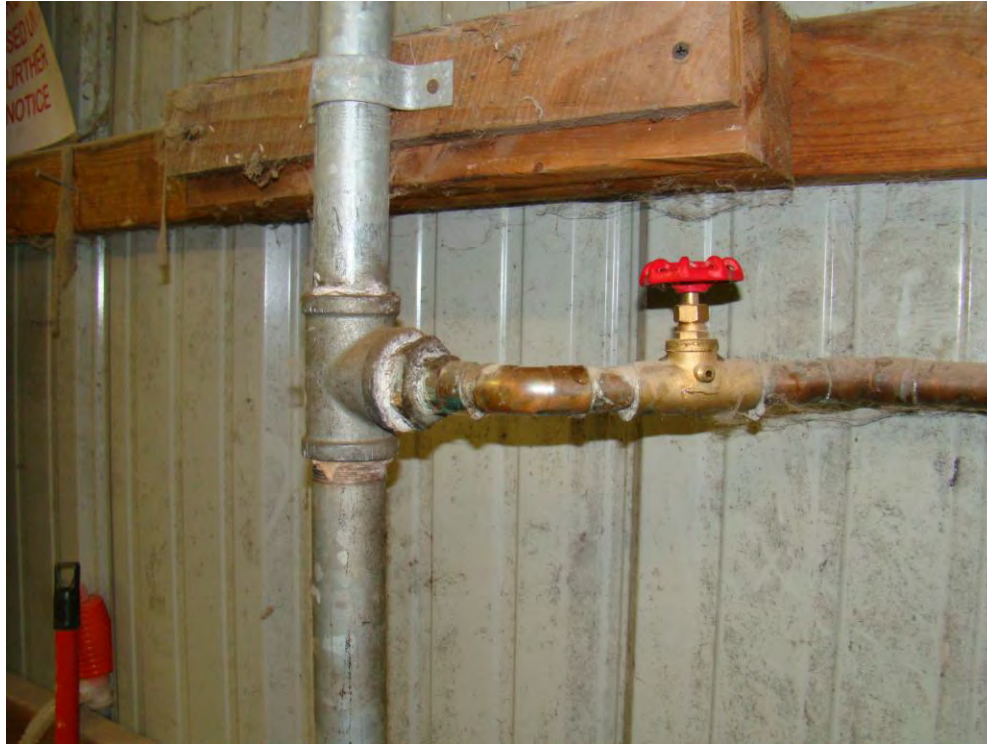
Leaking water valve for eye wash station

OSHA Standard Subpart K 1910.151
