Appendix A: Community Input

Focus Group Summary Report

Quincy Park District ***Quincy, Illinois***

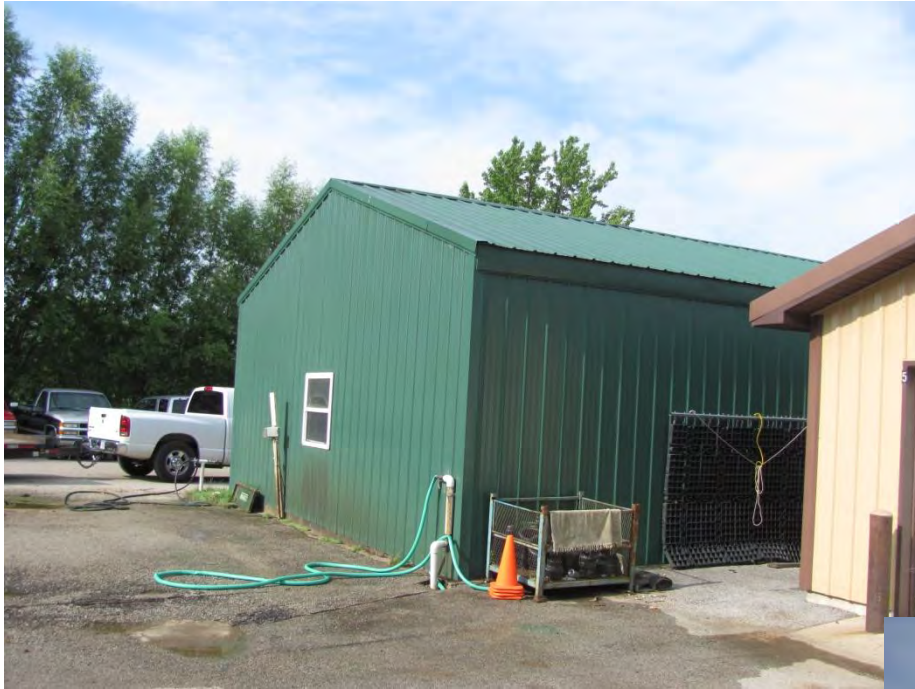
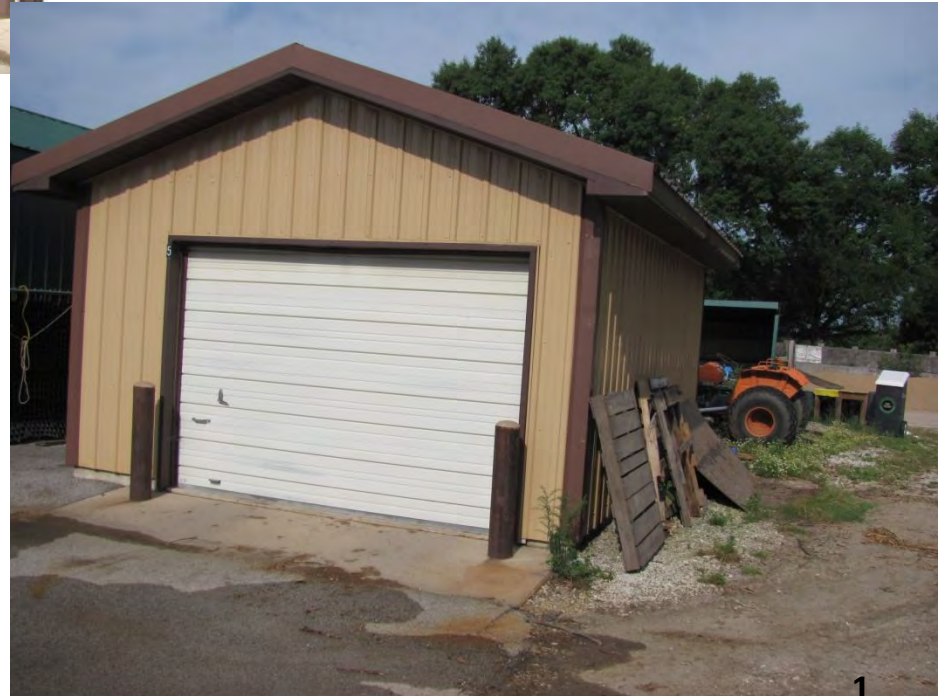
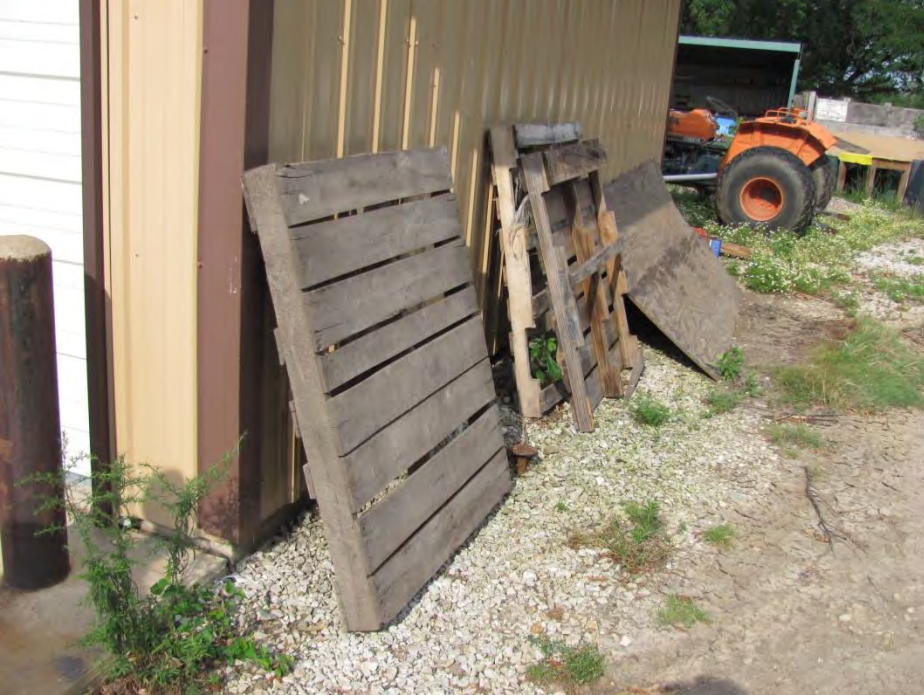
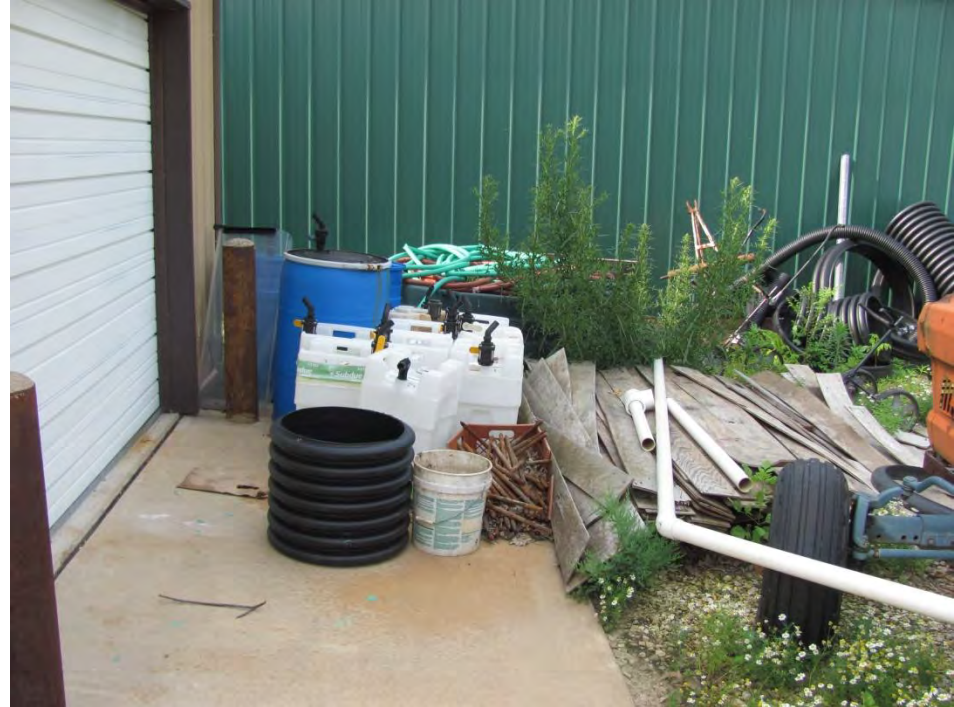
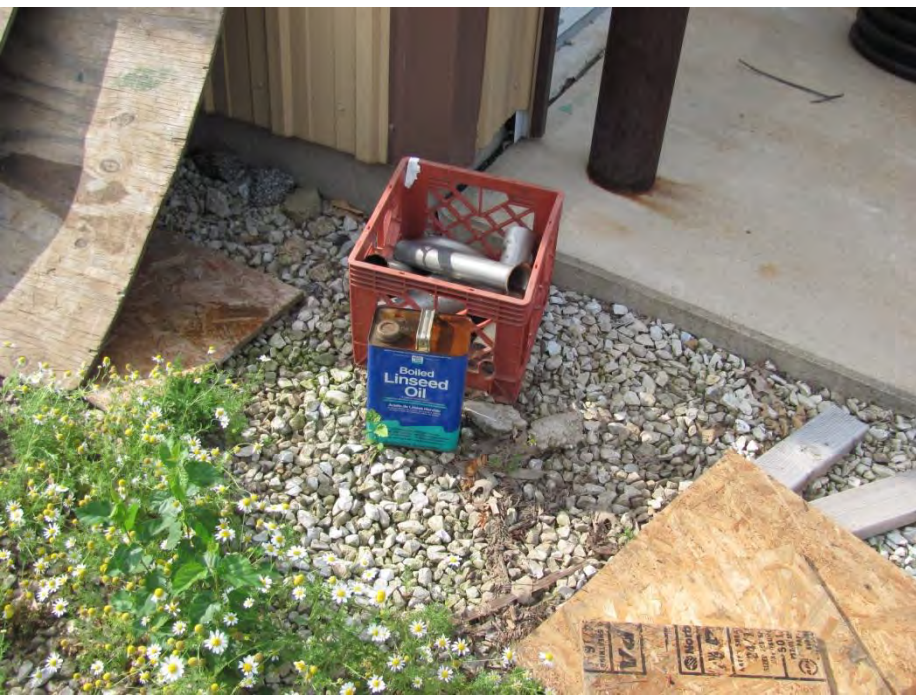
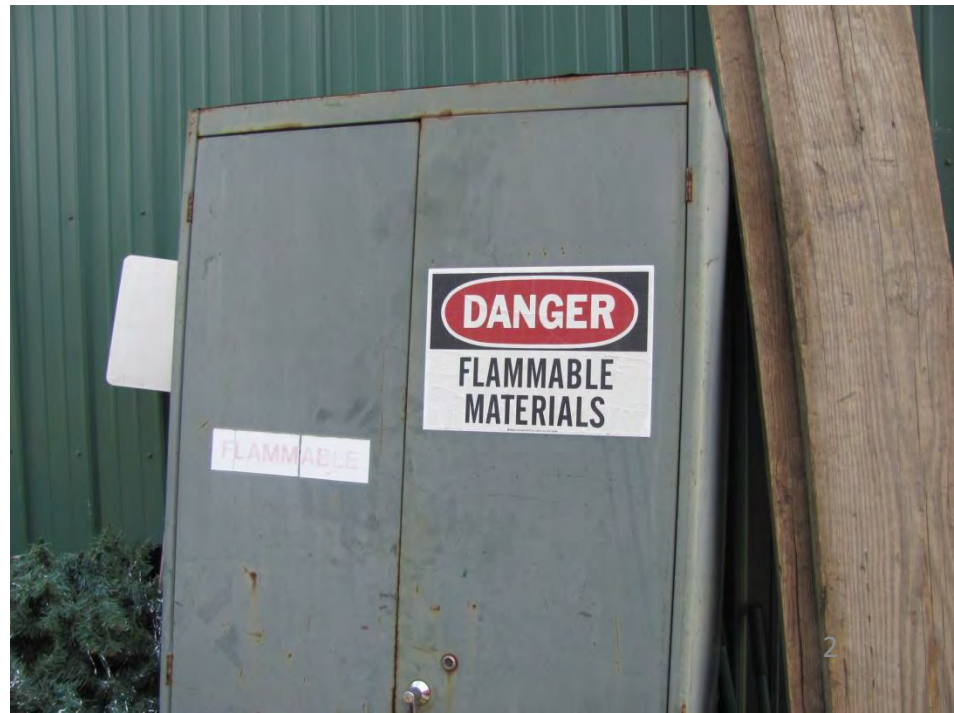
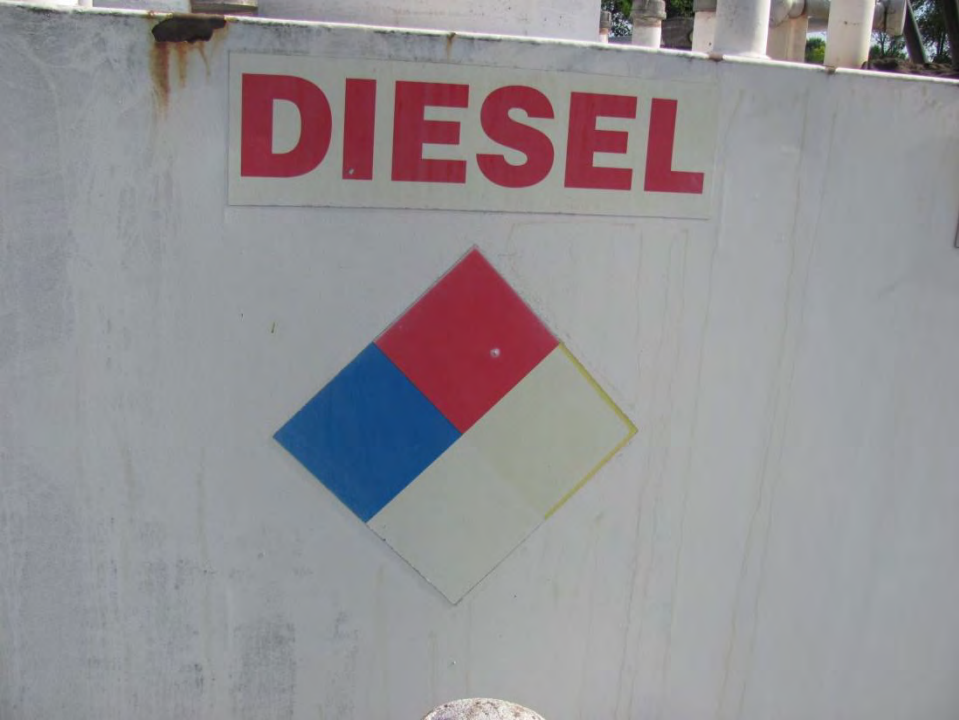
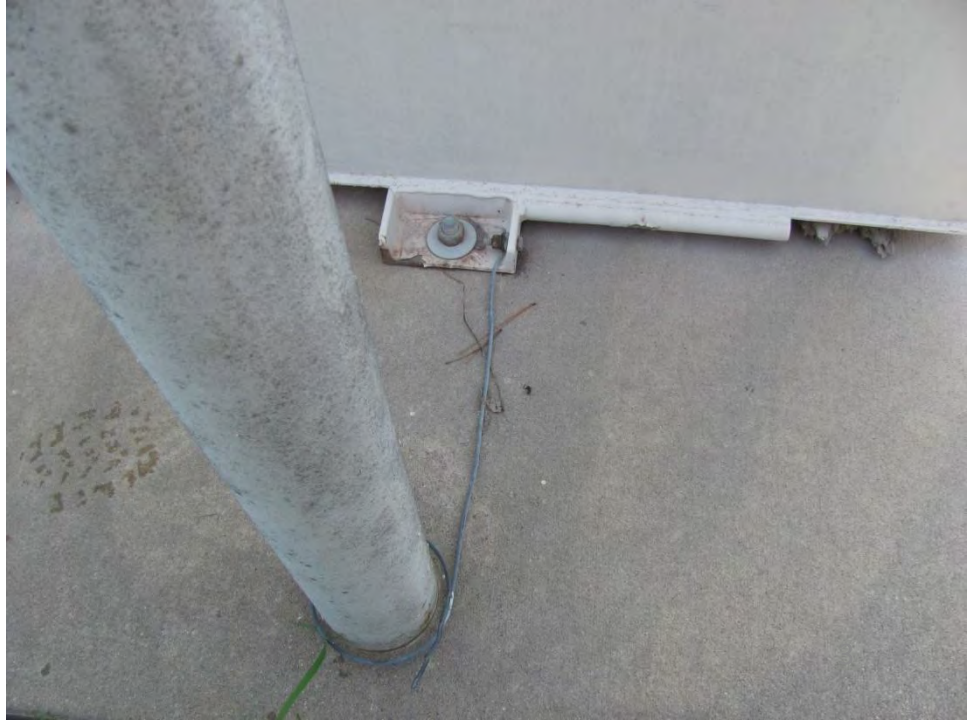
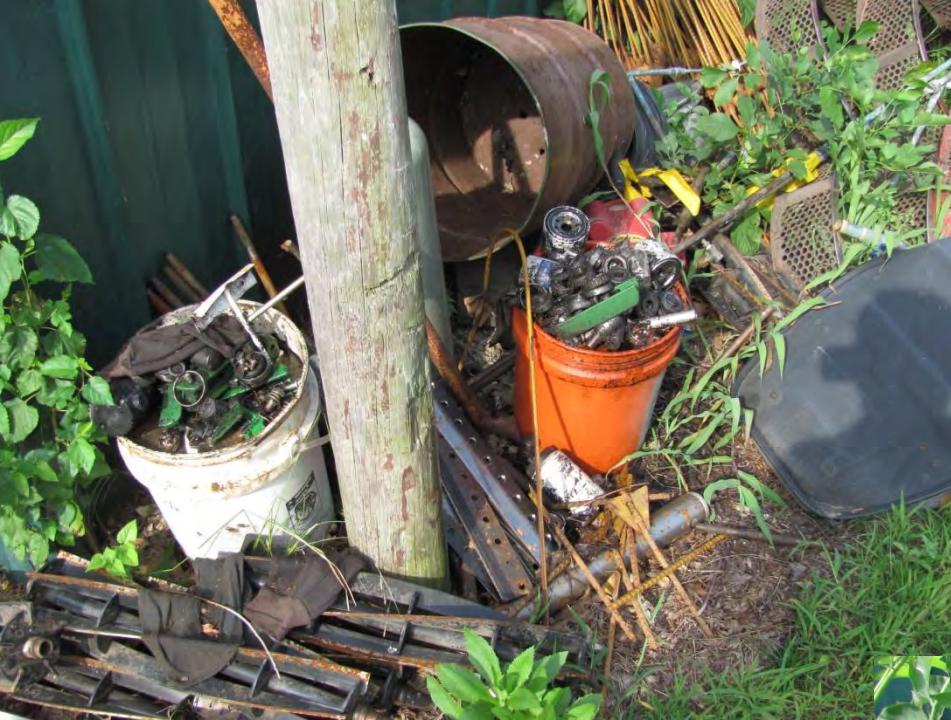
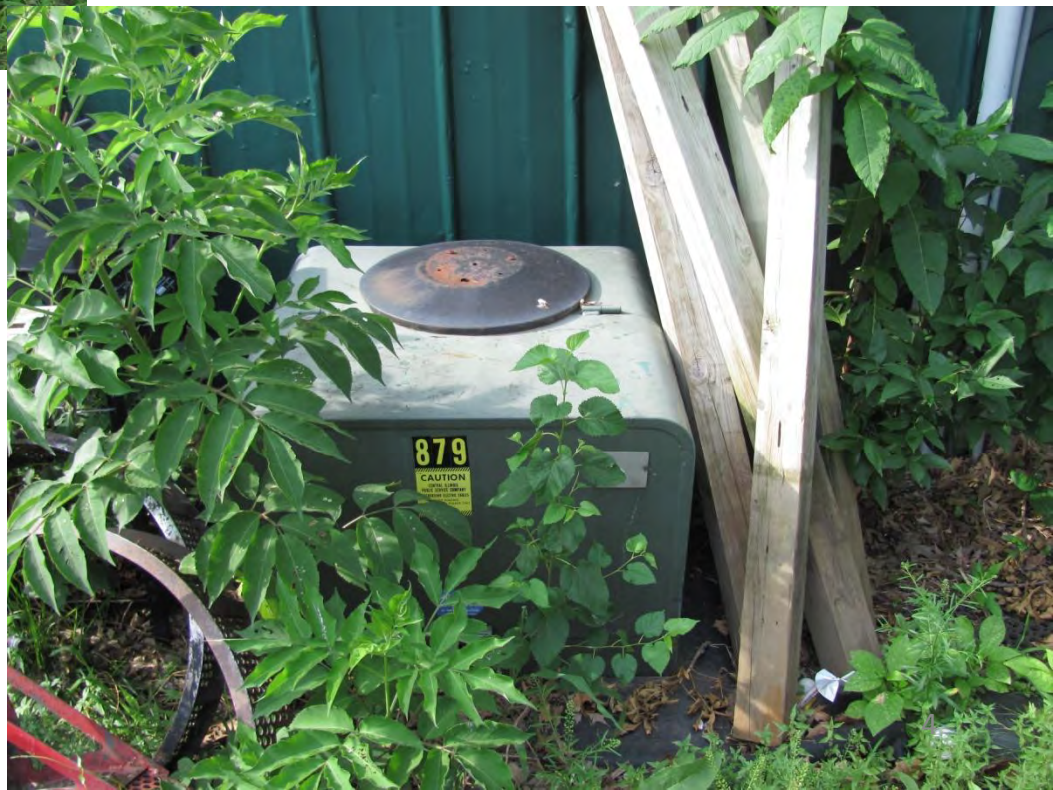
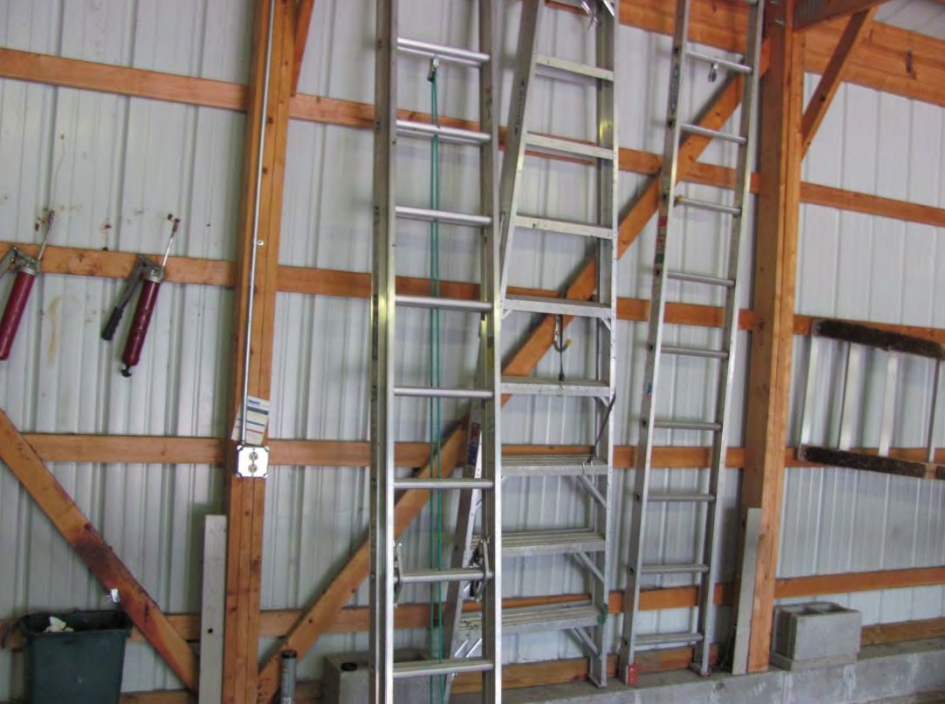
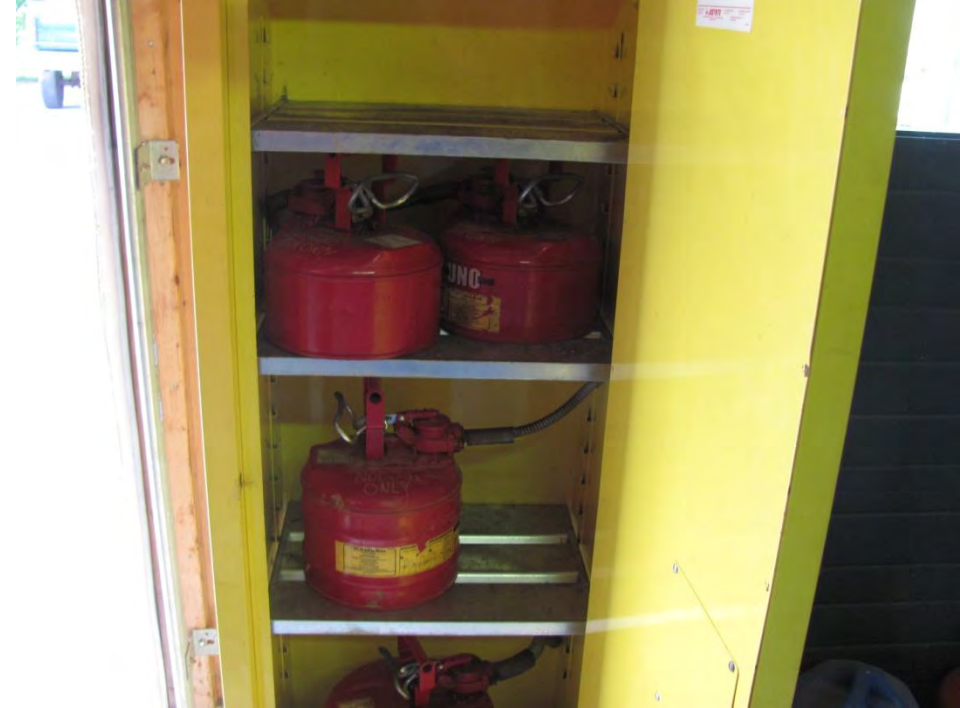
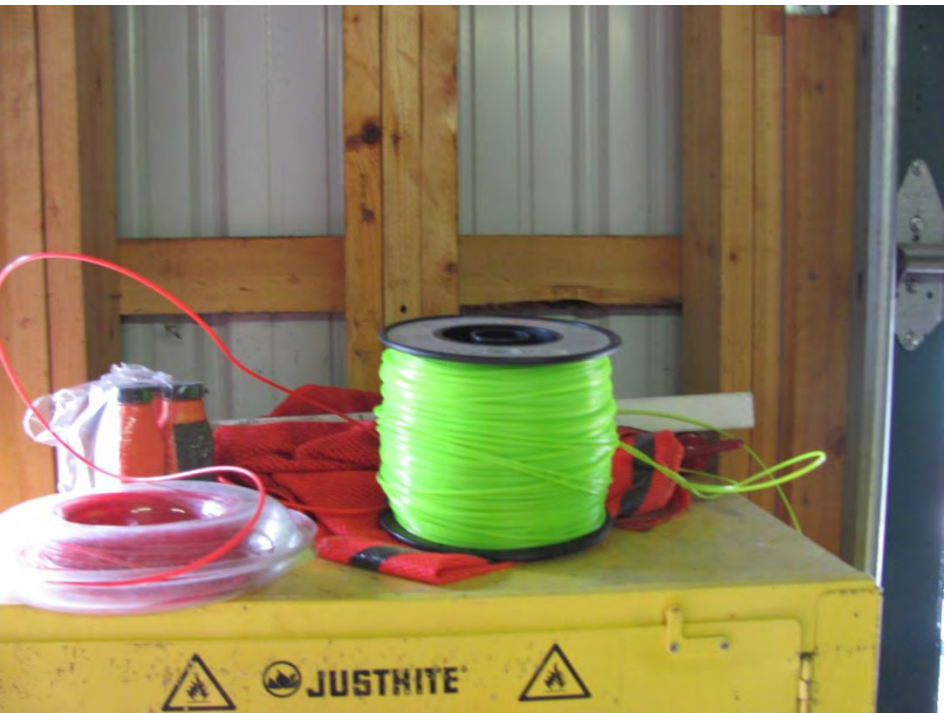
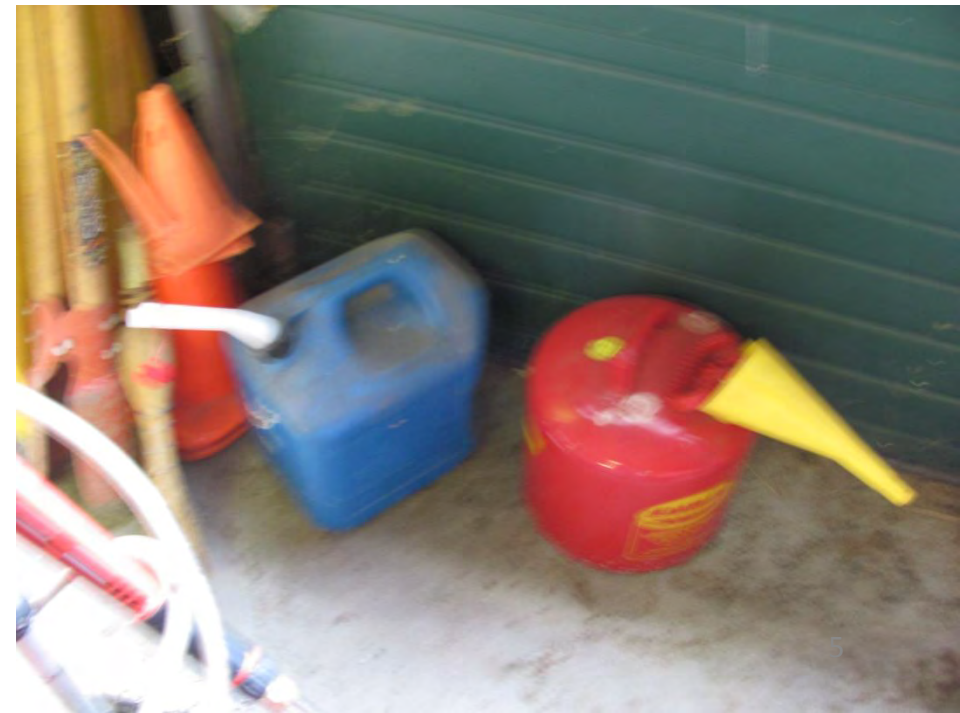
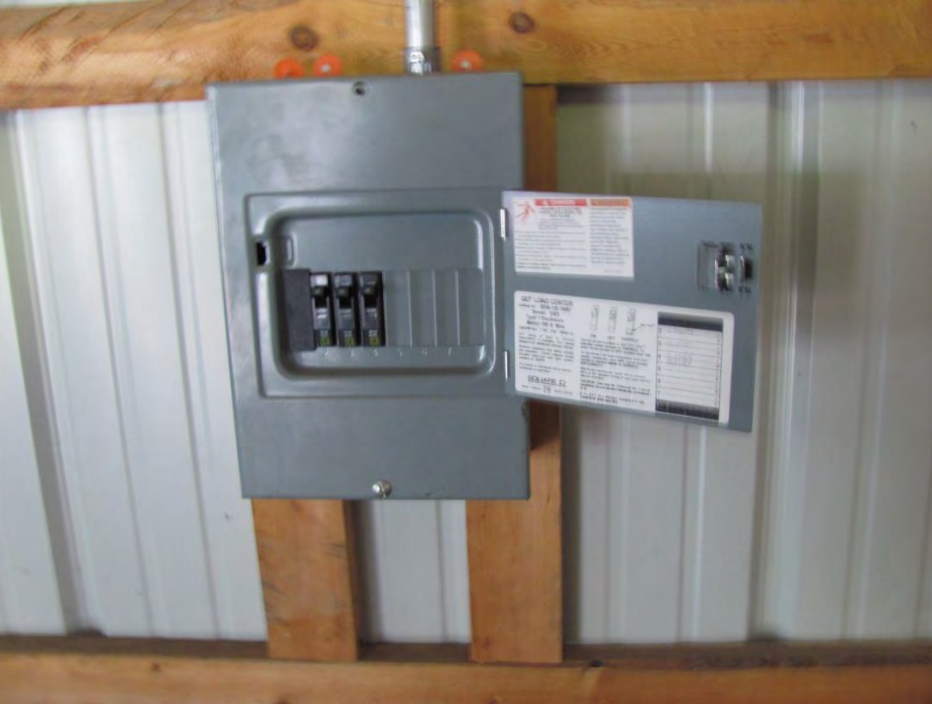
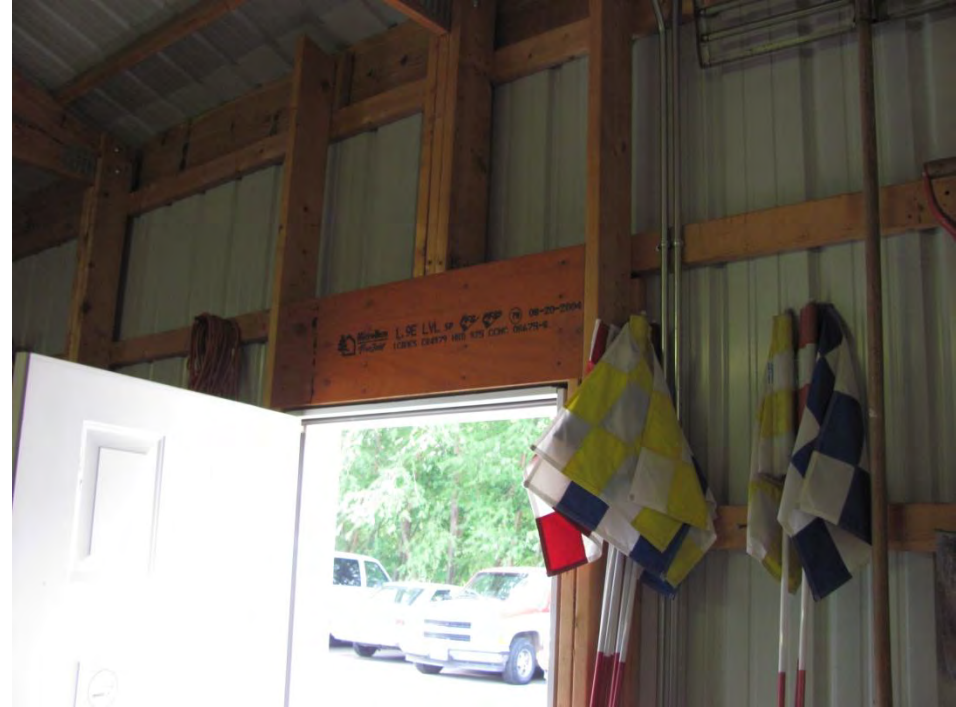
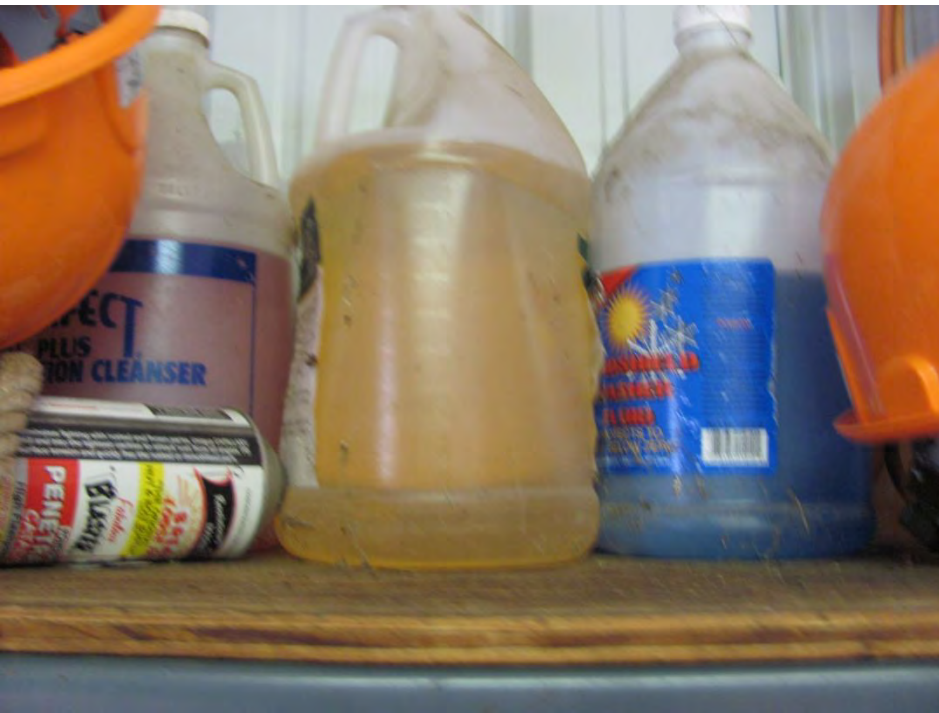
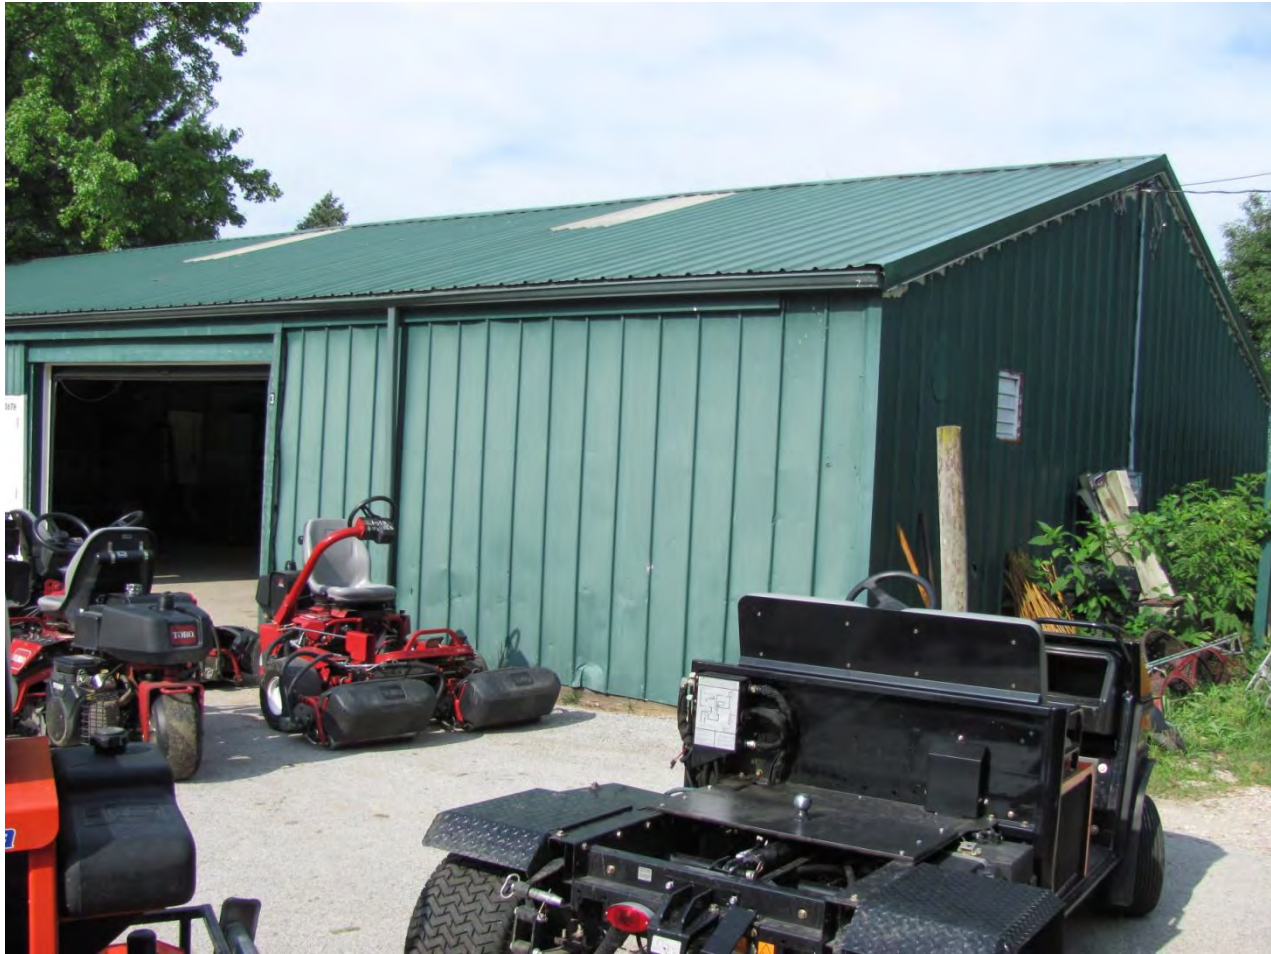
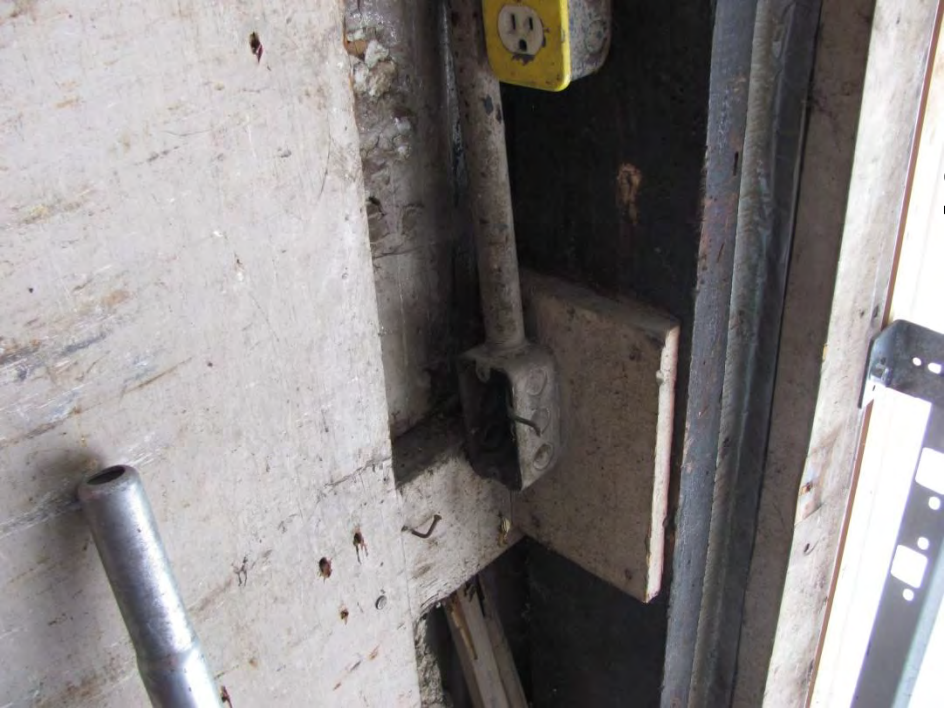
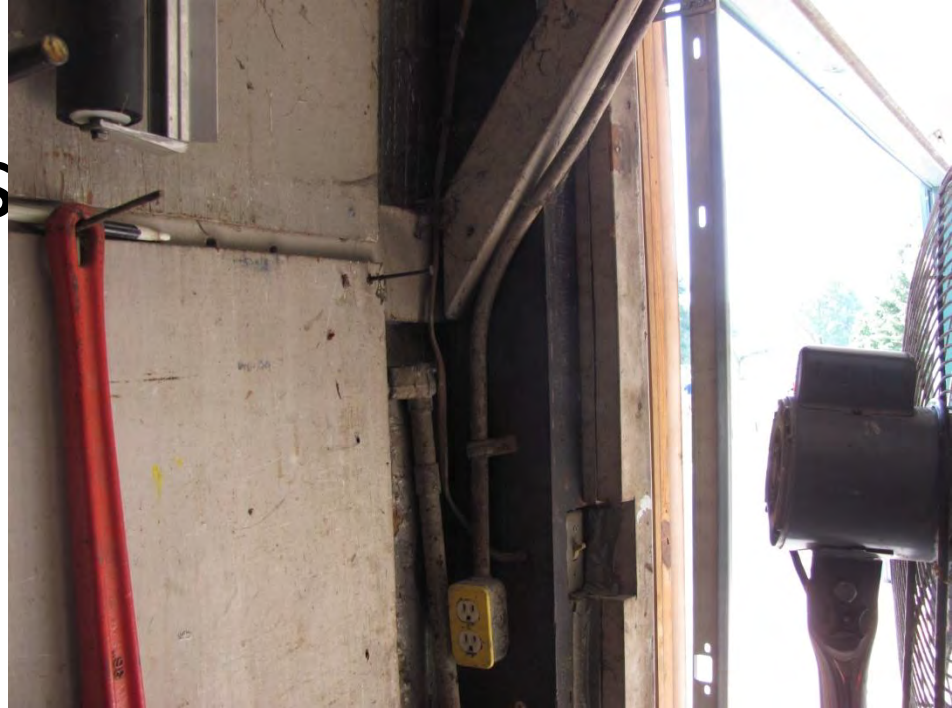
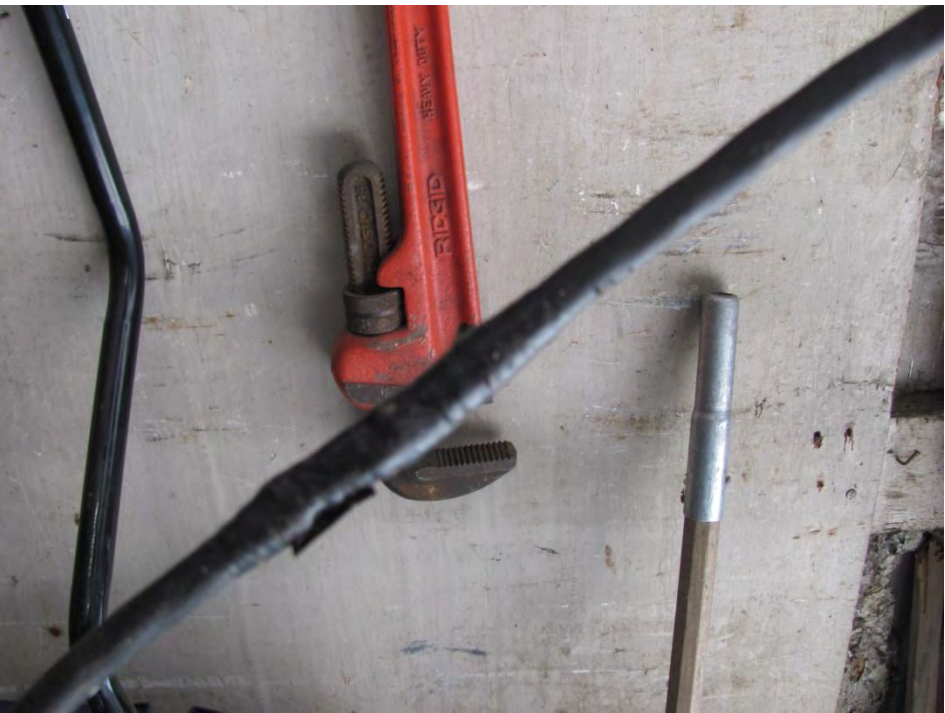
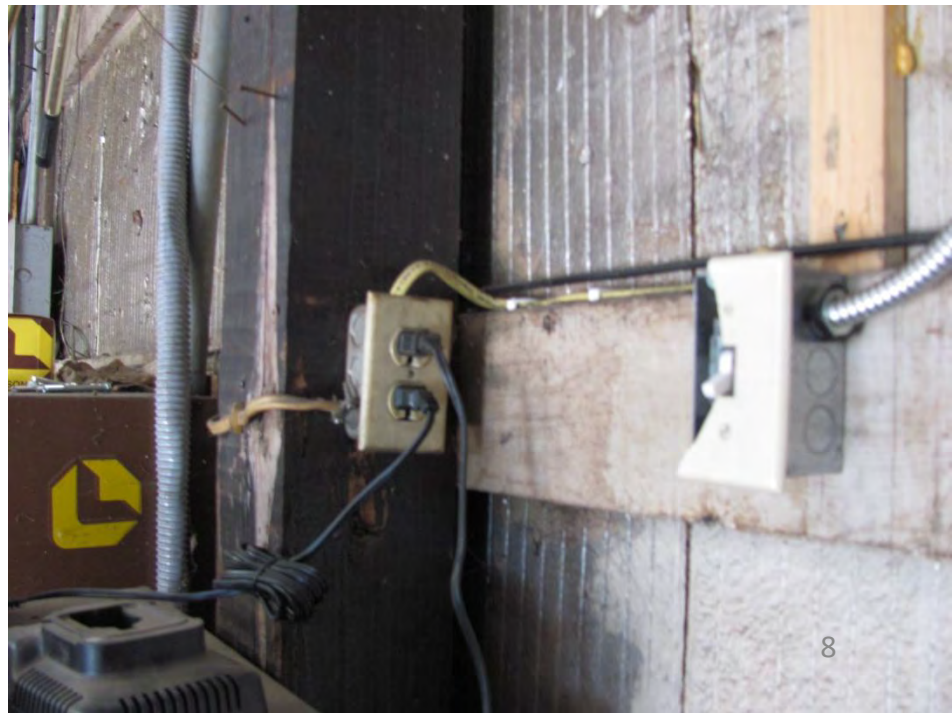
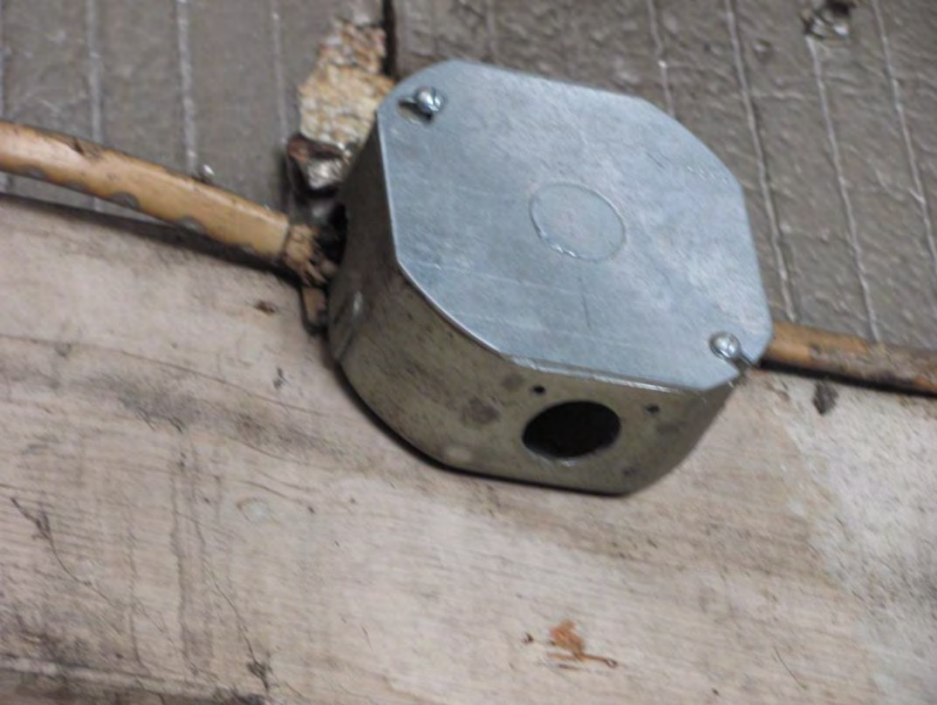
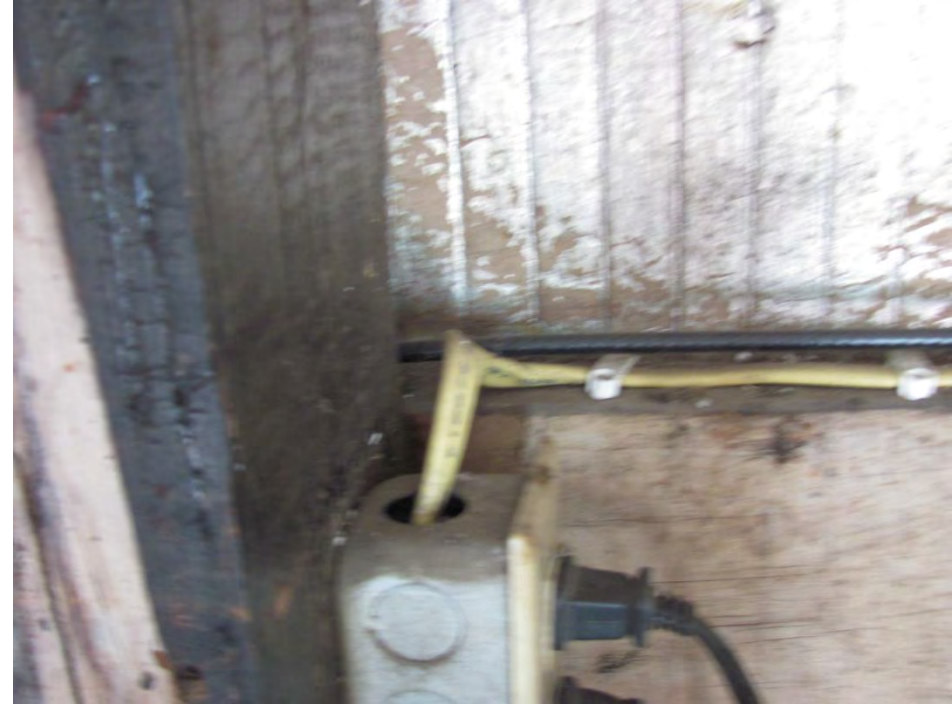
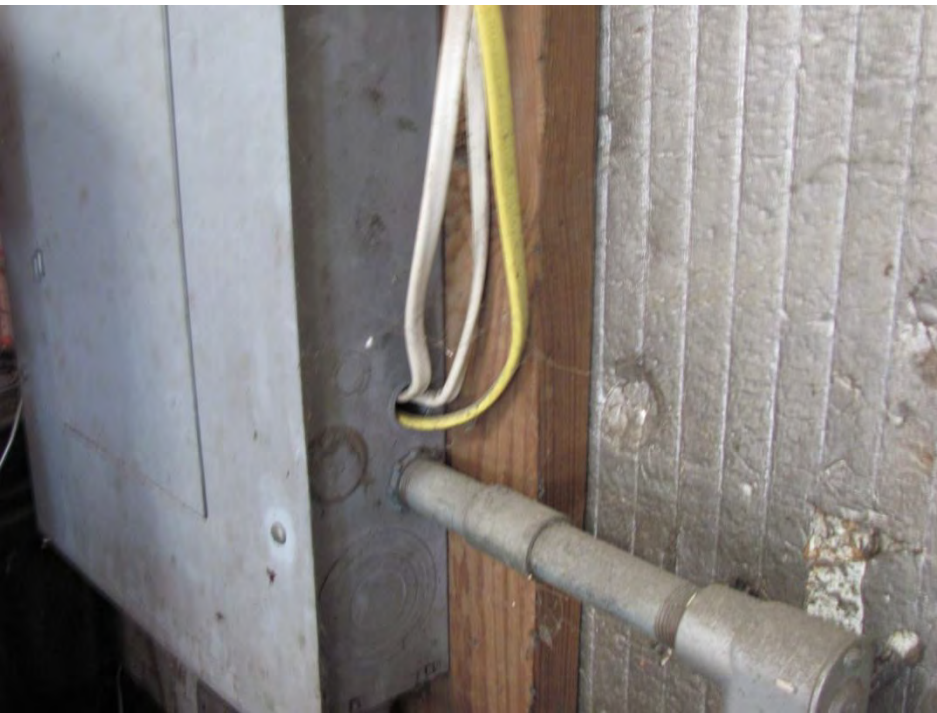
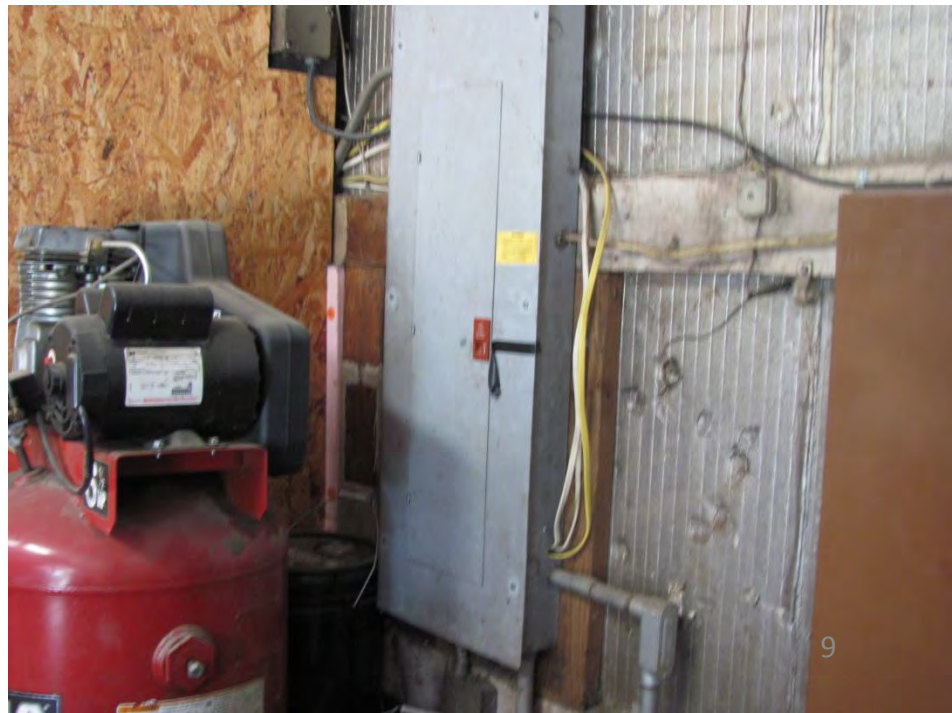
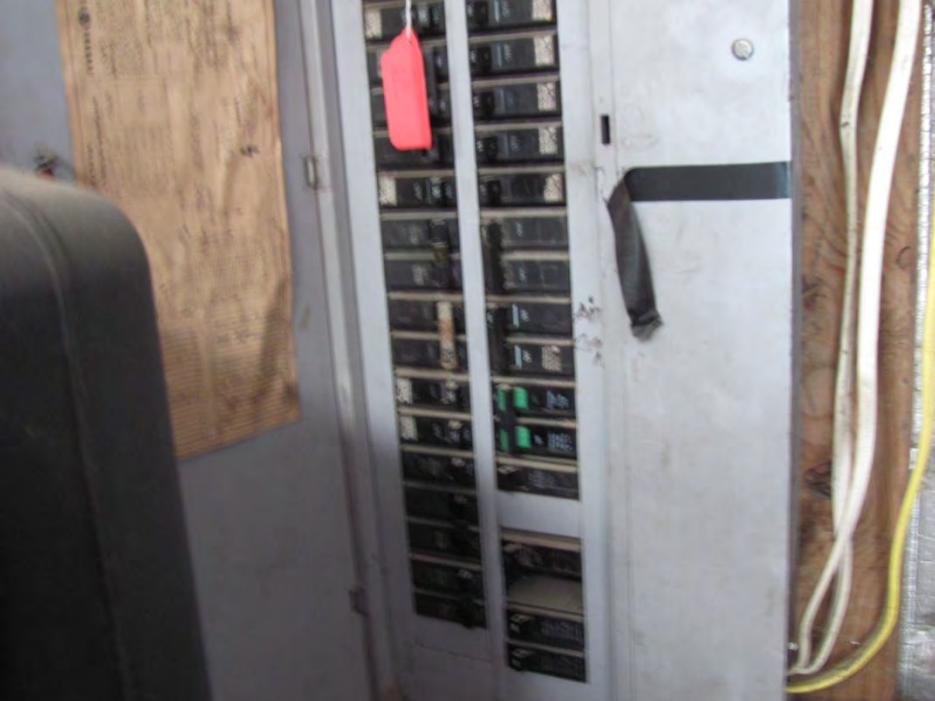
Slide #	Picture	Facility
1		Golf Buildings
2	TL	Housekeeping/Combustible materials
	TR	Housekeeping/insect breeding ground
	BL	Chemical placed outside
	BR	Cabinet is marked "Flammable", cabinet place outside, should be inside and secured. This not a true storage cabinet – this is an office storage cabinet.
3	TL	Fuel tank needs new NFPA placard
	BR	Fuel tank has grounding wire attached to the tank but is just wrapped around a pole and is not grounding the tank
4	TL	Debris around building creating a fire and insect hazard
	BR	Electrical transformer needs to be cleared for access and heat dissipation
5	TL	All ladders should be nonconductive
	TR	Good use of the flammable cabinet. Remember to store up to maximum of 60 gallons of flammable materials in one cabinet
	BL	Flammable cabinets are not designed for storage on top of cabinet
	BR	Gas cans let outside of storage cabinet
6	TL	All electrical panels need arc flash warning signs and all breakers need to be marked to identify its use

TR	No exit sign above exit door
	BL	Wrong label on chemical container
7		Maintenance Building at Golf Course
8	TL	Open electrical box
	TR	Romax wiring used improperly
	BL	Electrical tape on electrical cord as a repair
	BR	Broken electrical on/off cover plate - romax
9	TL	Romax – exposed wiring – open knockout
	TR	Romax – open knockout
	BL	Romax – open knockout
	BR	Same at a distance
10	TL	Open breaker slots – no breaker labeling
	TR	Bypass of grounding
	BL	Broken outlet
	BR	Exposed wiring

11	TL	Exposed wiring
	TR	Plugs taped together
	BL	Plugs taped together
	BR	Wrong use of romax
12	TL	Romax into outlet with no wiring protection
	TR	Two different types of amperage cords spliced together and taped
	BL	Open knockout
	BR	Exposed wiring
13	TL	Romax into electrical box
	TR	Extension cord used as permanent wiring
	BL	romax
	BR	romax
14	TL	Burnt ground fault plug
	TR	Good outlet outside of building
	BL	Metal wiring close to exposed plugs in golf cart shed
		Golf Cart Building
	BR	Missing cover on outlet
15	TL	Broken light fixture
	TR	No electrical panel marking
	BL	Electrical panels blocked
16	TL	Missing tongue guard
	TR	Missing guard
	BL	Missing guard
	BR	Drill needs to be mounted to keep from walking while in use
17	TL	Need a better place for battery storage
	TR	Crane will an annual certified inspection
	BL	Combustible item in grinding and welding area
	BR	Good job at keeping vehicle hoist inspected
18	TL	Need a better storage system to keep from creating trip hazards, fire hazards and housekeeping issues

21		Pro Shop
22	TL	No exit sign
	TR	Doors not marked to indicate usage
	BL	No exit sign
	BR	No exit sign
23	TL	No hand rail
	TR	Expired extinguisher
	BL	Blocked extinguisher
	BR	Compressed cylinder no secured from tipping
24	TL	Good GFCI outlet
	TR	Missing cover on outlet
	BL	Breaker panel missing breaker covers
	BR	Extension cord use as permanent wiring
25	TL	Missing cover for outlet
	TR	Electrical box not secured
	BL	Cylinders not secured
	BR	Plug not plugged in completely – exposed hot connection
26		Maintenance Shed
27	TL	Frayed cord
	TR	Frayed cord
	BL	Frayed cord
	BR	Electrical cord tied in knot – used to pull down light
28	TL	Missing breaker labels
	TR	Combo conduit and romax to wire
	BL	Wiring goes through hole in wall – not protected
	BR	Missing knockouts
29	TL	No protective sheath on light
	TR	Frayed cord
	BL	Power strip plug into power strip
	BR	Poor electrical wiring on outside of building
30	TL	Poor mid rail on lift cage – no chains for protection

TR	Flammables outside of flammable cabinet
	BL	Metal ladder
	BR	House keeping
33	TL	Space heater usage – need policy for usage and correct heaters to prevent fires
	TR	Same
	BL	No exit sign
	BR	Gas can left outside
34	TL	Housekeeping
	BR	same
35		Wavering Park Building
36	TL	Temporary light being used as permanent light
	TR	Improper type of extension coed for workplace – house hold type
	BL	Romax
	BR	romax
37	TL	Overload of outlet
	TR	Romax – no protection
	BL	Romax wiring to equipment
	BR	Missing guards
38	TL	Load limit
	TR	Poor chemical storage
	BL	User friendly container with chemical
	BR	No marking on container
39	C	No grounding
40		Maintenance Building
41	TL	Missing cover
	TR	Missing cover
	BL	No GFCI near sink outlet
	BR	Missing markings
42	TL	No plug adapters
	TR	FE on floor
	BL	Extension cord used on permanent basis
	BR	Missing guards and shields

We recommend the QPD put a plan in place to address all concerns. It would be a good idea to address the "low hanging fruit" (the easiest stuff) first. These smaller steps will help the staff see that things are getting done and be viewed as accomplishments. The success of completing the smaller items will help build a systematic approach when comes to completing the larger more difficult task.

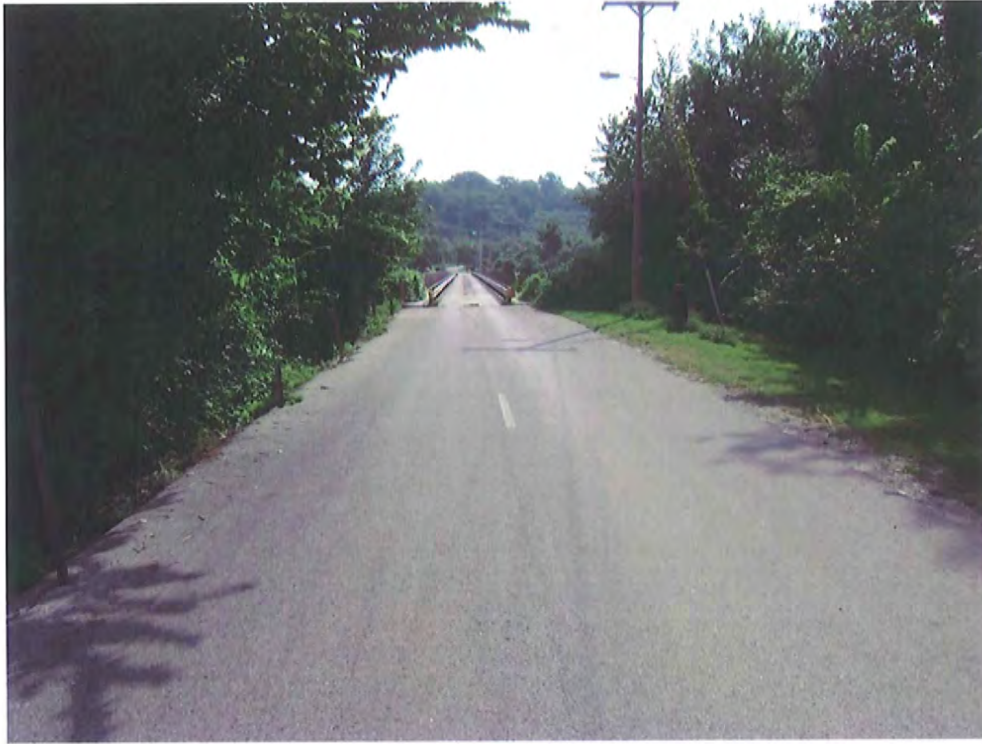
Photo No. 1
Looking east at the bridge and approach roadway.

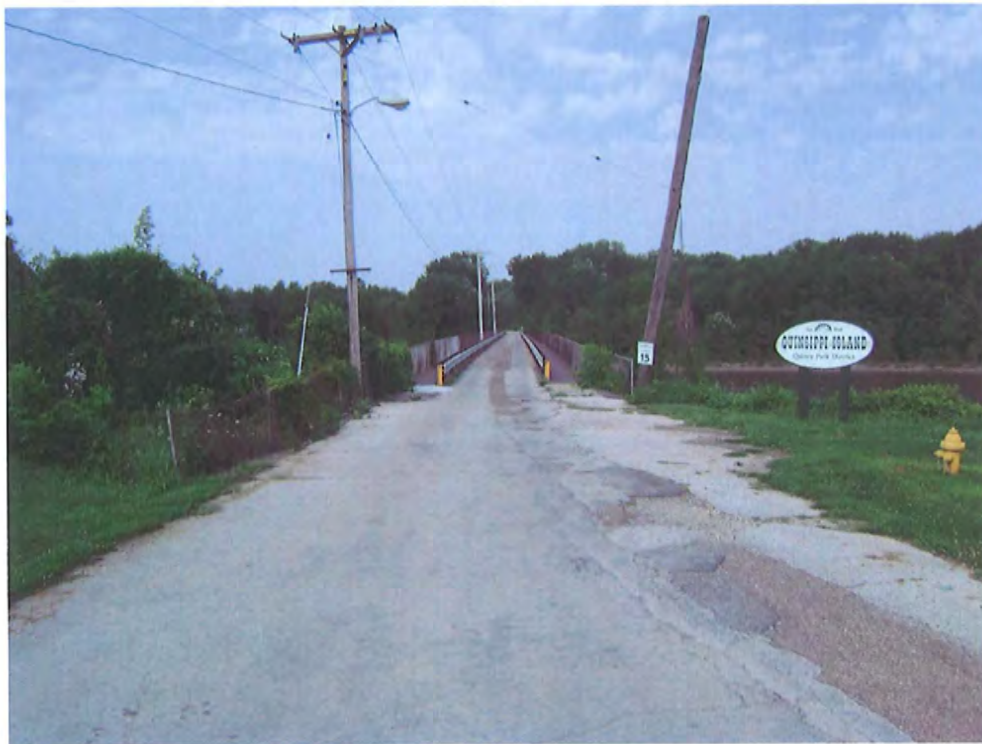
Photo No. 2
Looking west at the bridge and approach roadway.

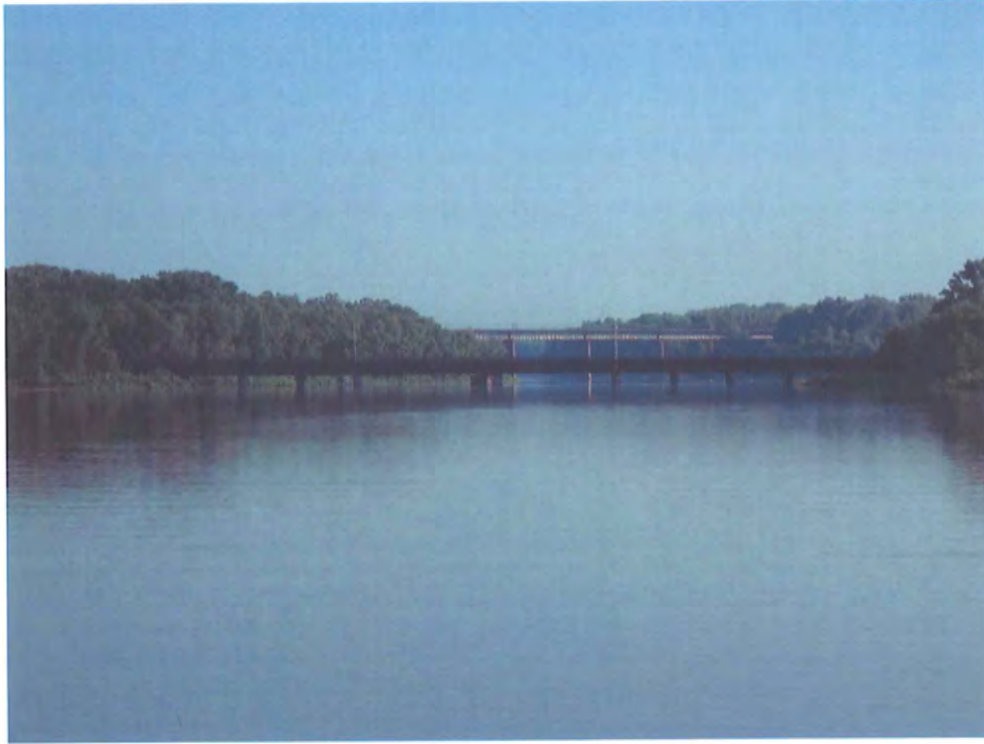
Photo No. 3
Looking north at the south elevation of the bridge.

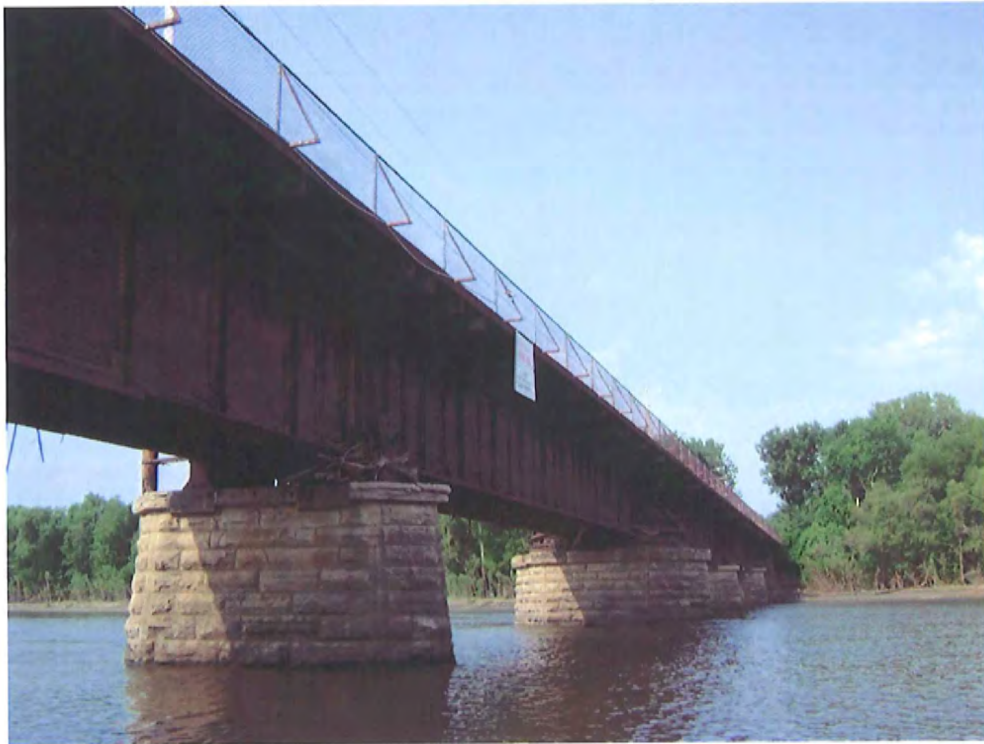
Photo No. 4
Looking west along the north elevation of the bridge.
