Appendix A: Community Input

Focus Group Summary Report

Quincy Park District ***Quincy, Illinois***

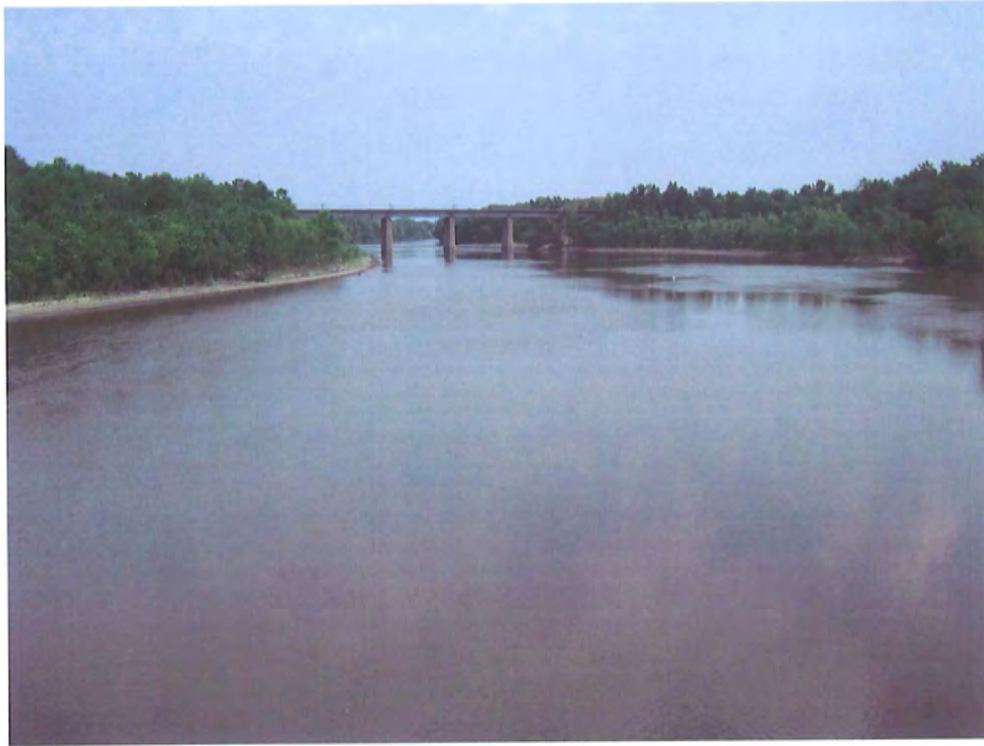
Photo No. 5
Looking north at upstream Quincy Bay.

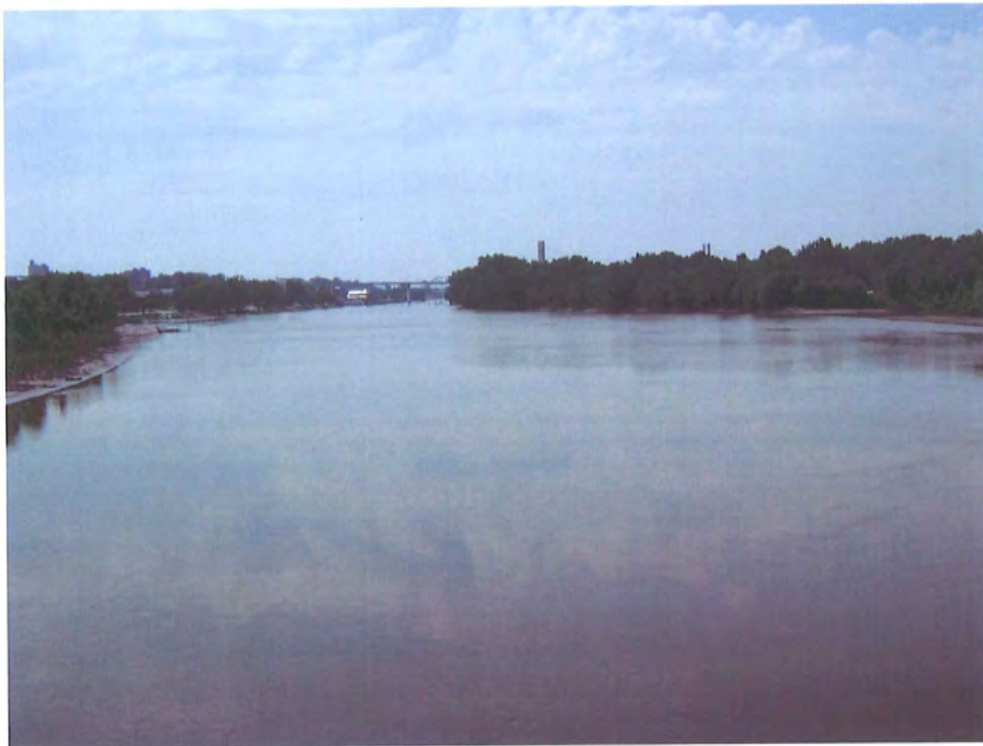
Photo No. 6
Looking south at downstream Quincy Bay.

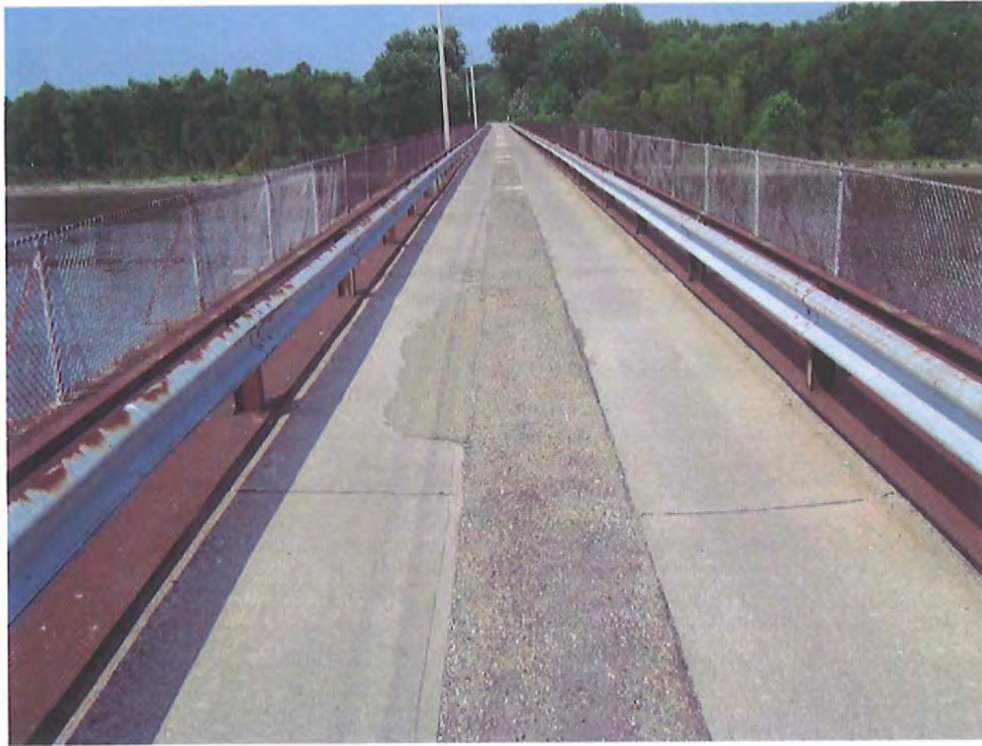
Photo No. 7
Looking west at the top of the deck.

- Replace deteriorated rivets in spans 3 and 4 with high strength bolts.
- Replace deck.
- Mortar deteriorated masonry joints and epoxy seal cracks in the stones.

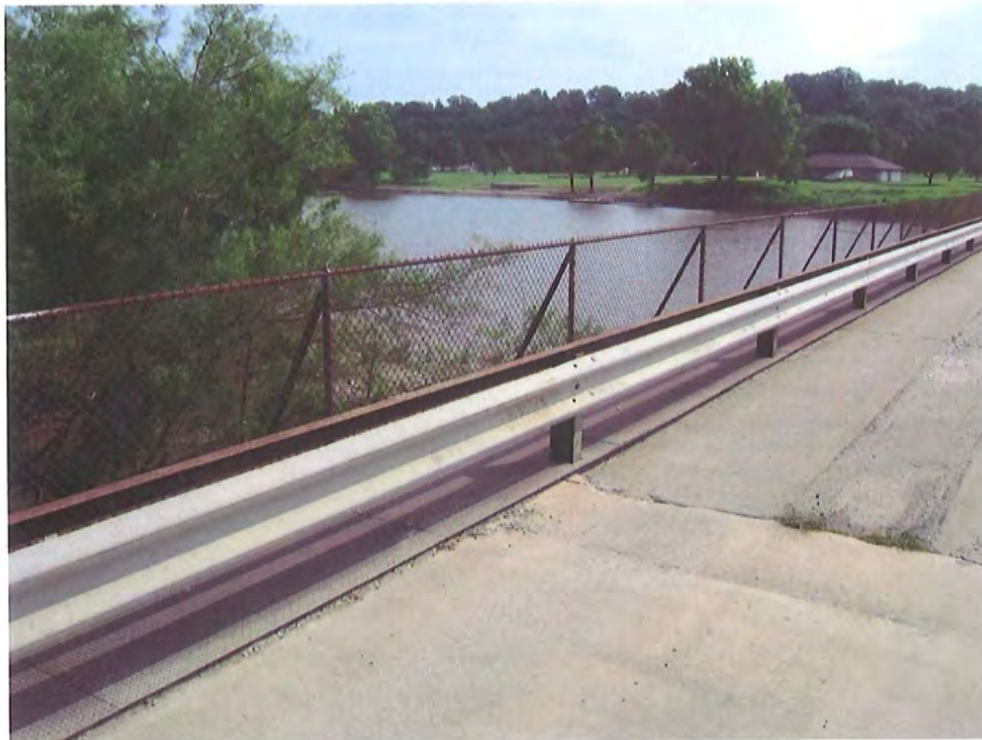
Photo No. 8
Looking northeast along the north guardrail and pedestrian rail.

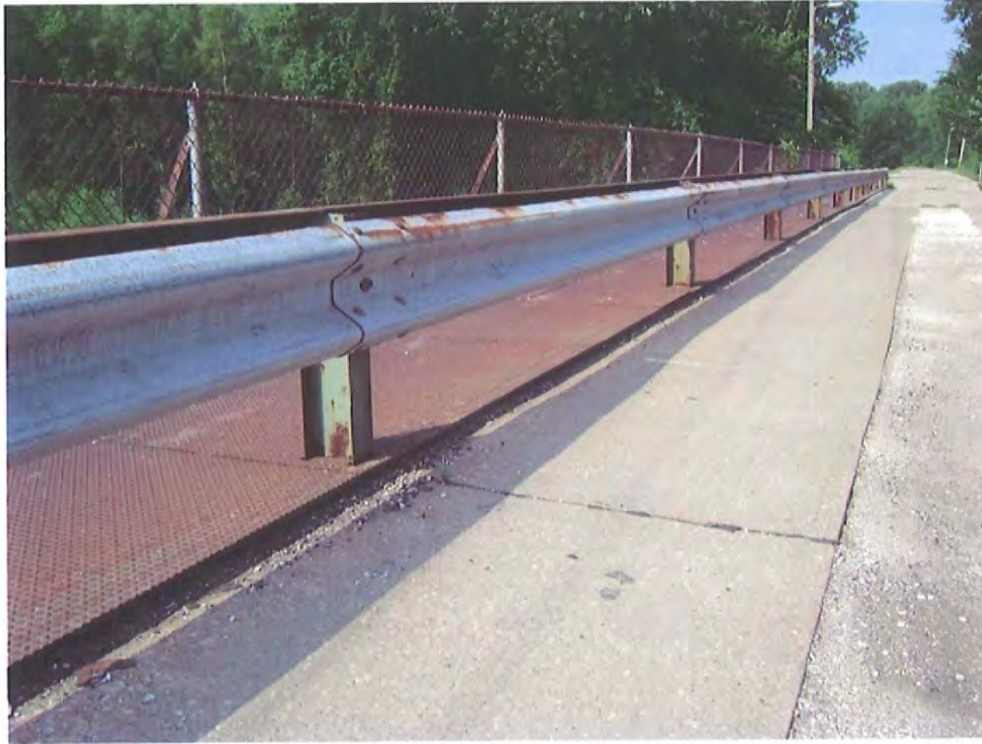
Photo No. 9
Looking west along the south guardrail and pedestrian lane.

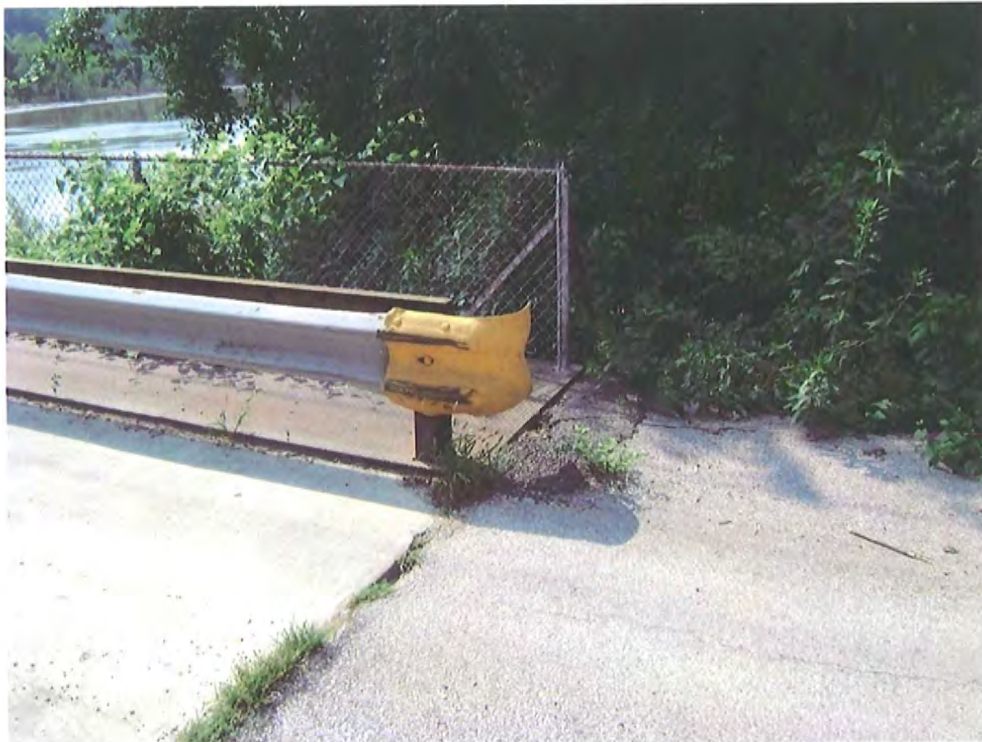
Photo No. 10
Looking south at the west abutment joint.

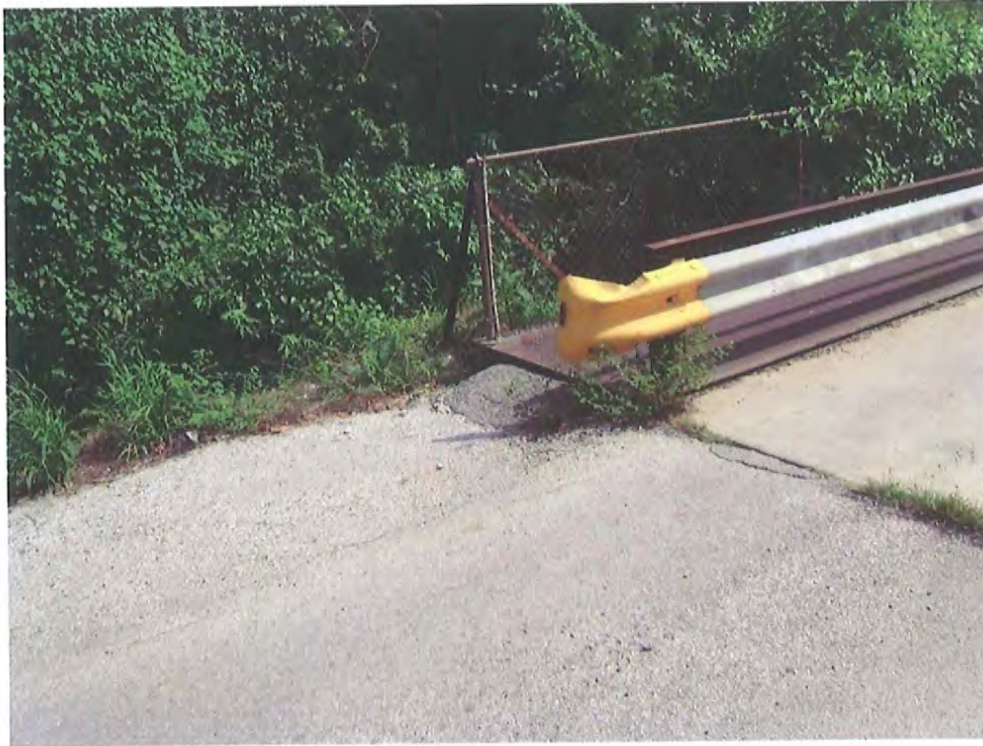
Photo No. 11
Looking north at the west abutment joint.

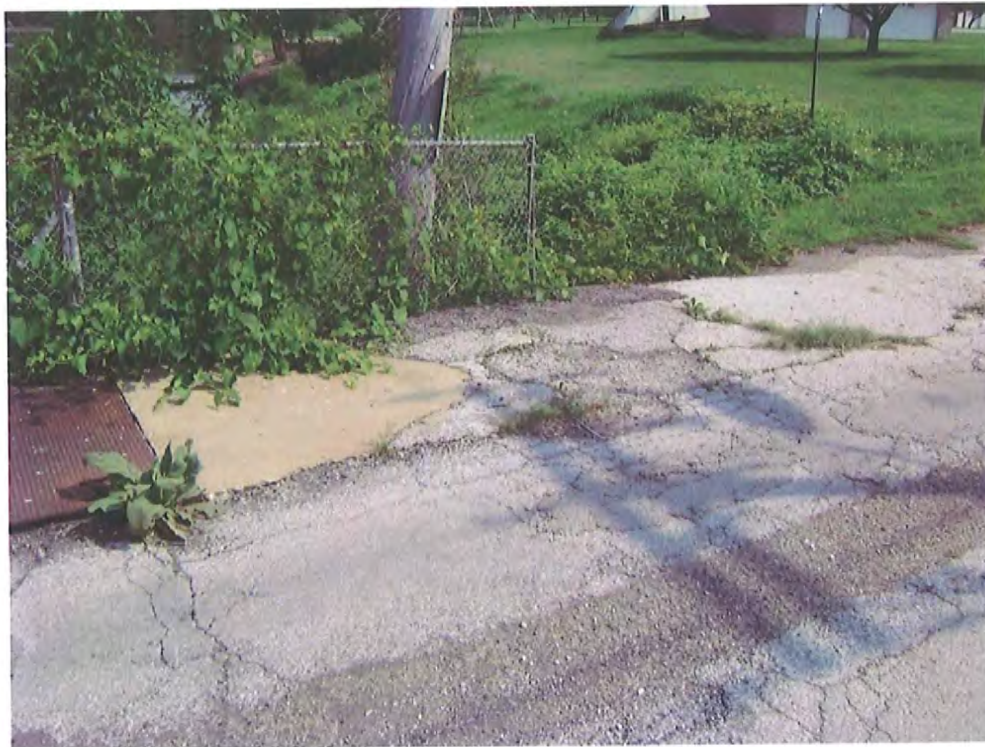
Photo No. 12
Looking north at the east abutment joint.

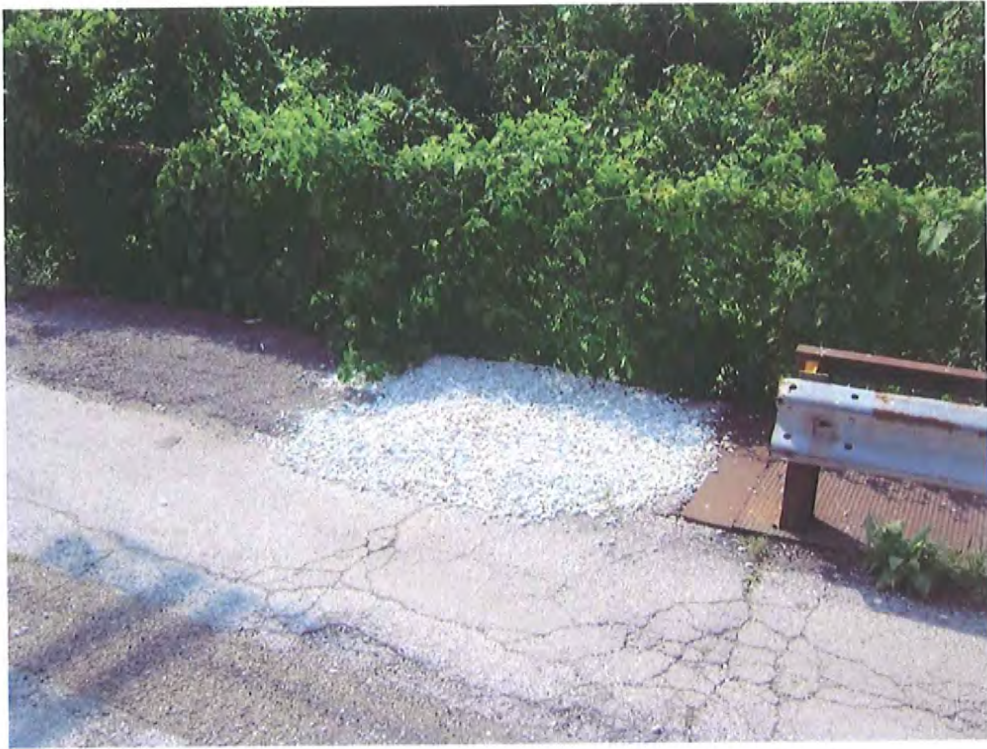
Photo No. 13
Looking south at the east abutment joint.

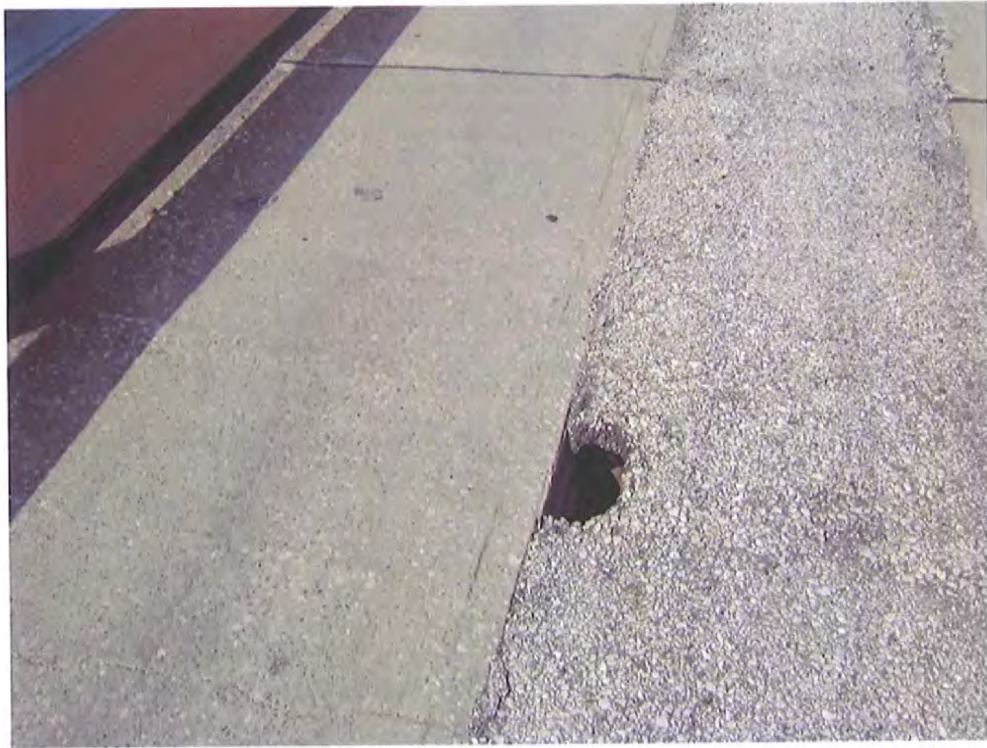
Photo No. 14
Hole through deck the near the middle of the structure.

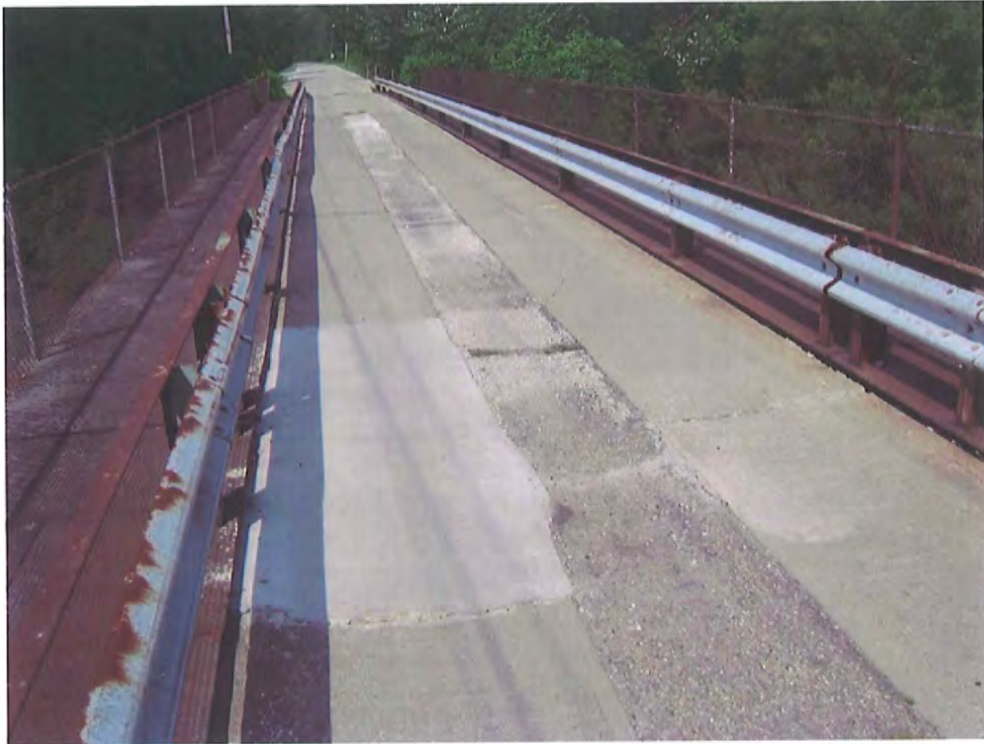
Photo No. 15
Looking west at full depth concrete repair.

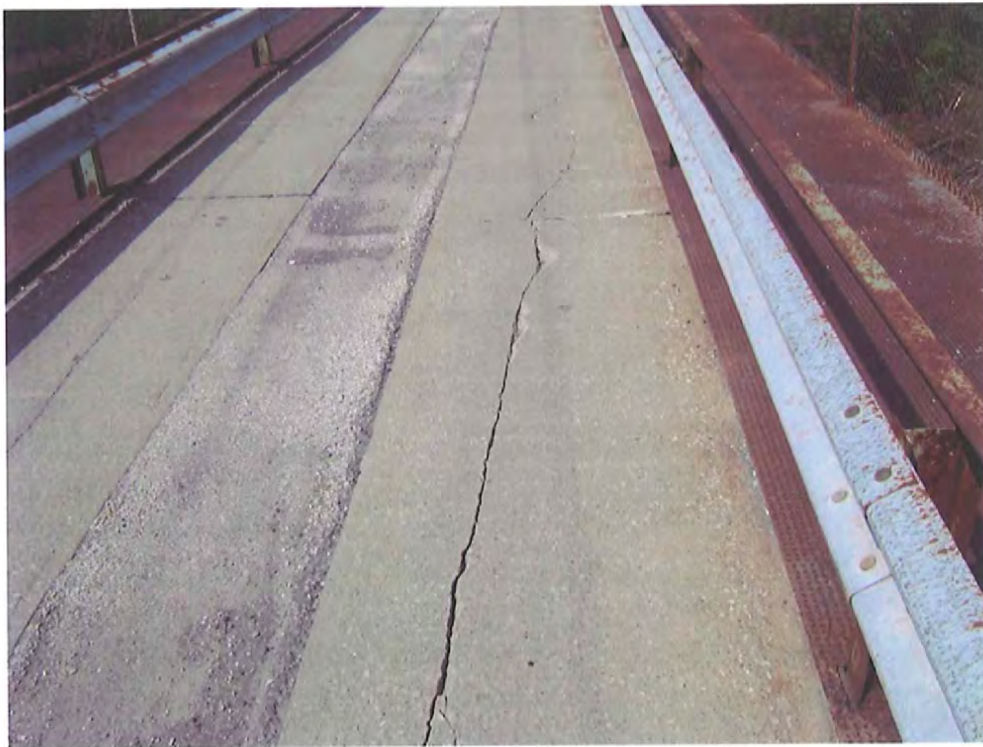
Photo No. 16
Looking west at typical longitudinal cracking.

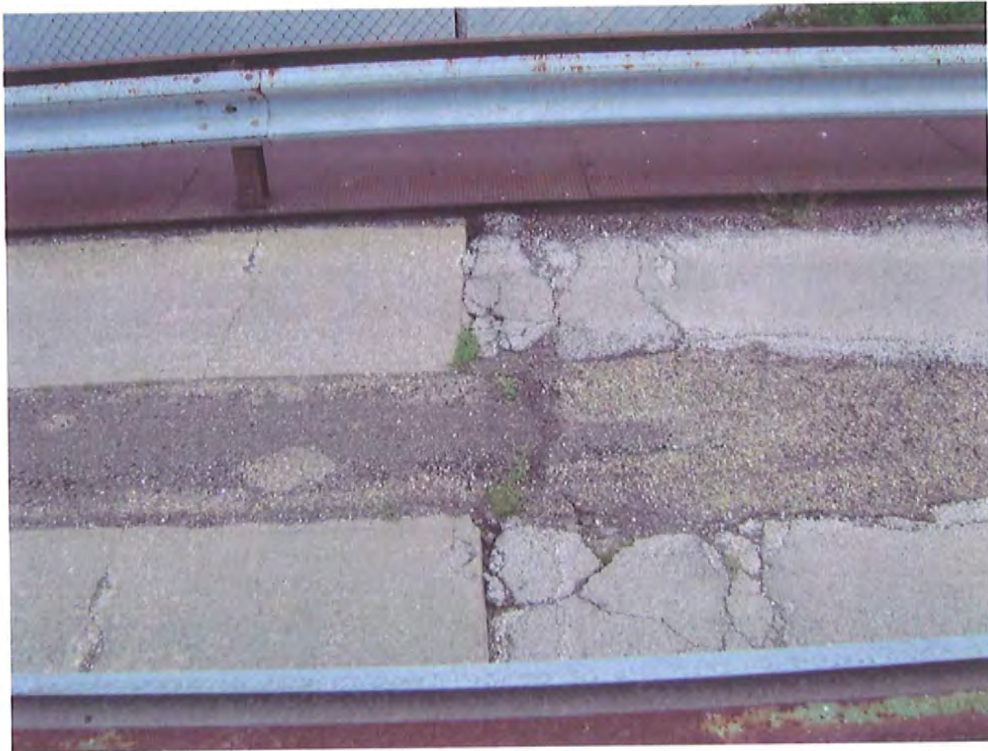
Photo No. 17
Looking south at west abutment joint above stone arch.

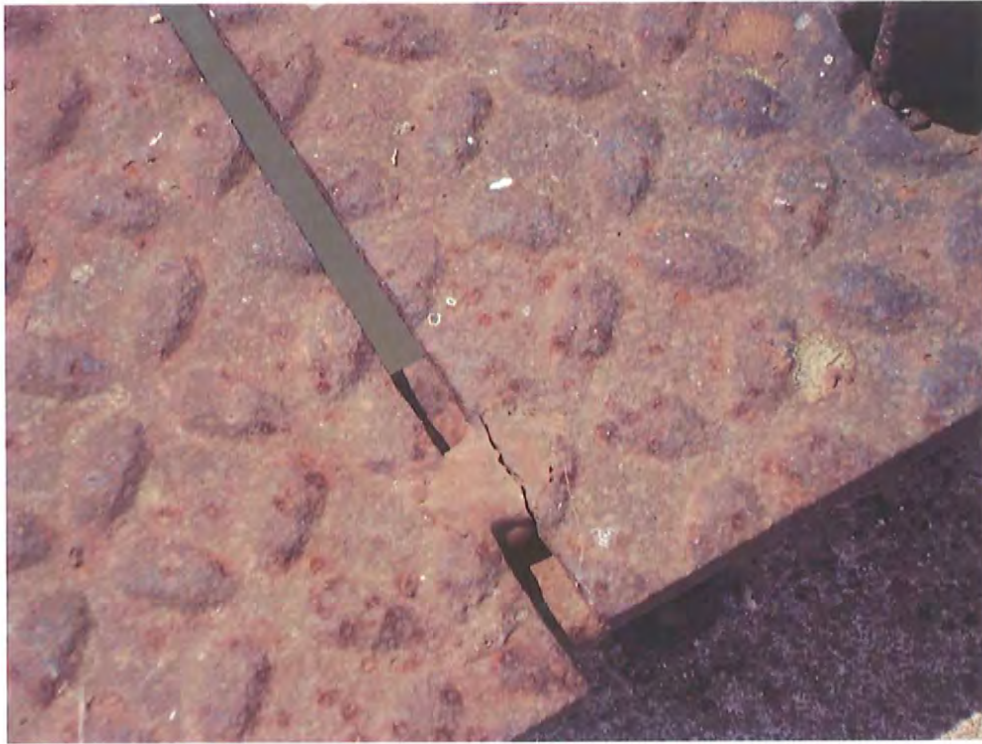
Photo No. 20
Looking southwest at typical transverse cracking in deck.

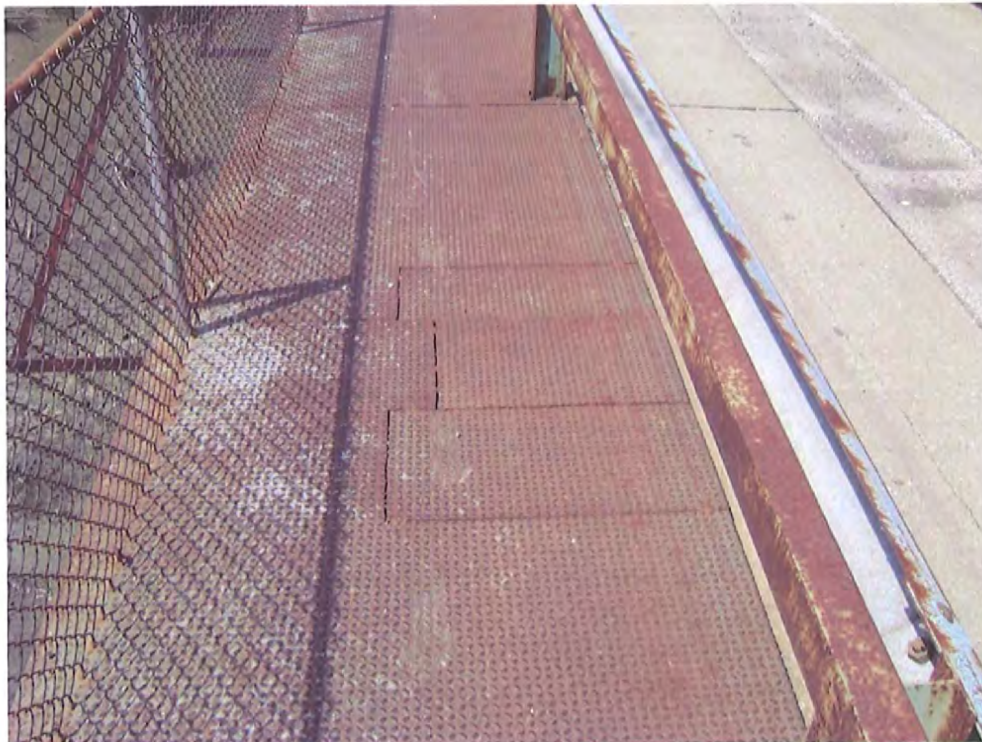
Photo No. 21
Looking at typical weld fracture on checkered plating.

- Re-weld areas of the checkered plating that have fractured.
- Post "One Lane Bridge" signs on both ends of the structure.
- Add bituminous material at the west approach ramps of both pedestrian lanes to provide smoother transition.
- Re-attach the top rail (pipe) at the west end of the north pedestrian rail.
- Tighten all loose guardrail connections and re-connect the guardrail to the first post at the northeast corner of the bridge.
- Remove tar and drill weep holes in the bottom flange in spans 3 and 4 to allow water to drain.

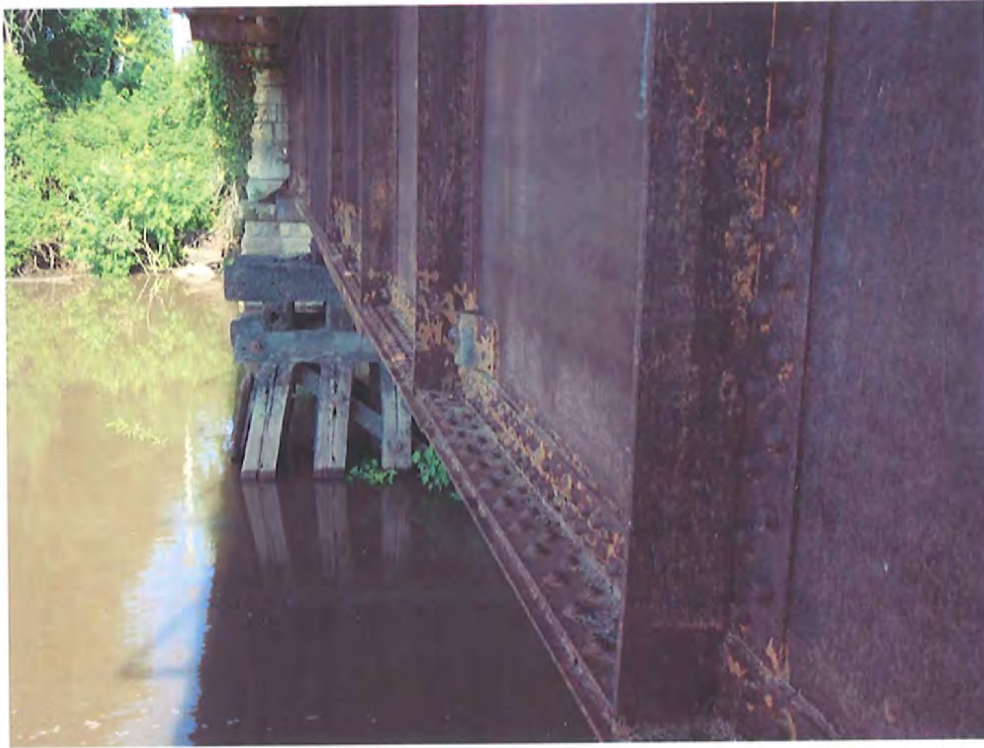
The steel girders are in fair condition. The surface rust and pitting is minor and common, especially for structures this old. The ½" thick steel plate along the top flange of the girders is severely deteriorated. Its strength was neglected for the rating calculations due to its condition. Water that drains through the deck reaches these plates before any of the other steel; therefore it is easy to understand why they are in such poor condition. If the deck were to be replaced we recommend removing these plates.

Photo No. 24
Looking west along the top flange of south girder, span 1.

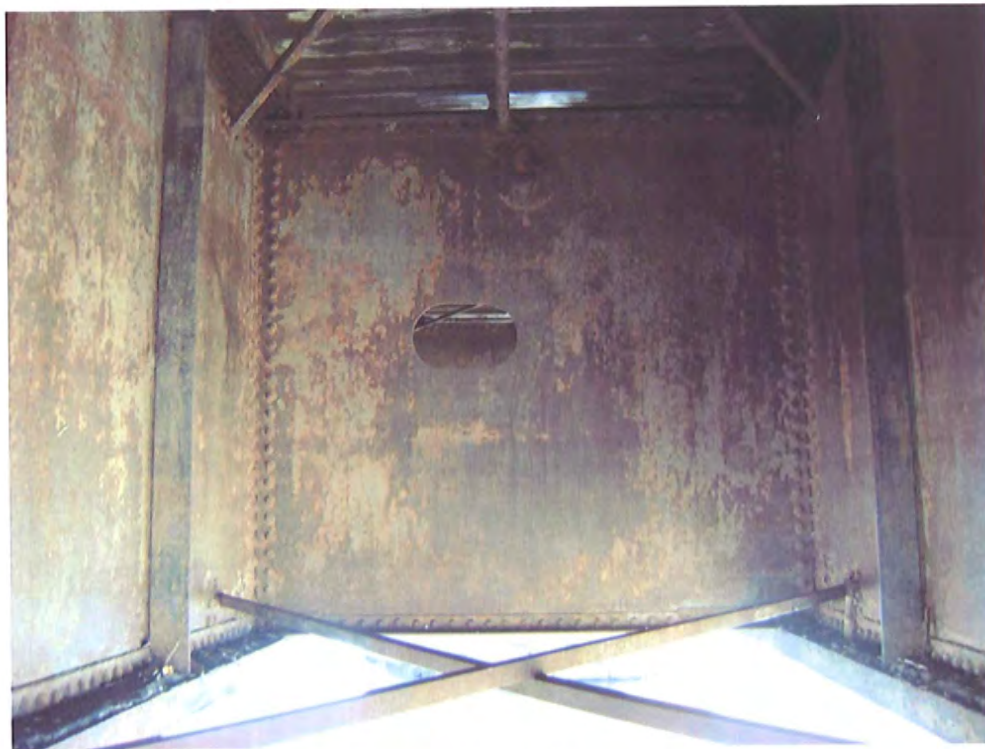
The angles and channels of the top and bottom flanges are in fair condition with no serious deterioration. In spans 3 and 4 the channel at the bottom flange is turned up, causing water to collect without any way to drain. The bituminous filler used in span 3 does not appear to be allowing water to drain fully, so further deterioration of the rivets continues. The condition of the rivets for span 4 is poor and it is assumed that the unseen rivets in span 3 are of the same condition. The bituminous filler in span 3 should be removed and weep holes to allow water to drain should be drilled at the bottom flange of spans 3 and 4.

Photo No. 39
Looking east along the bottom flange of north girder, span 3.

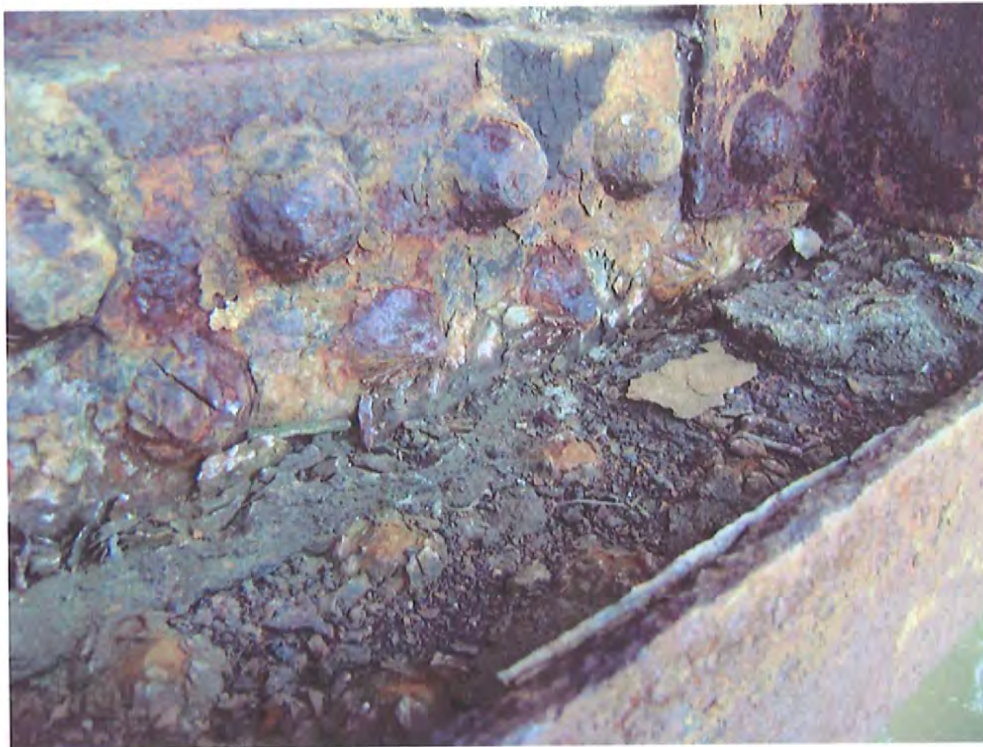
Photo No. 41
Looking at pack rusting at the top flange splice of south girder, span 3.

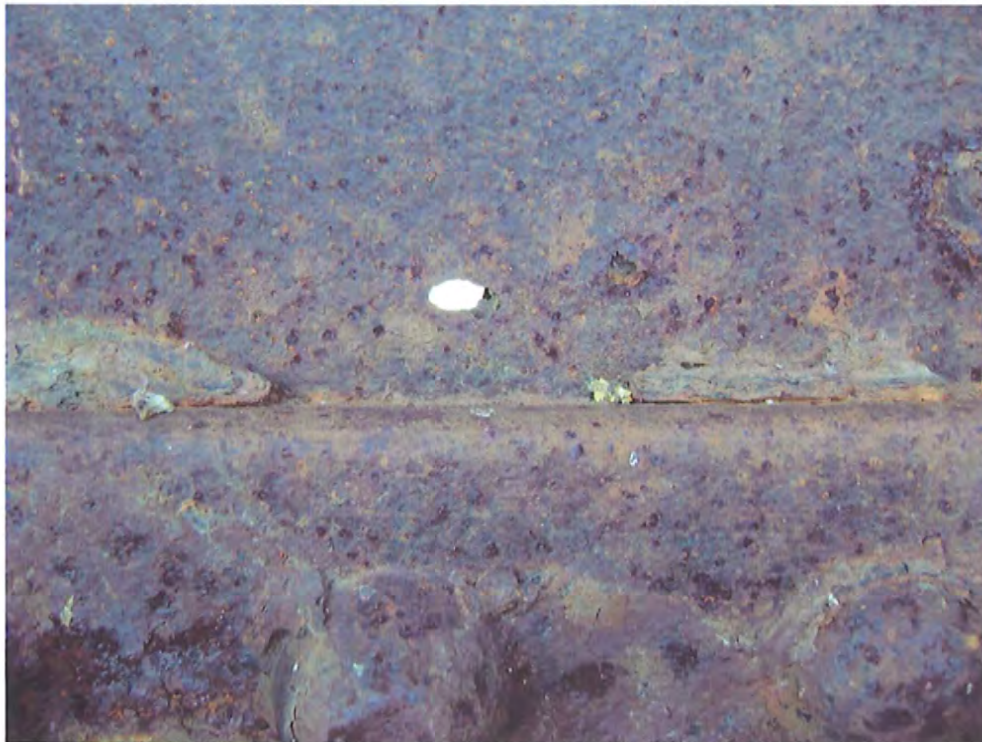
Photo No. 49
Looking at deteriorated rivets at bottom flange of north girder, span 4.

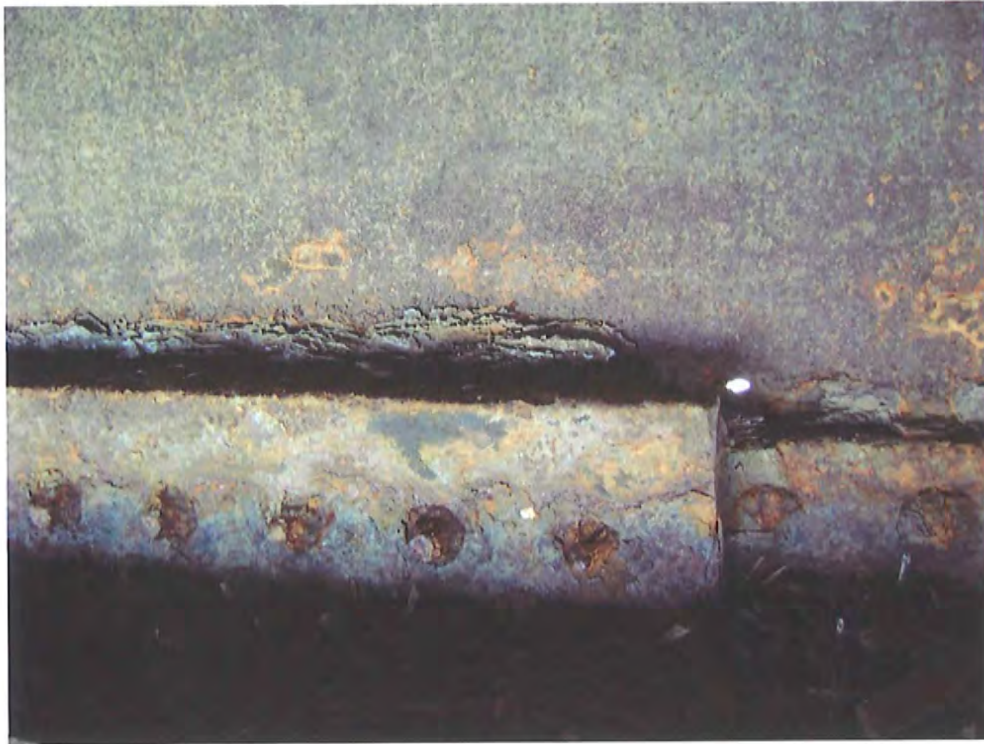
The webs in span 4 near the west end are in poor condition at the connection to the angles. The location of the deterioration is fortunate since this is not a high positive moment region, nor is located directly above a bearing. The reasoning for this deterioration is unknown, but it could be a result of more moisture getting through the deck at this location.

Photo No. 50
Looking at hole in web of north girder, span 4.

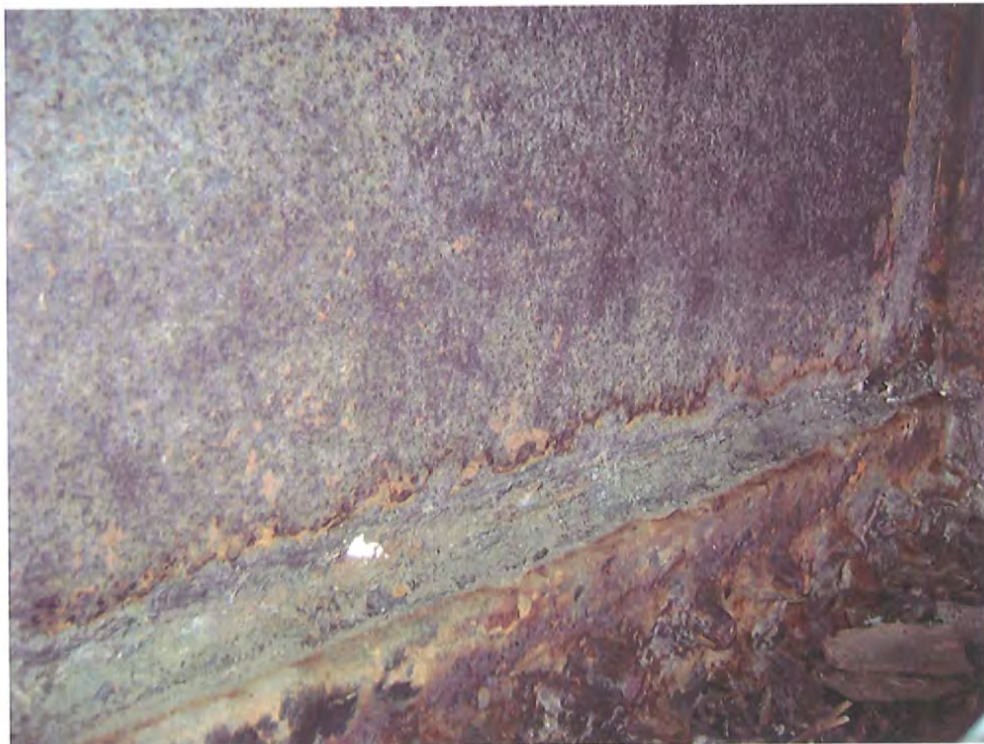
Photo No. 51
Looking at web deterioration of north girder, span 4.

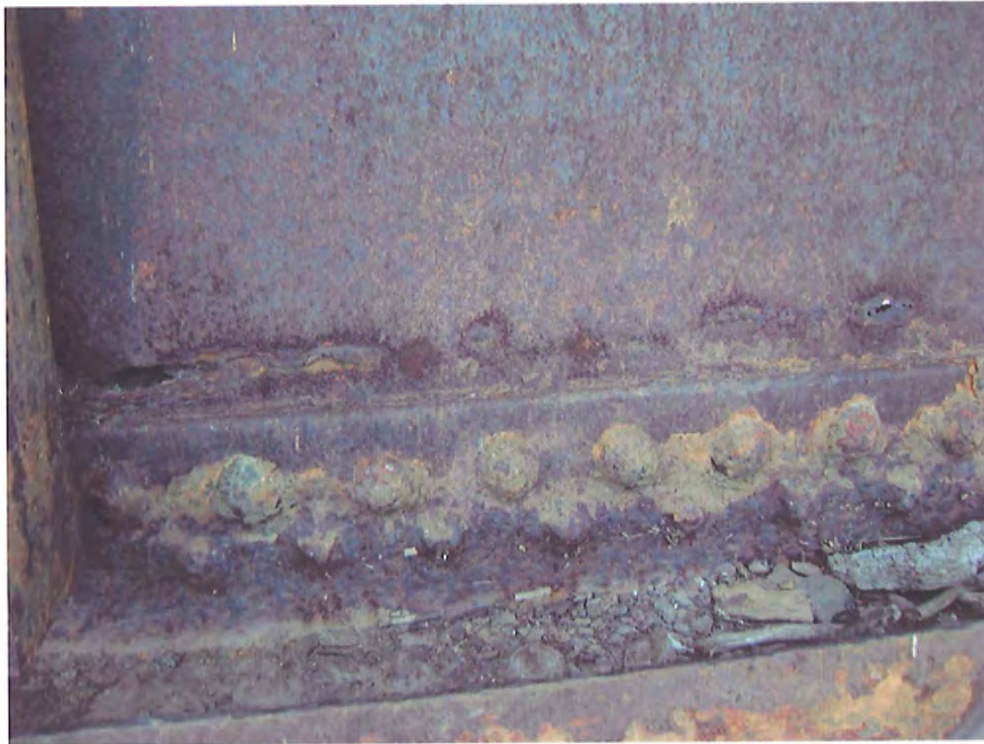
Photo No. 52
Looking at web deterioration of south girder, span 4.

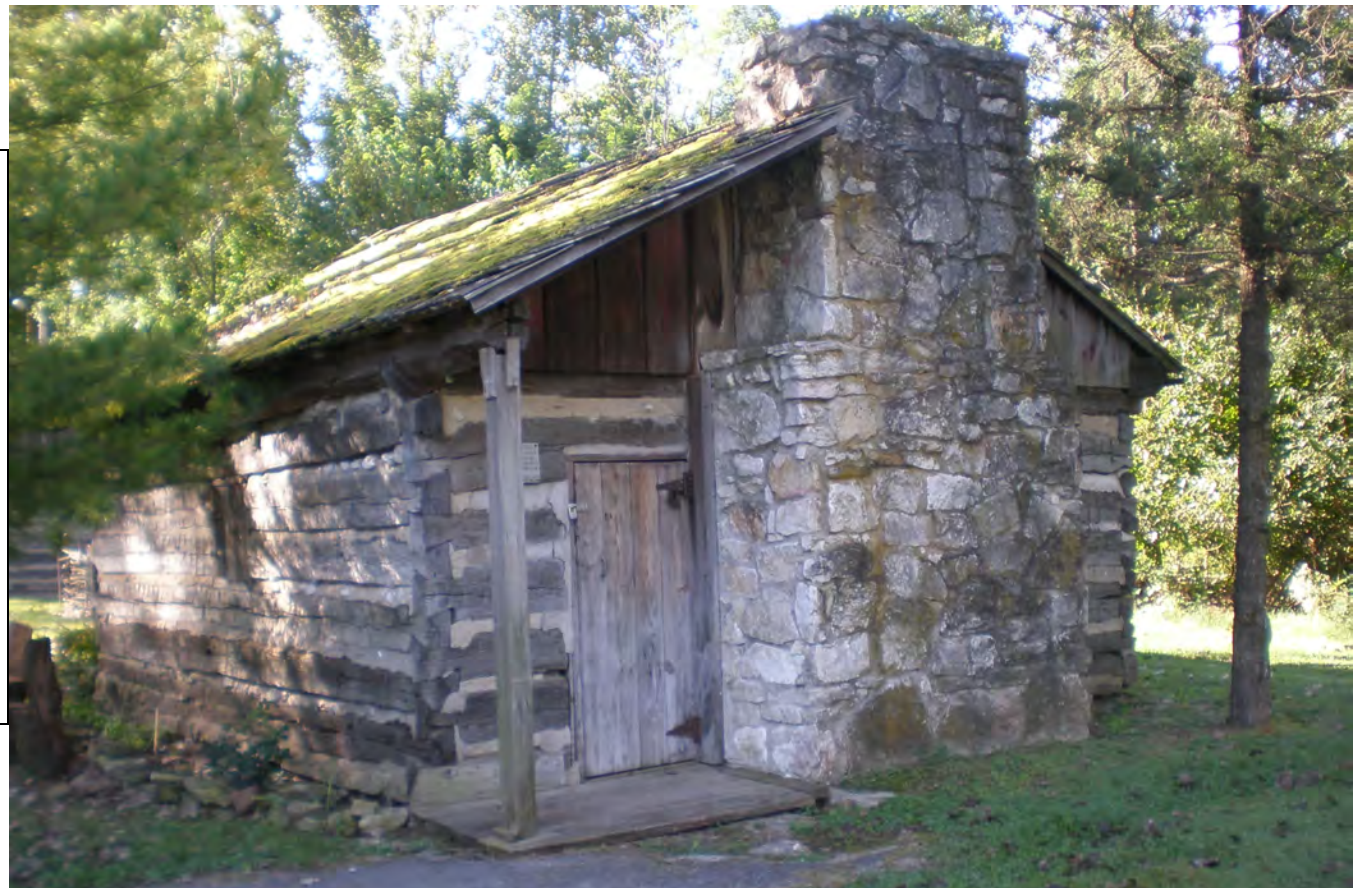
Figure I. D.A. Hull Cabin.

This cabin has a variety of overhanging tree branches that litter the roof and shade it from the sun. These should be trimmed back. Plants along the edge of the cabin should be removed.

This Hull cabin is overall in fair condition in that it is unlikely to collapse any time soon although it does need attention within 2-4 years to ensure that deterioration does not accelerate. The tables that follow provide more detail on the overall state of the cabin.

The chimney of this building was doubtlessly constructed on site and not moved from its original location. It is not know if this chimney replicates the original form or is a new design. It will be necessary to work around the chimney as the building is dismantled and rebuilt. The doors need to be repaired by replacing deteriorated planks. Windows need to be repaired and replaced where missing. The floor of the building is in acceptable condition but it is unknown how or if the floor it attached to the walls. It is probable that the floor is floating on sleepers. These will have been allowed to settle into the underlying soil and are no doubt decayed; a new sub floor structure is needed. The existing floor boards will be salvaged and reused is possible as will the gable ends.

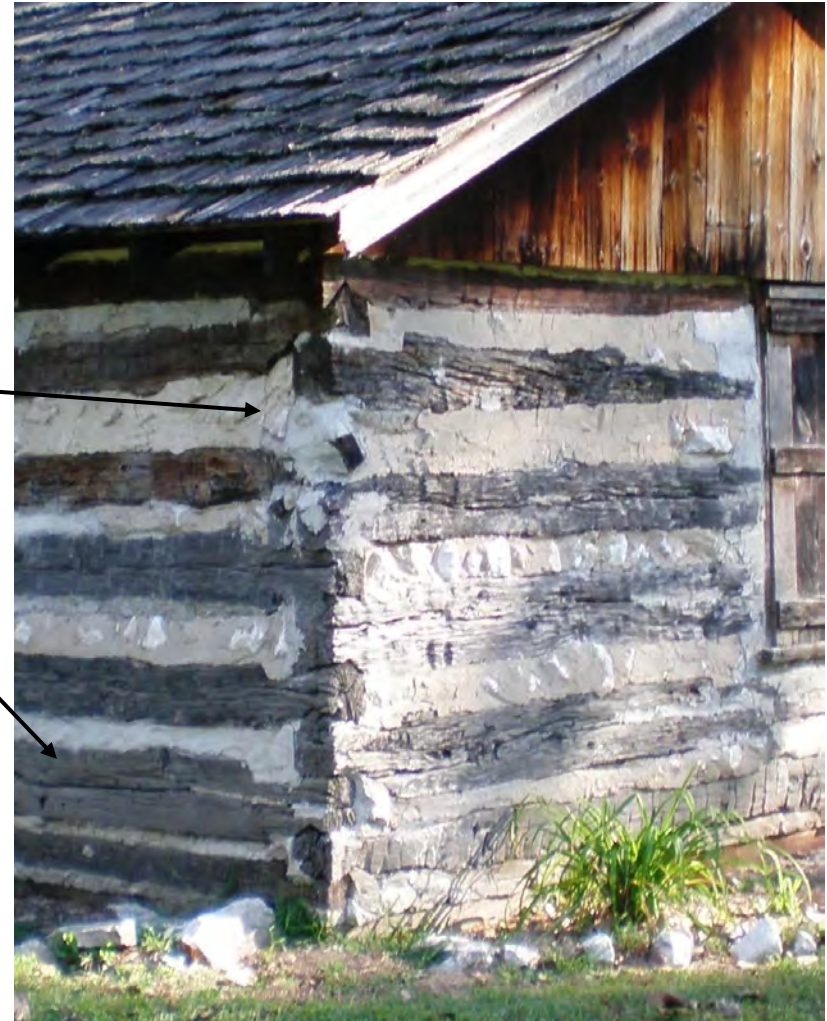
The steeple notching is difficult to see because of the daubing in some corners.

Large checks and partially replaced logs are common in this cabin.

The floor gives evidence that it is settling and that the floor joists are decayed, because of the floor's uneven condition. The foundation has failed and the building is bowed in middle as a result .

The log walls are in poor condition. The logs are deeply checked, frequently over-daubed which traps moisture, and are in contact with the ground and vegetation that grows adjacent to the sills.

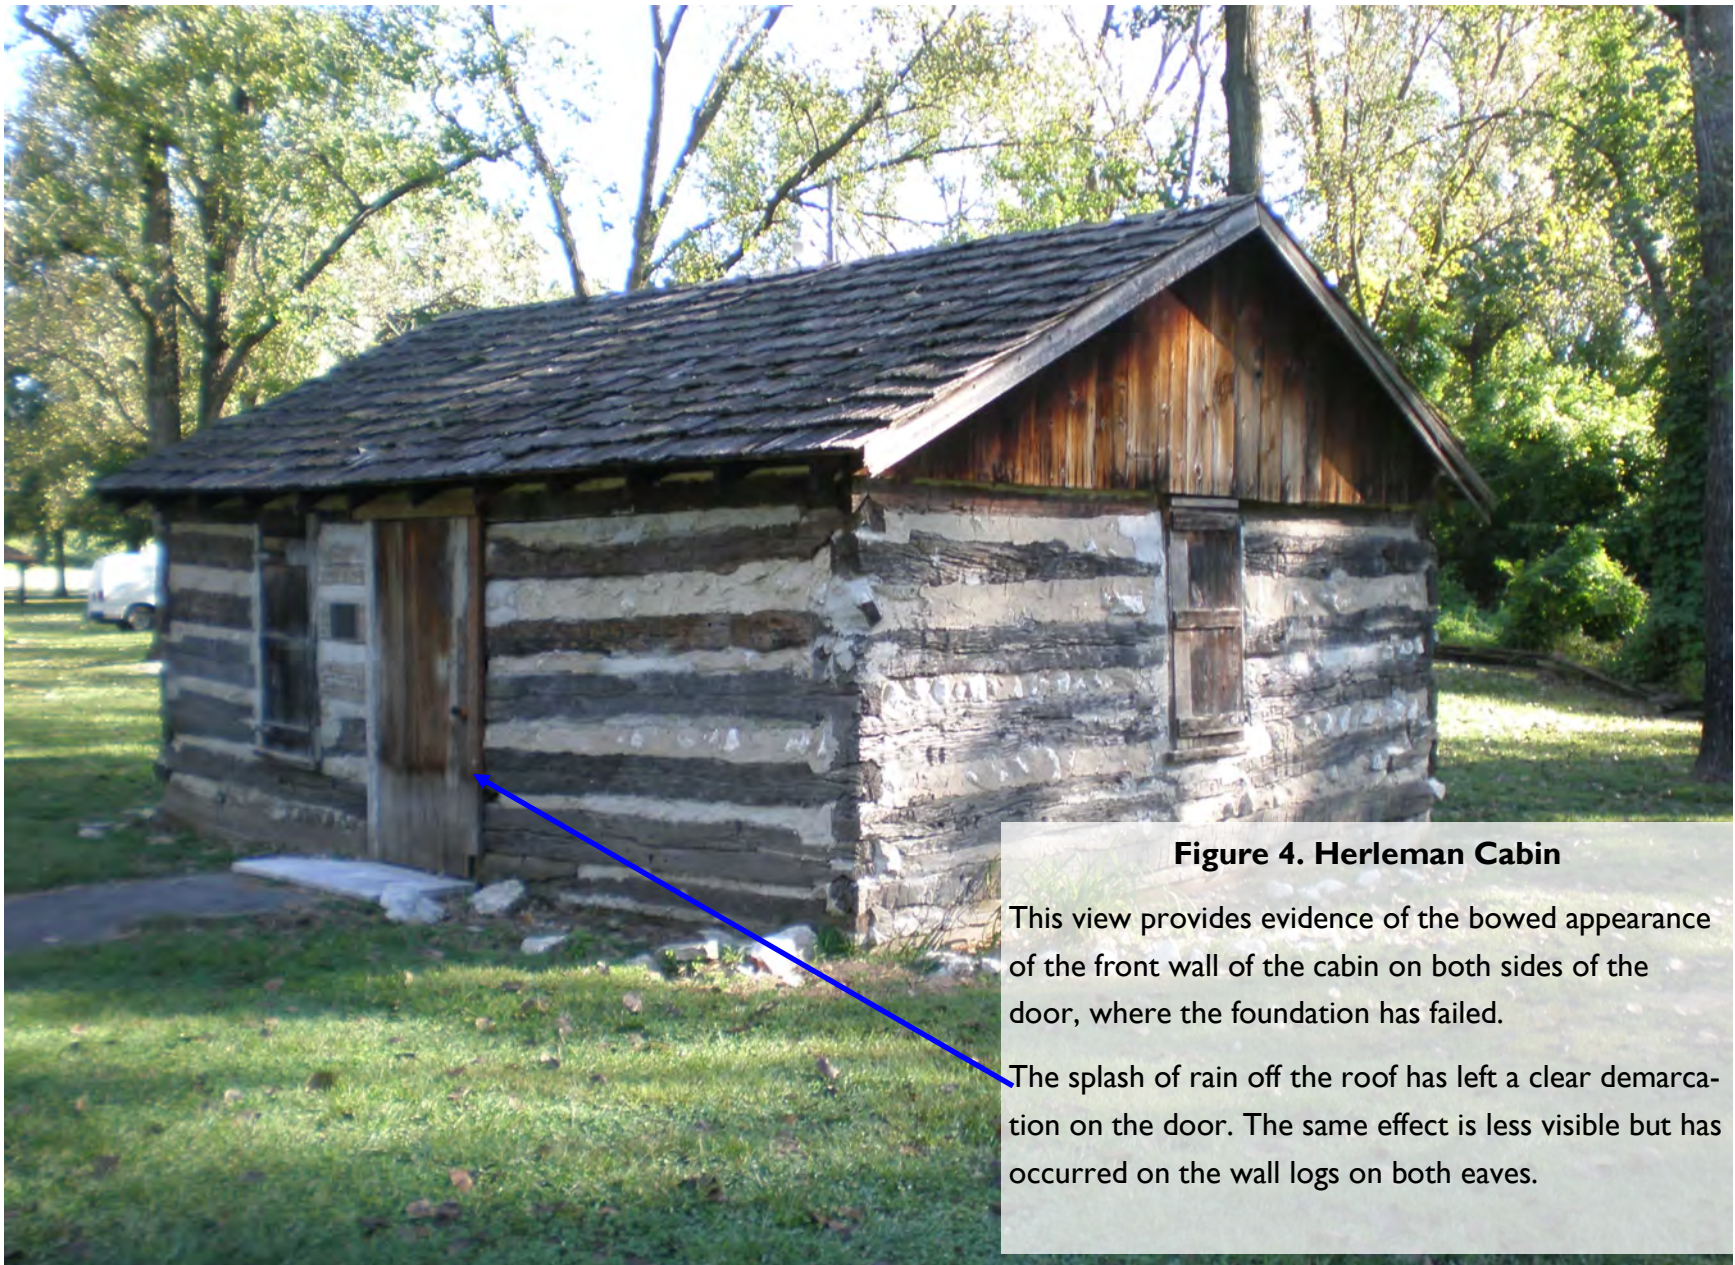
Figure 4. Herleman Cabin

This view provides evidence of the bowed appearance of the front wall of the cabin on both sides of the door, where the foundation has failed.
