Appendix A: Community Input

Focus Group Summary Report

Quincy Park District ***Quincy, Illinois***

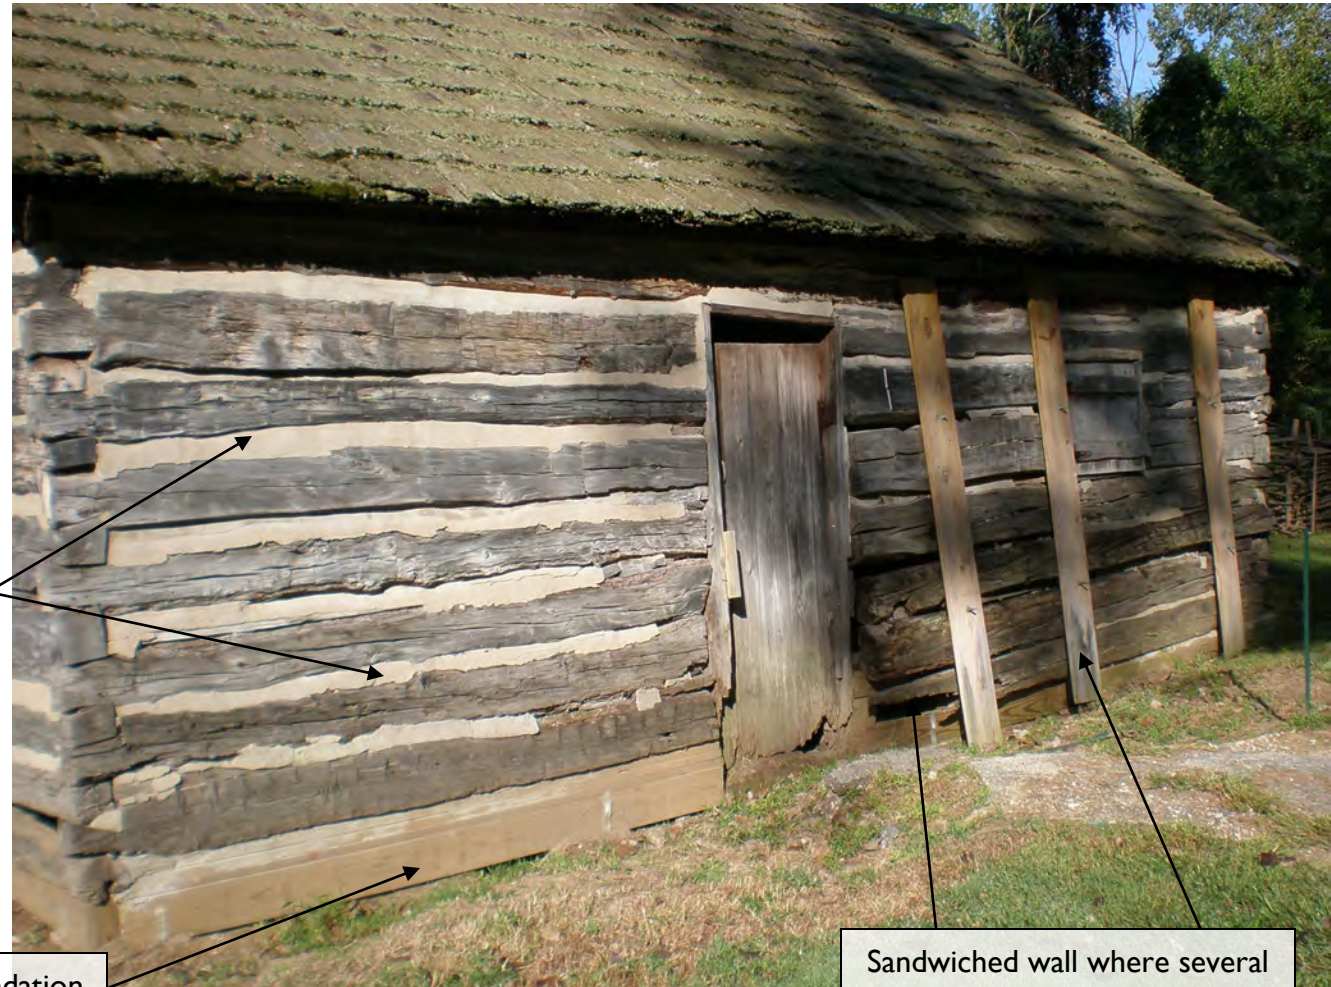
Heavy daubing filling chink space and checks in logs.

Temporary wooden foundation on cement block.

Sandwiched wall where several logs are unstable or decayed.

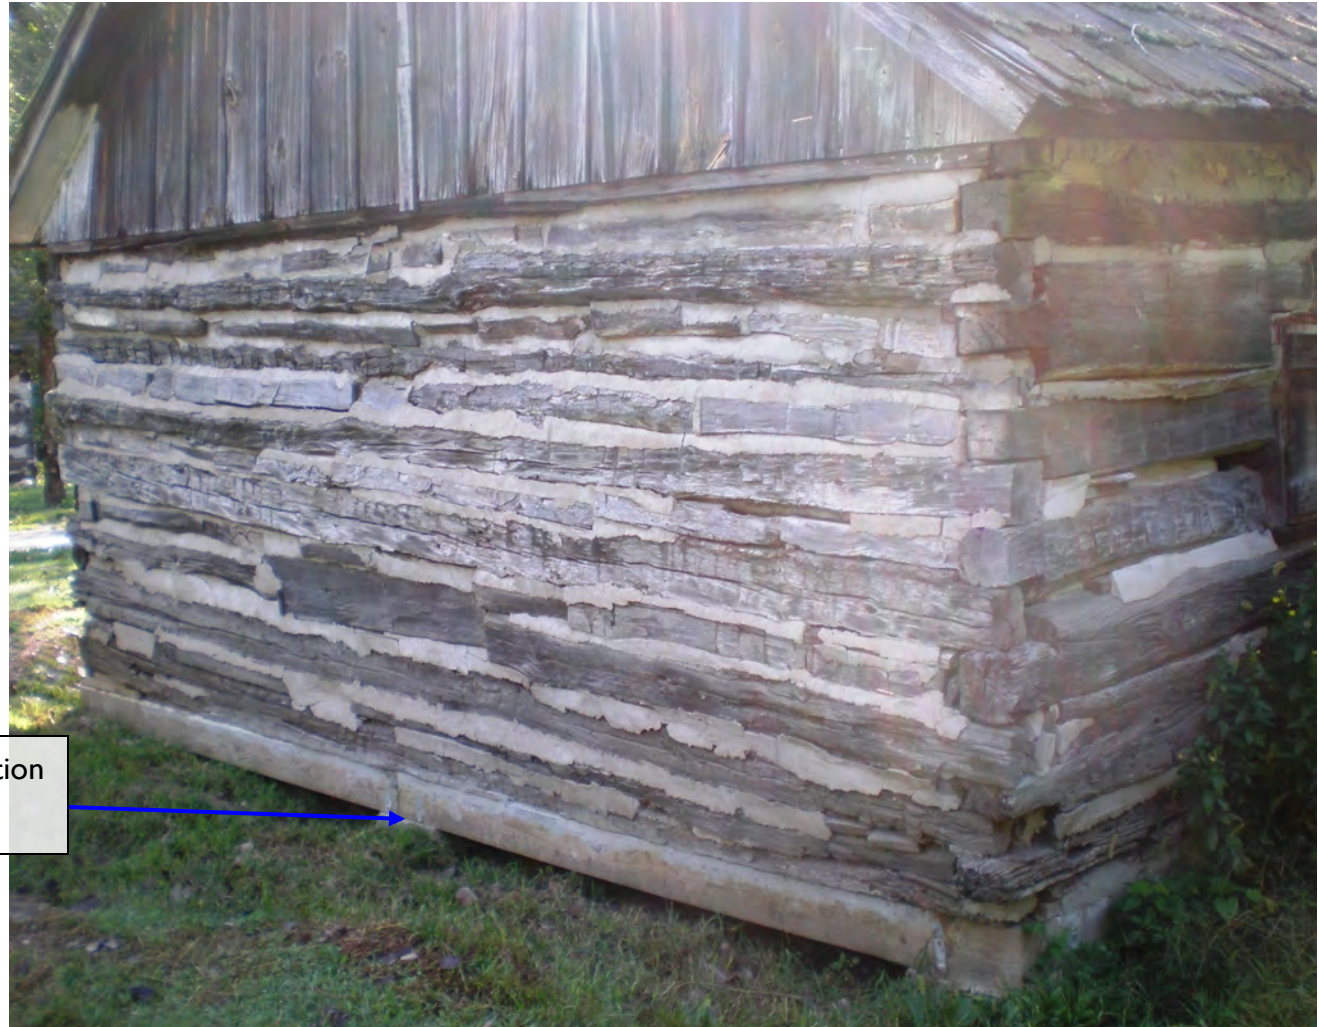
Figure 6. Clat Adams Cabin

This wall is a complicated jumble of whole logs, partial wall logs, large wooden chinking, and daubing used freely both to fill the chink space and to fill checks in the logs.

Temporary wooden foundation on cement block

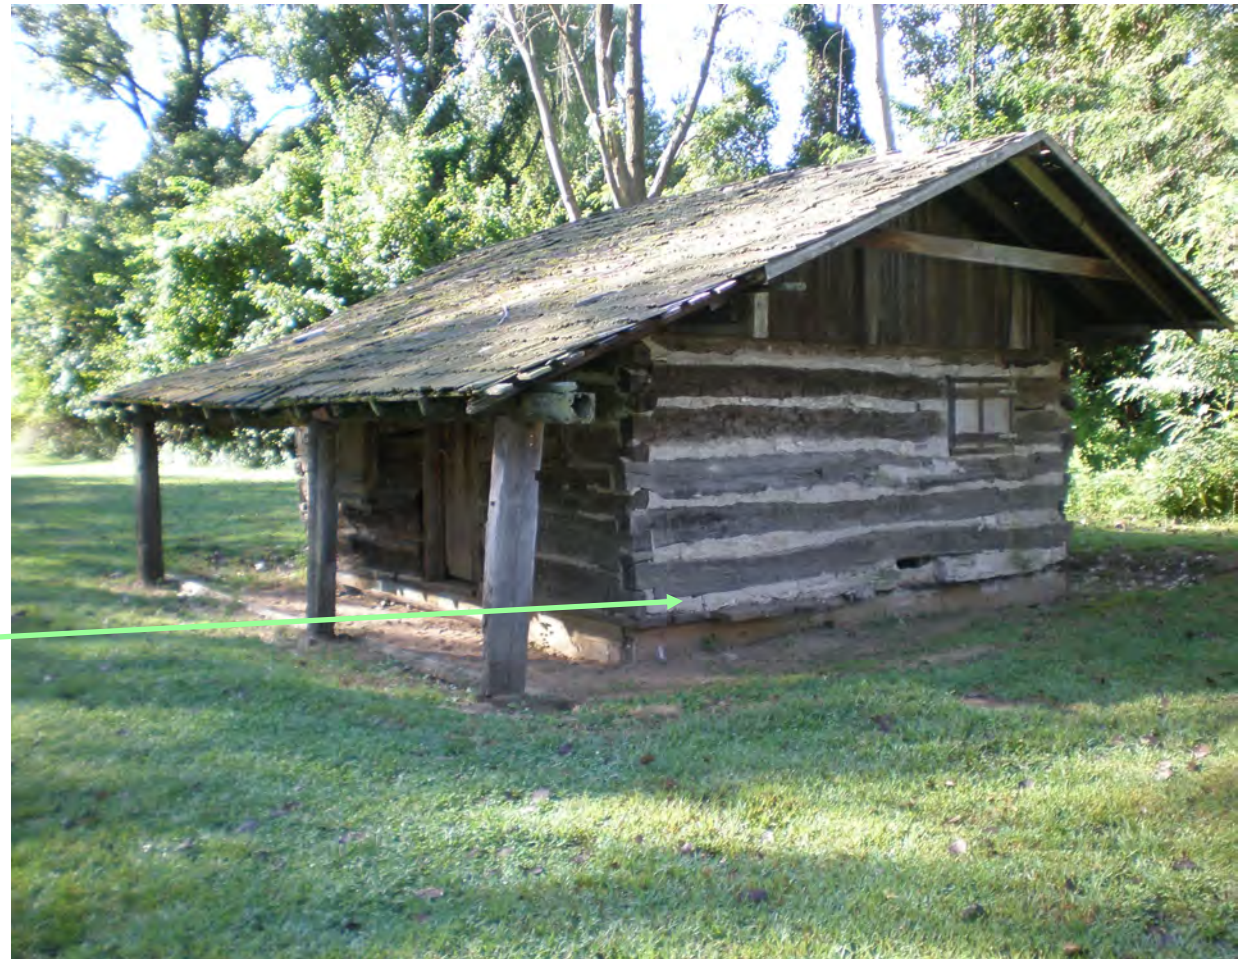
Figure 8. Fraser Cabin

The cabin is heavily daubed and on the north wall daubing has been substituted for a half log below the spandrel.

The cabin has had a temporary pressure treated wooden foundation that rests on large concrete blocks. The contractor that installed this foundation apparently excavated beneath the cabin. The cabin was not raised back to the surrounding ground surface and remains 1'6" feet below grade. Disassembly will allow for the hole to be filled in, and a new foundation constructed that will keep the building even with the current surface. The cabin could also be rebuilt adjacent to this location, ignoring the hole.

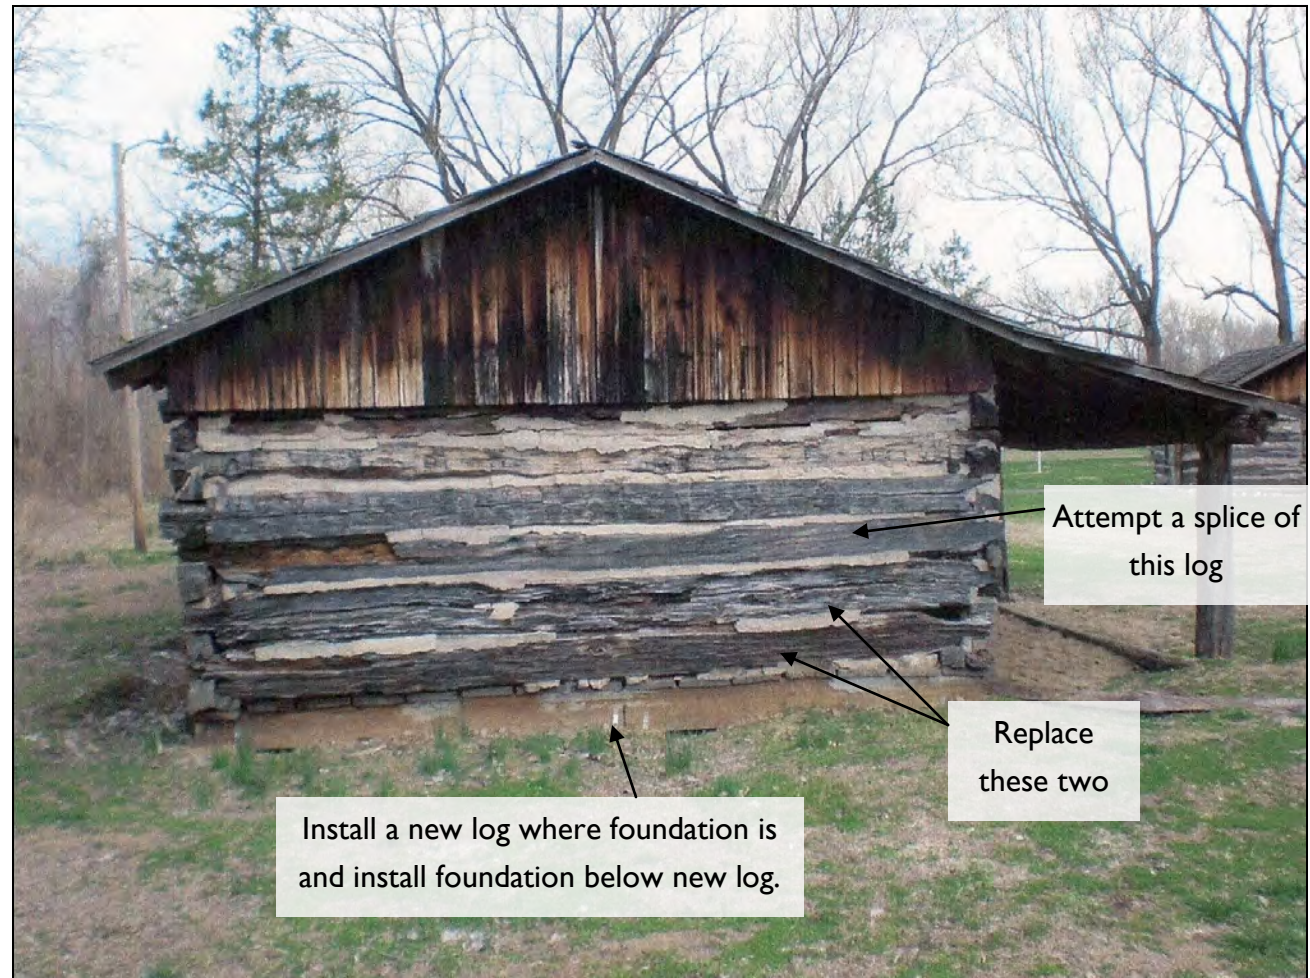
Figure 9. Fraser Cabin

The south wall exhibits serious deterioration. The lower three logs need to be replaced on this wall. The 4th log needs to be spliced to retain historic character. The daubing in other logs may hide other serious problems.

Fraser Cabin Wall Logs Condition (table 22)		
South Wall Logs	Condition	Recommendation
1	Missing	replace
2	Poor	replace
3	Poor	replace
4	Fair	Splice on end 8'
5	Large checks	Clean, borate, epoxy repair
6-7	Checks	Clean, borate, epoxy repair
North Wall Logs		
1	Missing	replace
2	OK	
3	OK	
4	Poor-hollow	replace
5-7	OK

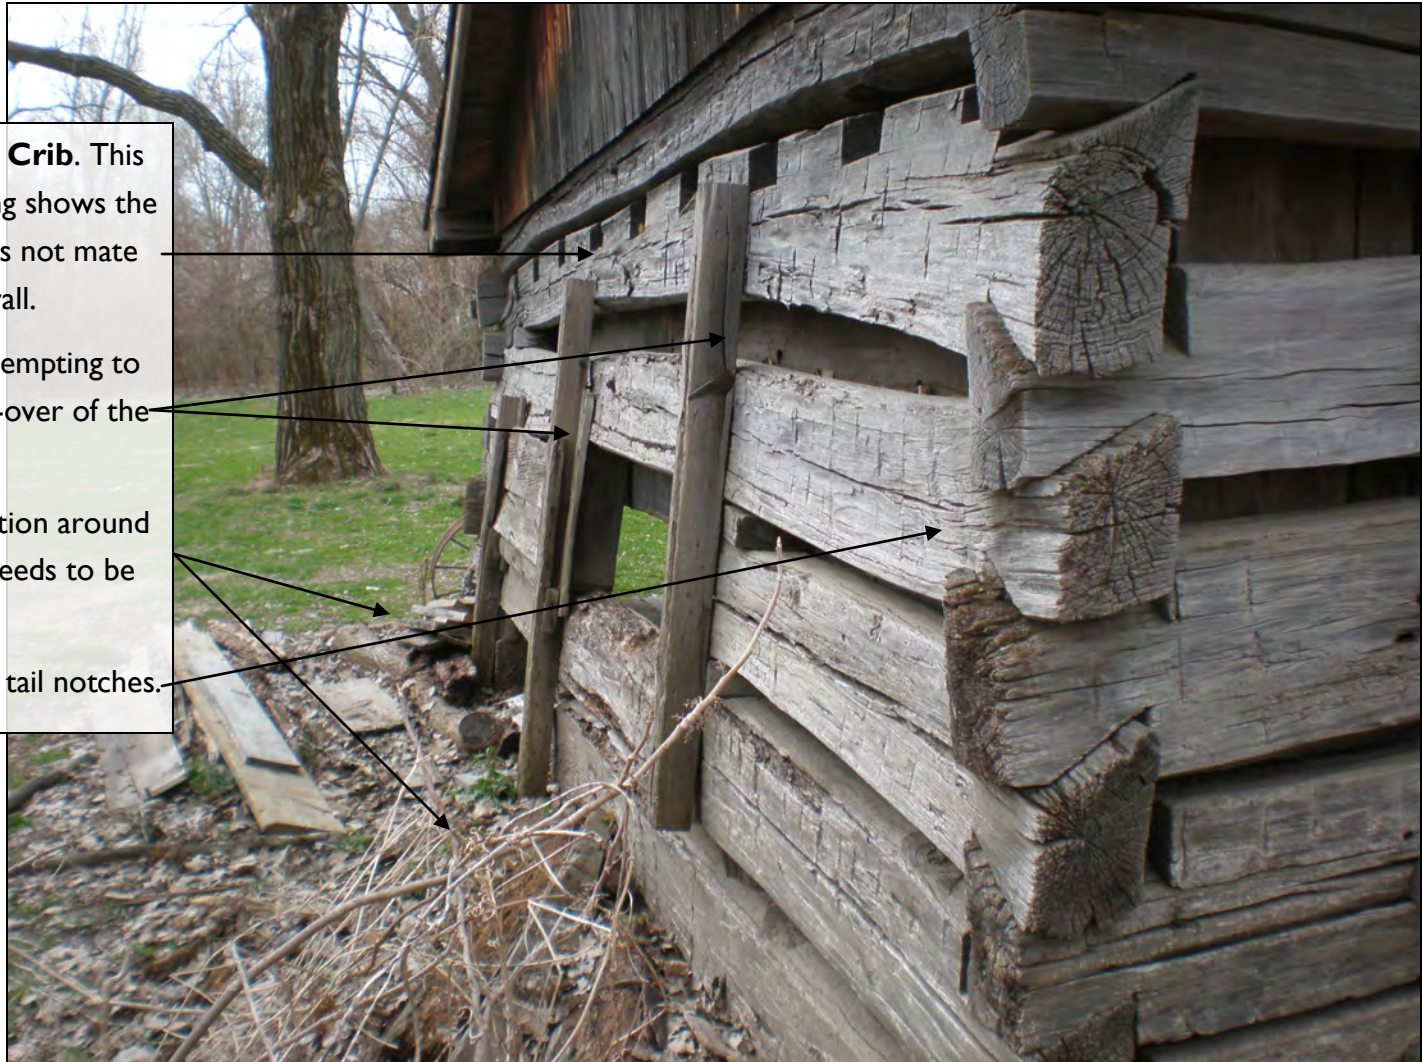
Debris and vegetation around the building that needs to be removed.

Nicely made dove tail notches.

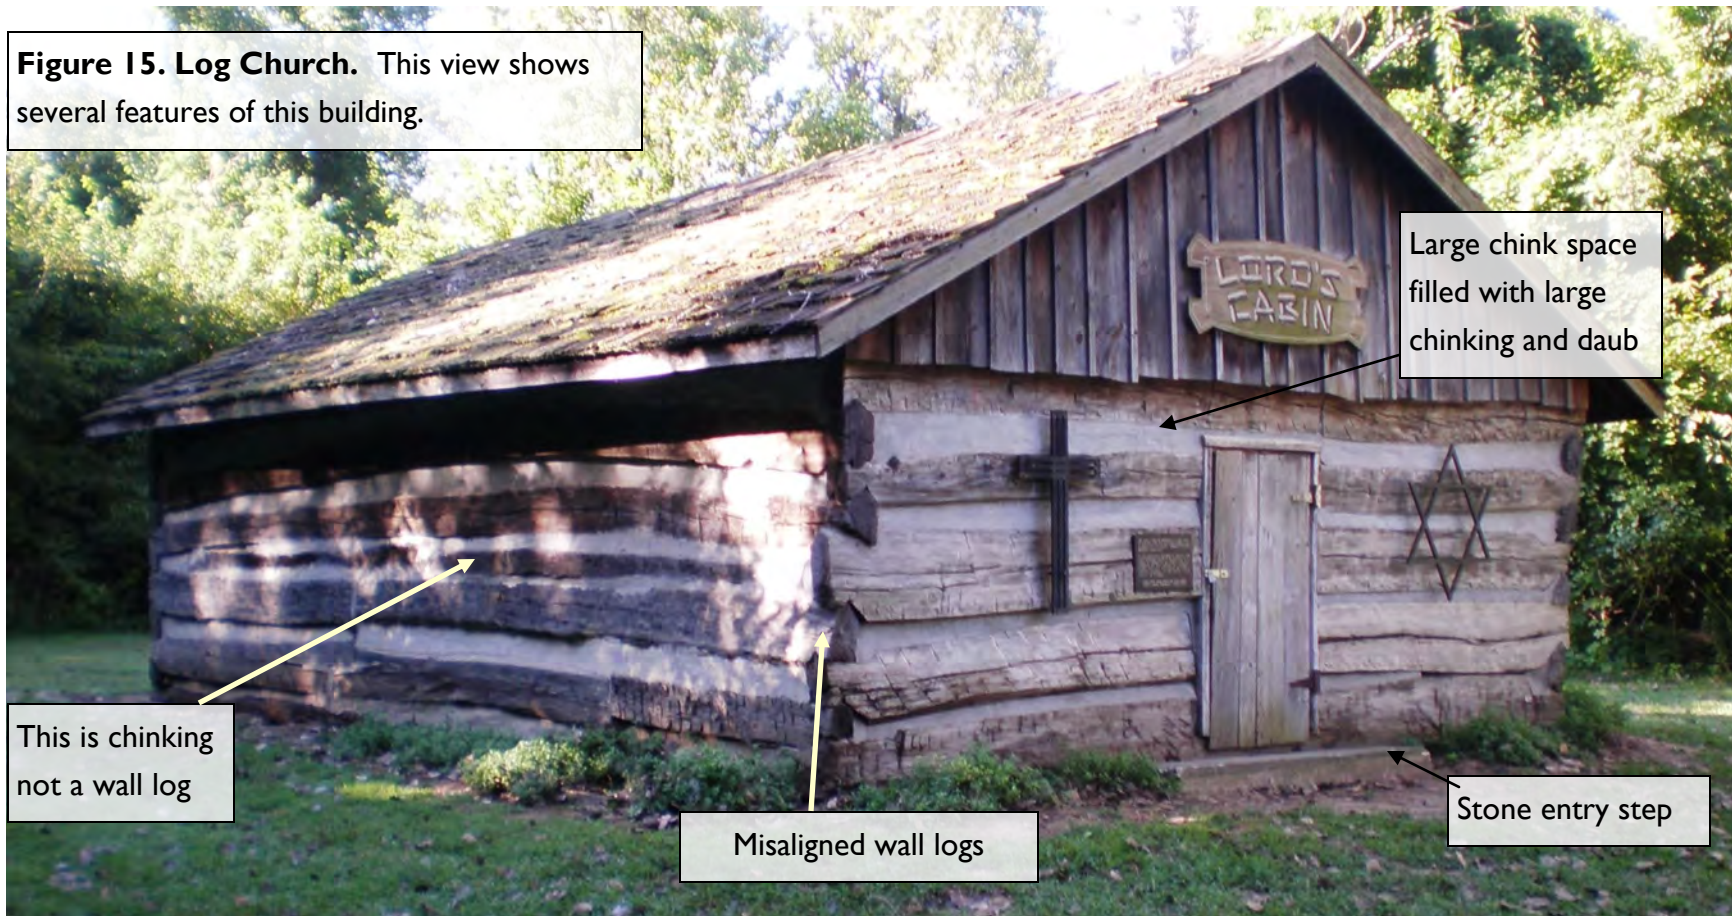
Figure 15. Log Church. This view shows several features of this building.

The building is not square at the present with lower logs sitting outside of the logs that are higher up in the stack. The roof is similar to other buildings with 2x6" rafters with skip sheeting covered with shakes laid 10" to the weather and inter-leafed with felt paper. The roof covers about 1000 square feet. The eaves are not very long and there are several logs that have been damaged by rain fall that has dripped on to them. The building, like all the others at this site floods on a decadal basis. The foundation is composed of concrete piers. Animals inhabit the area under the building. A large granite step marks the front entry .

Generally, the building is in fair condition but there are significant problems with the foundation, certain wall logs and the roof. The building is subsiding into the surrounding sandy soil and this in turn has caused the lower logs to decay. The animals that burrow beneath the building no doubt contribute to this problem by undermining the stability of the foundation piers. The amount of daubing in the cabin poses a problem because one can not know for certain about decay hiding in the logs under the daubing. There remains, not so much as unknowns, but rather potential to the downside. None of the decayed logs are going to somehow be found to be in good condition, but one or two of the sound logs may have pockets of decay that will need to be treated. This is true of all of the cabins in the village.

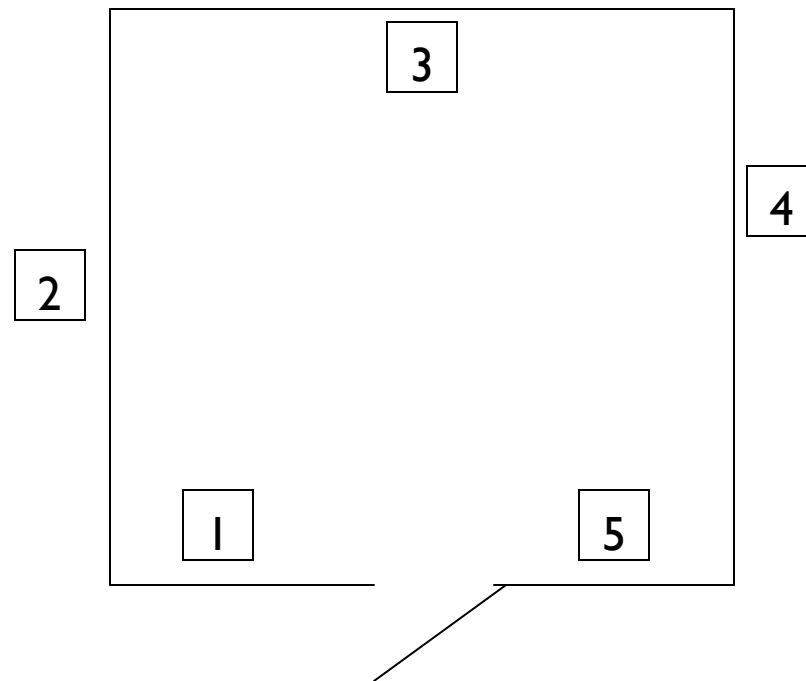
Numbered walls of the church
correspond to following tables

Log Church Wall Logs Condition (table 36)		
Wall 1 Logs	Condition	Recommendation
1	Spandrel, fair condition	Clean, borate and epoxy repair
2	Large check	Clean, borate and epoxy repair
3	Large check	Clean, borate and epoxy repair
4	Large check	Clean, borate and epoxy repair
5	Ok , possibly did not come from barn	
Wall 2 Logs		
1	Sill, not hewn, decayed	replace
2	In three section, checked	Clean, borate and epoxy repair
3	In two sections, checked	Clean, borate and epoxy repair
4	Fair condition	Clean, borate and epoxy repair
5-6	ok	
Wall 3 Logs		
1	Spandrel, extensive decay	replace
2	Fair	Minor repairs
3	ok	
4-5	fair	Clean, borate and epoxy repair

Log Church Wall Logs Condition (table 37)		
Wall 4 Logs	Condition	Recommendation
1	decayed	replace
2	fair	minor repair
3	decayed for 5'	Replace/splice 5 feet of the log
4	fair	minor repair
5	decayed	Clean, borate and epoxy repair
6	fair	minor repair
Wall 5 Logs		
1	ok	
2	fair	Repair large check
3	fair	Repair large check
4	fair	Repair large check
5	ok

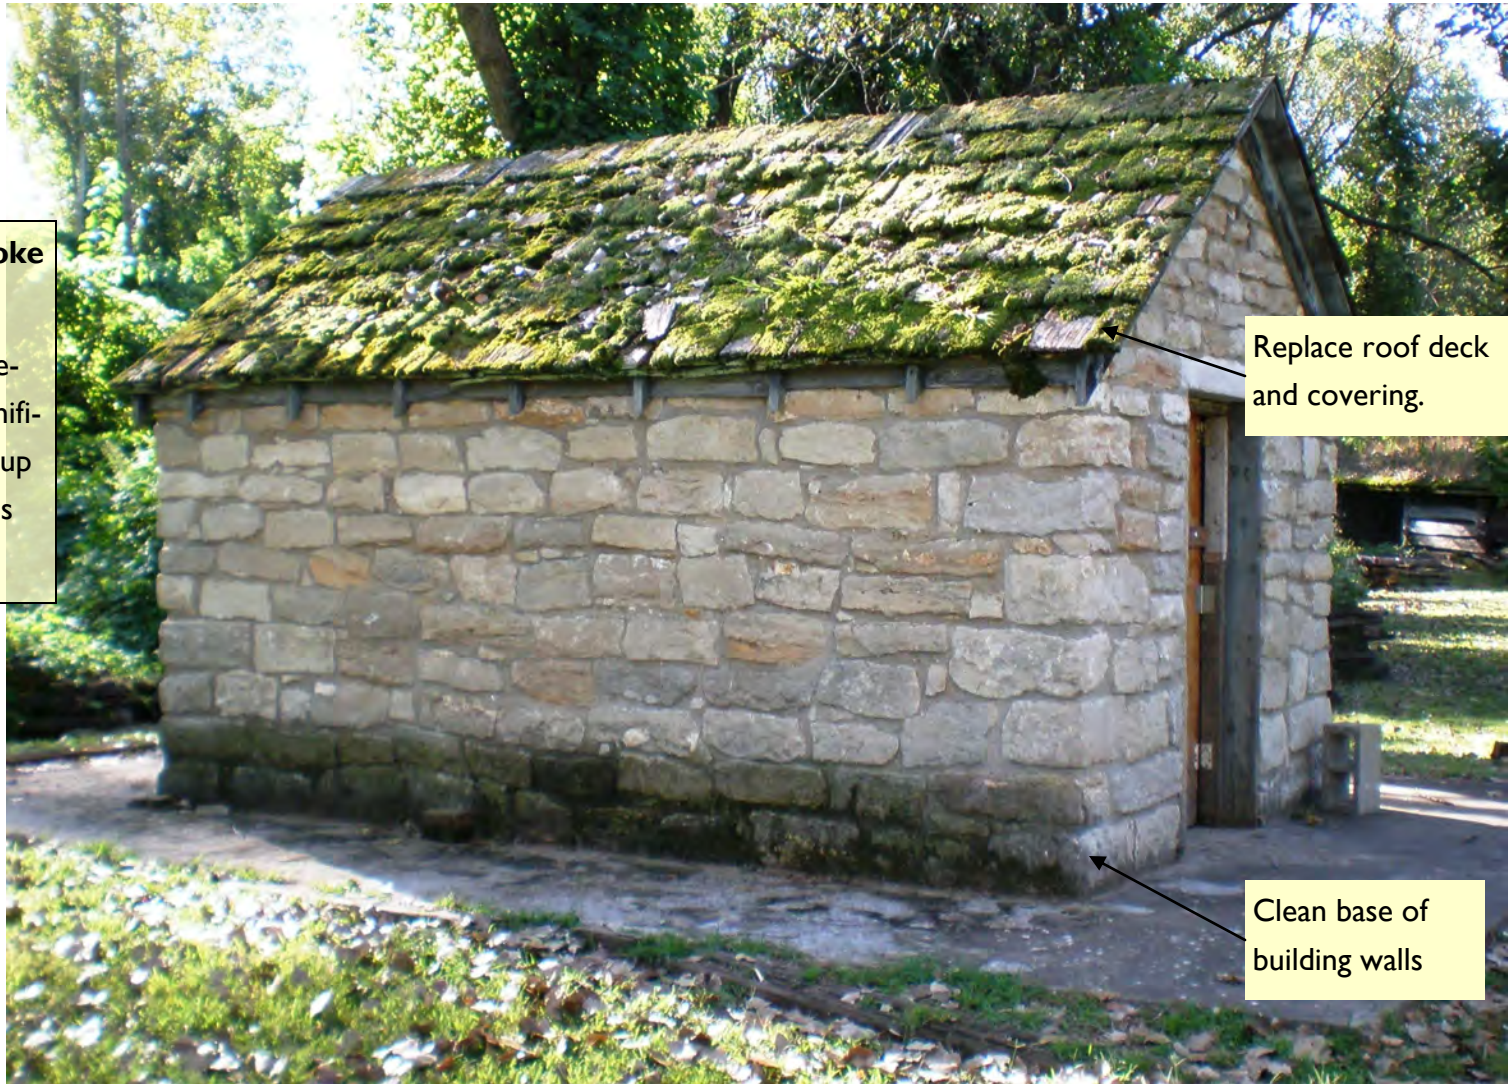
Figure 17 Smoke House

Roof is fully deteriorated and significant mold build up on base of wall is apparent.

The roof of the building is in poor condition but it may be possible to redeck the roof without replacing the rafters. The rafters did not appear to be seriously damaged. The one value to replacing the rafters would be to extend them slightly to move moisture further away from the building. The current use of the building for storage is does not cause any damage to the building.

be cleaned (1 cup of bleach in 1 gallon of water and a stiff bristle brush) and then treated with a borate solution to prevent the return of the mold. The cleaning and borate treatment should be repeated annually.

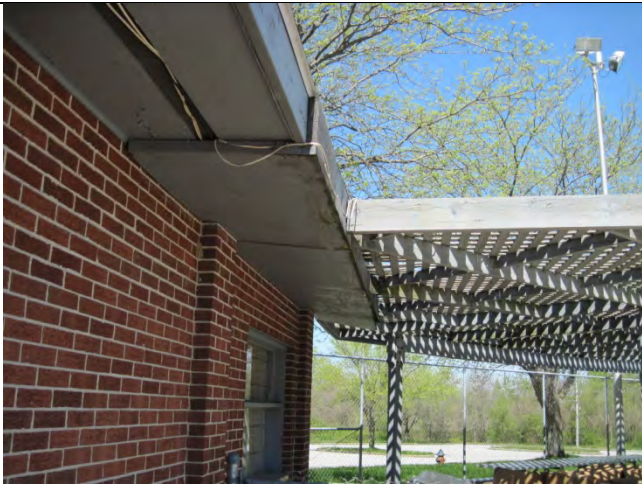
Needed Repairs: Facia and Soffet needs painting and some repairs. Where the sunscreen meets the concession area, water is trapped, causing the wood to deteriorate. This needs repaired and redesigned.

Soffet Water Damage

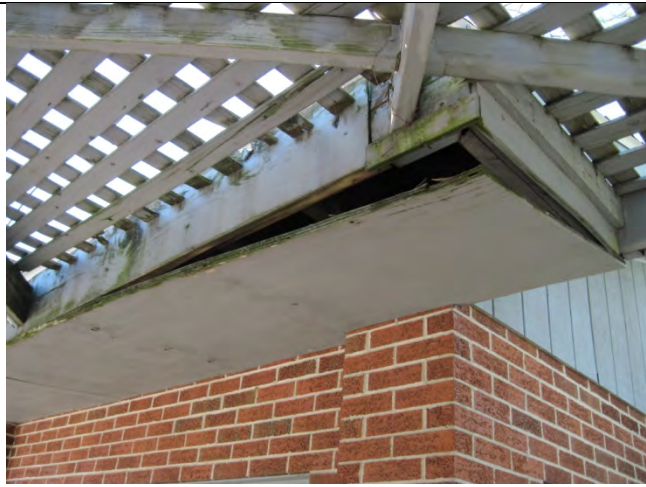
Soffet Water Damage

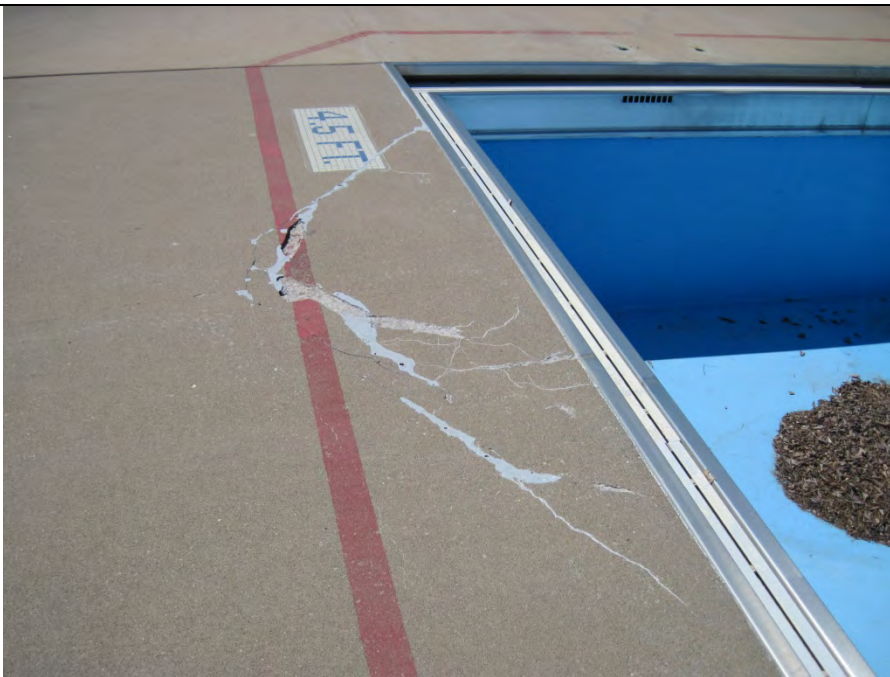
Summary - Basins: All pool basins; main, baby, diving, are free of significant cracks. They are holding water and functioning as designed. There is no significant repair history for the basin. Drain covers were modified to comply with new rules in 2009. The pool decks have some moderate cracking. There is nothing that would indicate a failure of these systems the next 5 years.

Deck Cracking

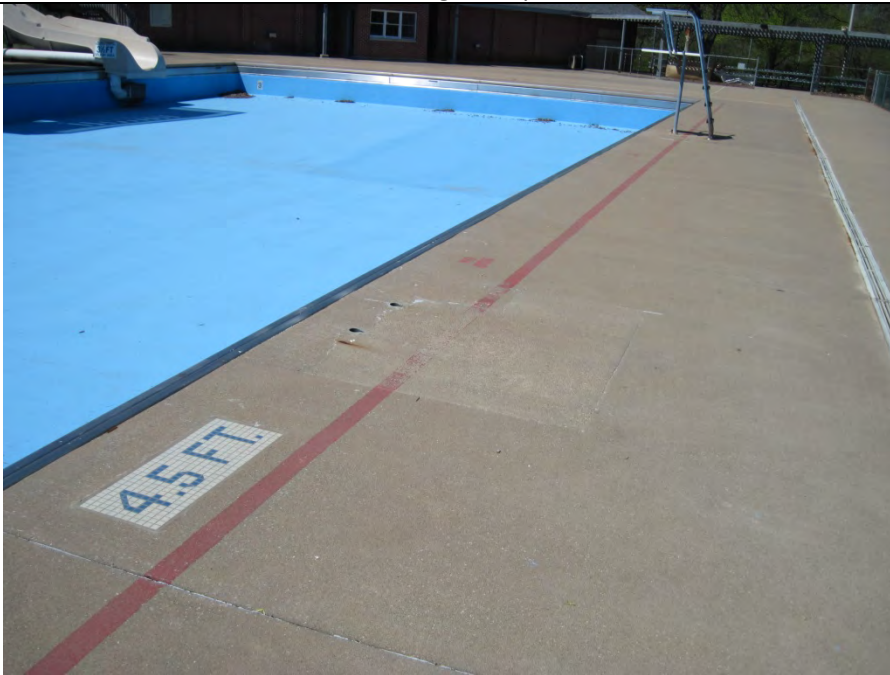
Summary: Nearly all pool plumbing is PVC pipe which will not failure due to corrosion. There was a failure in a single line that ran under the deck near the main basin approximately 12 years ago. This line pulled free from a fitting. A line in the filter building failed due to pressure. Most of the valves that control flow have been replaced at least once due to corrosion, but this is normal for pools.

Deck cut to repair filtered water pipe failure

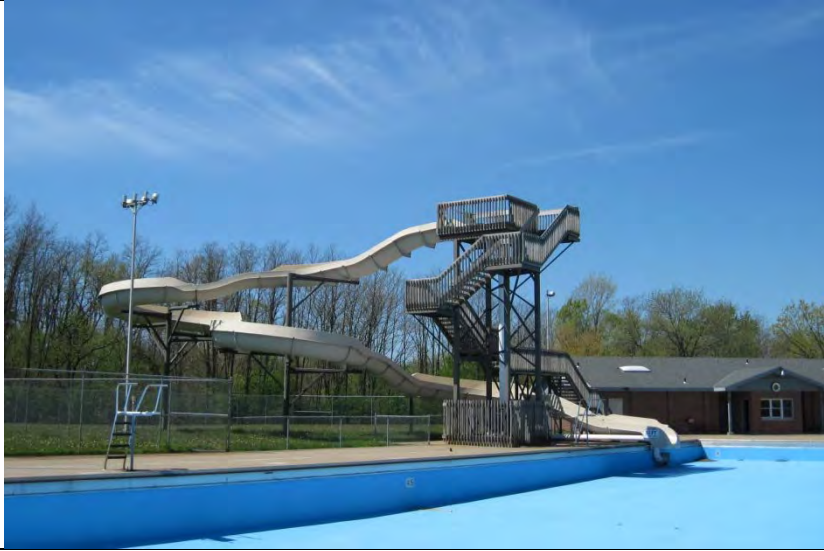
Water Slide

The water slide was installed in 1985. The slide motor and pump are old (maybe original) but there has been a repair to the pump blades and bearings in approximately 2005. There is serious corrosion of the metal support components of the slide and stairs. This will likely need to be address in the next 5 years.

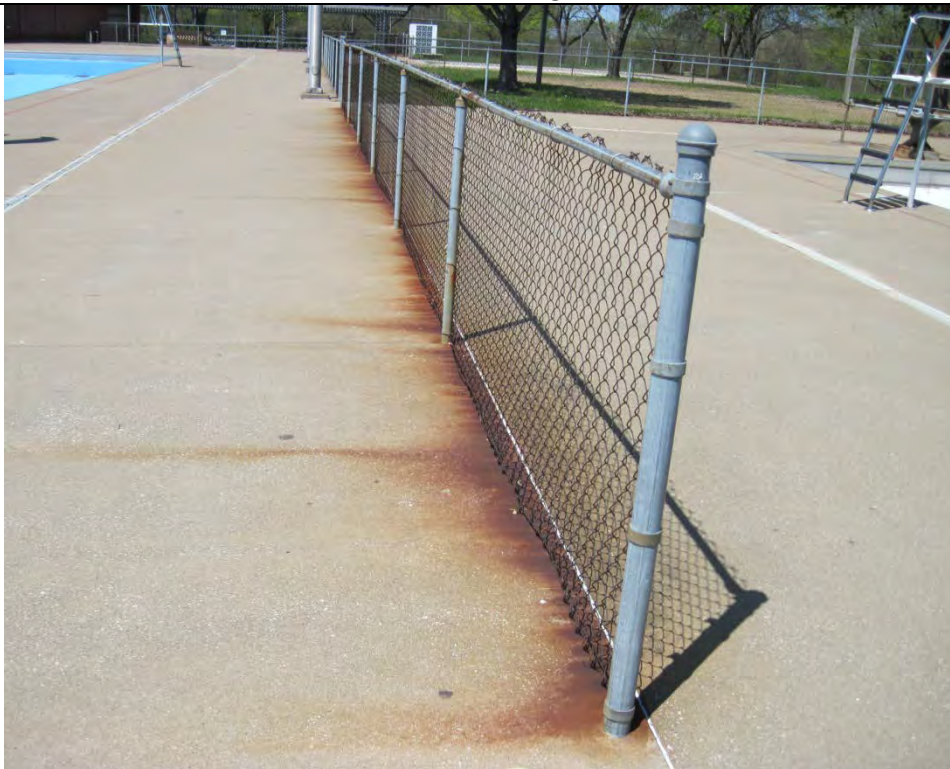
The fencing throughout the facility is old and rusting.

Fence Rusting
