Underwater Inspection Report

Owner: Quincy Park Authority
Structure: Quinsippi Island Bridge
Location: Quincy, Illinois
Body of Water: Mississippi River
Inspection Date: June 18, 2020

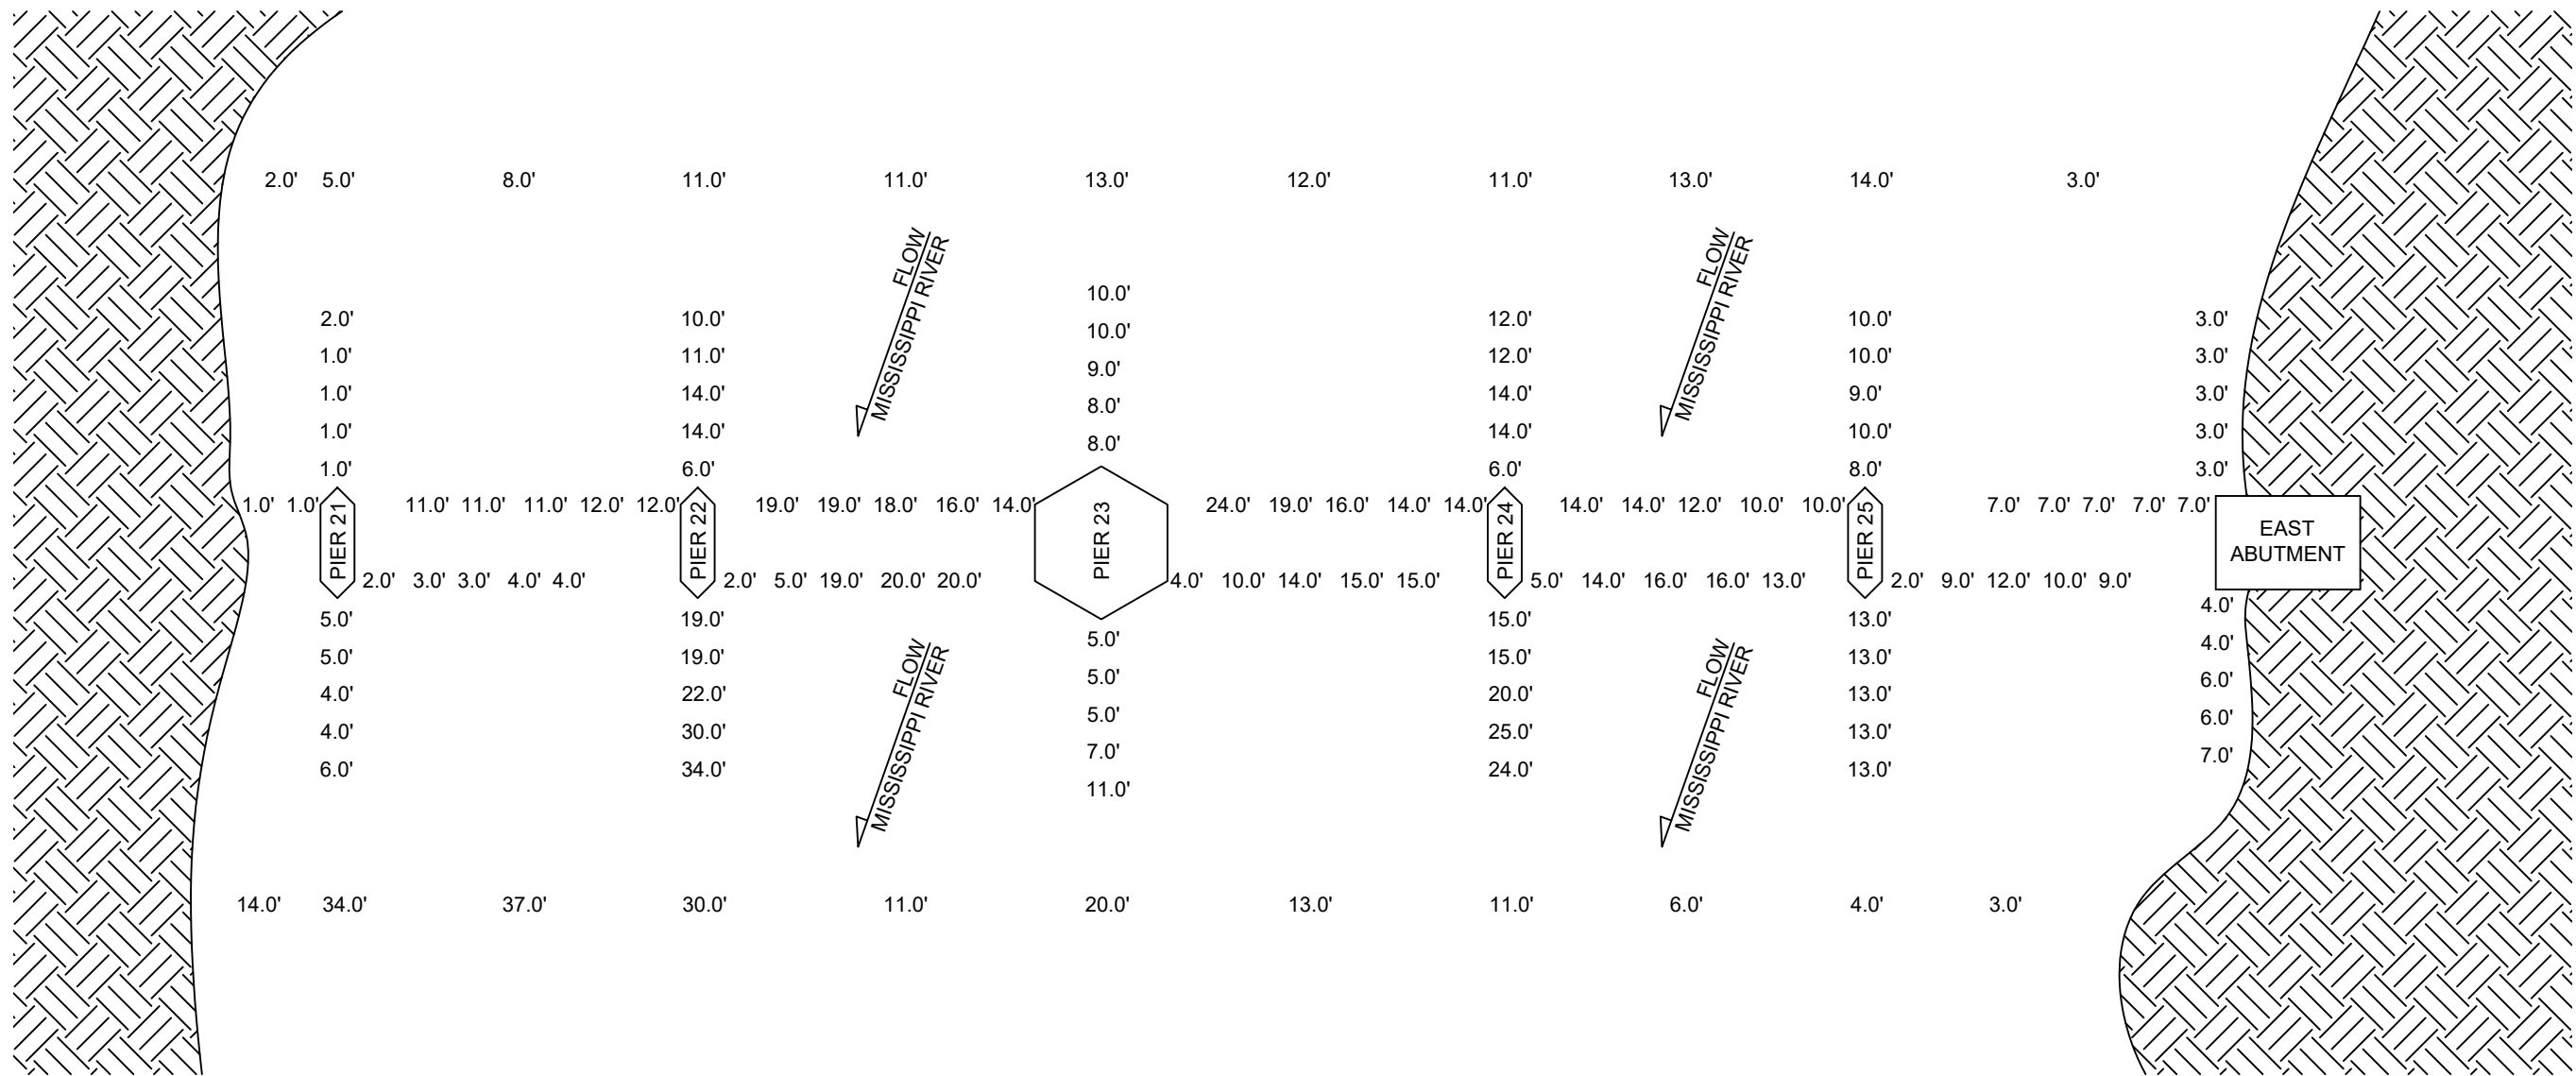
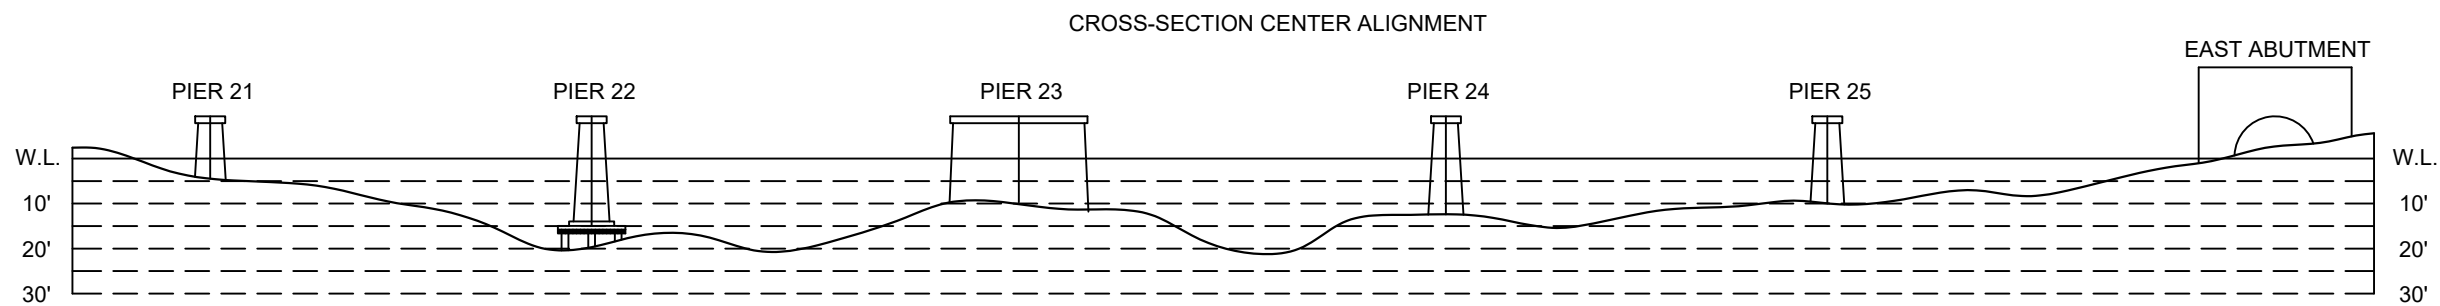
| • Drawing A-6 | PIER 22 |

Pier 22 was constructed from masonry stone with mortar fill (See 'Appendix A, A6' and 'Appendix B, Figures 19 - 22'). Pier 22 also had AB mats, Grout Bags, and Grout Backfill installed along the Right Face, Downstream Bullnose, and the Left Face. These AB Mats were installed to help protect the Pier as Timber Cribbing was exposed on the Downstream Bullnose.

- The timber cribbing was found to be undermined. This area measured 10-feet wide at center by 3-inches high and had up to 1½-feet of loss.

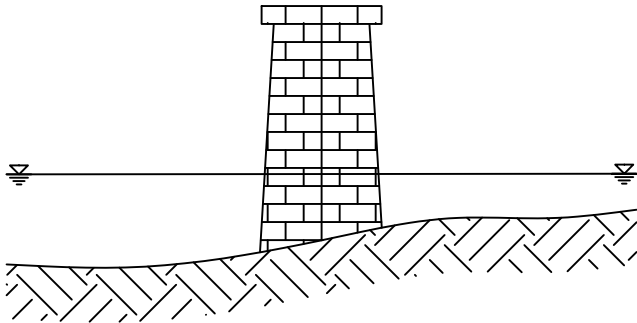
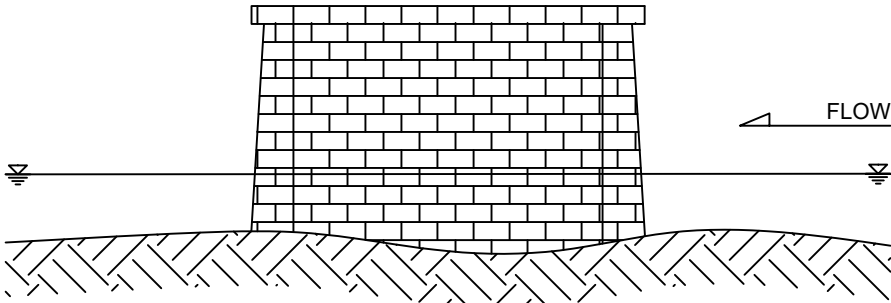
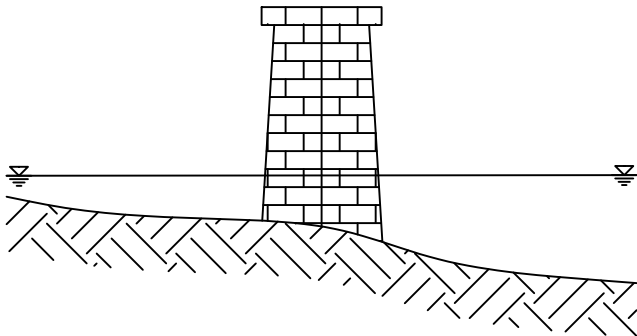
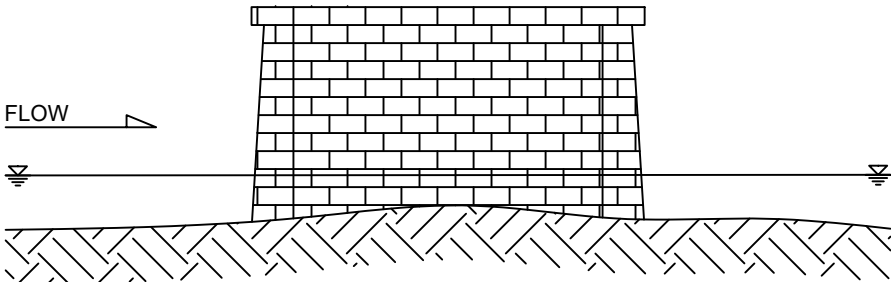
| • Drawing A-7 | PIER 21 |

Pier 21 was constructed from masonry stone with mortar fill (See 'Appendix A, A7' and 'Appendix B, Figures 23 - 26').

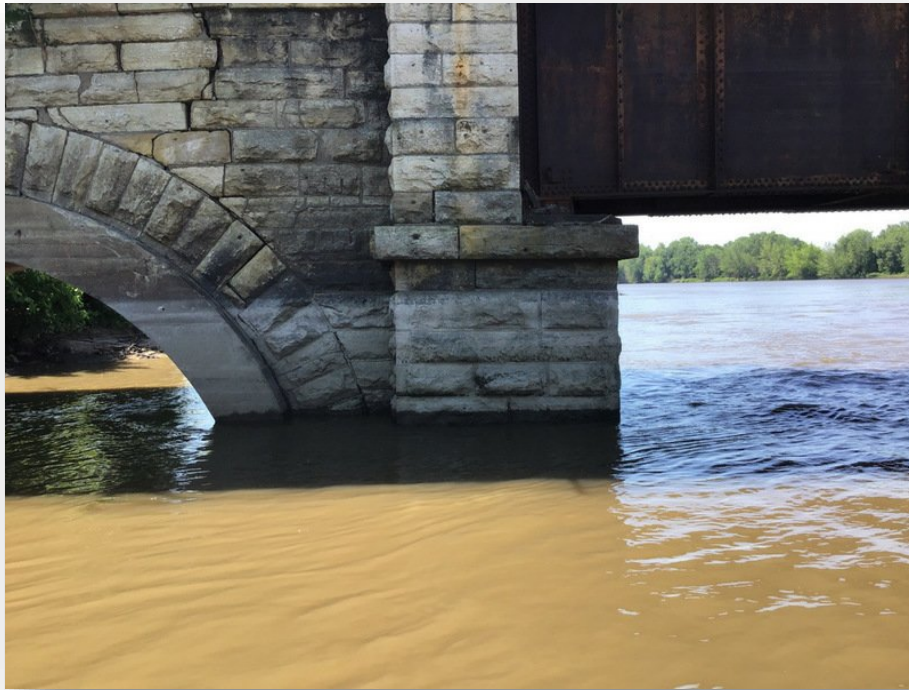
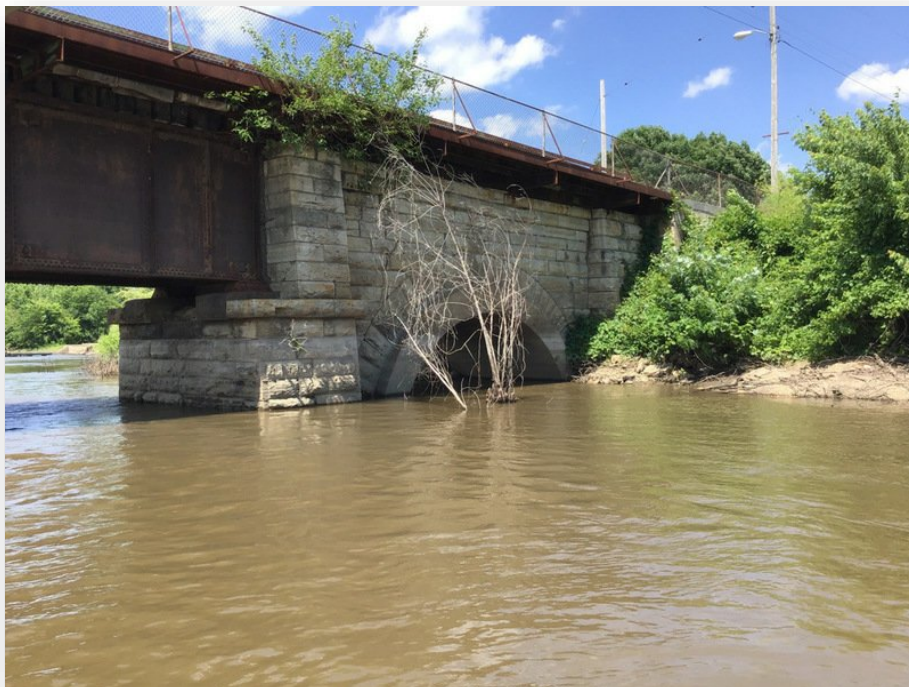
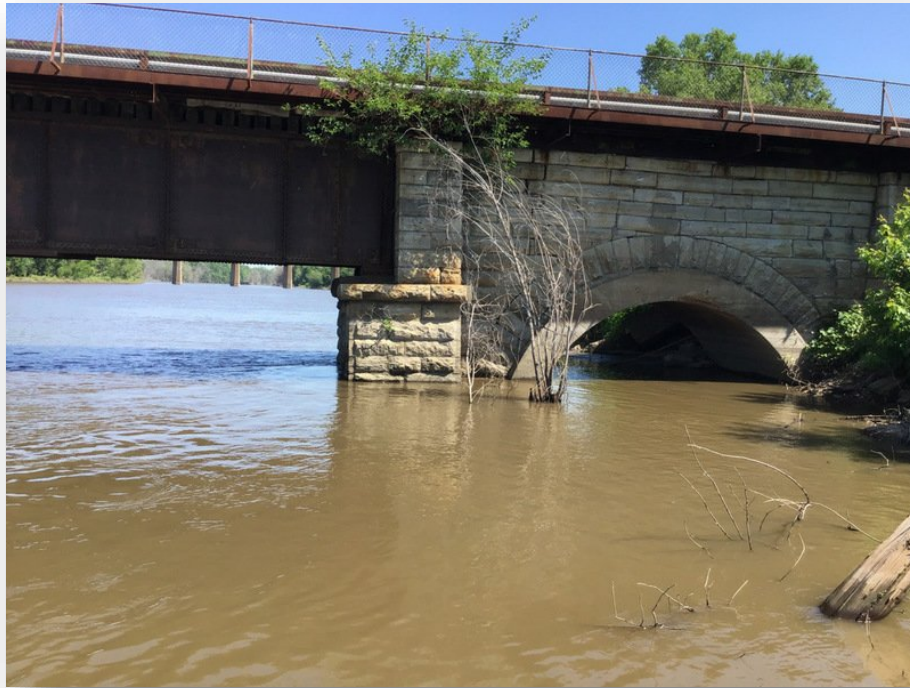
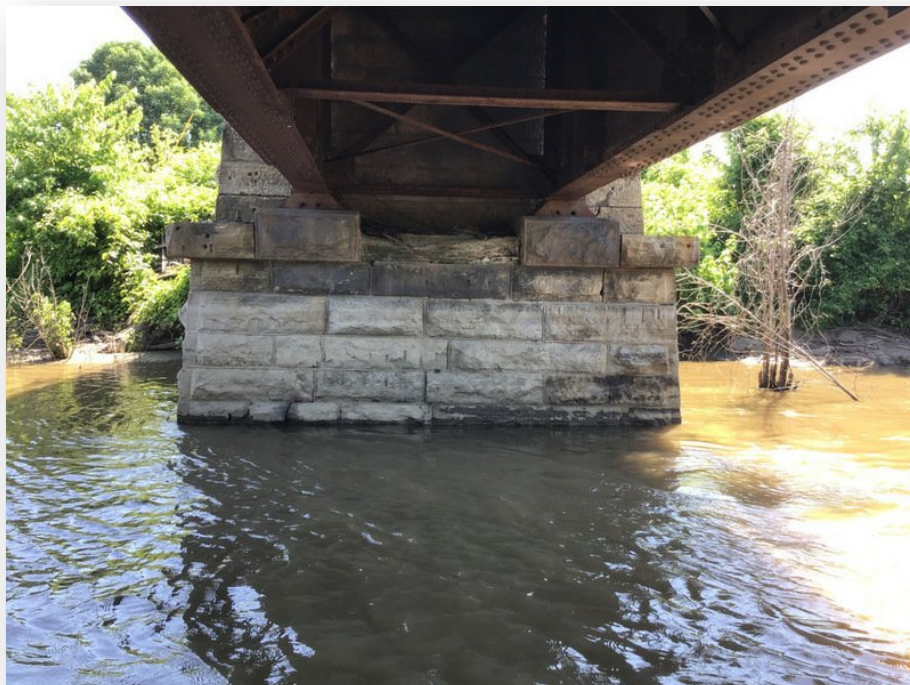
The East Abutment was constructed from Masonry Stone with mortar fill (See 'Appendix B, Figures 3 - 6').

- Overall, there was minor mortar loss in sporadic areas with minor deterioration along the freeze/thaw zone.
- Upstream Face:
 - Overall, the masonry stone and mortar were in satisfactory condition above and below the waterline.
- Right Face:
 - Overall, the masonry stone and mortar were in satisfactory condition above and below the waterline.
 - This side of the Abutment was in very shallow water.
- Downstream Face:
 - Overall, the masonry stone and mortar were in satisfactory condition above and below the waterline.
- Left Face:
 - Overall, the masonry stone and mortar were in satisfactory condition above and below the waterline.
 - There was a minor amount of debris stacked up (See 'Appendix B, Figure 27').
- The bottom substrate consisted of small riprap and mud.

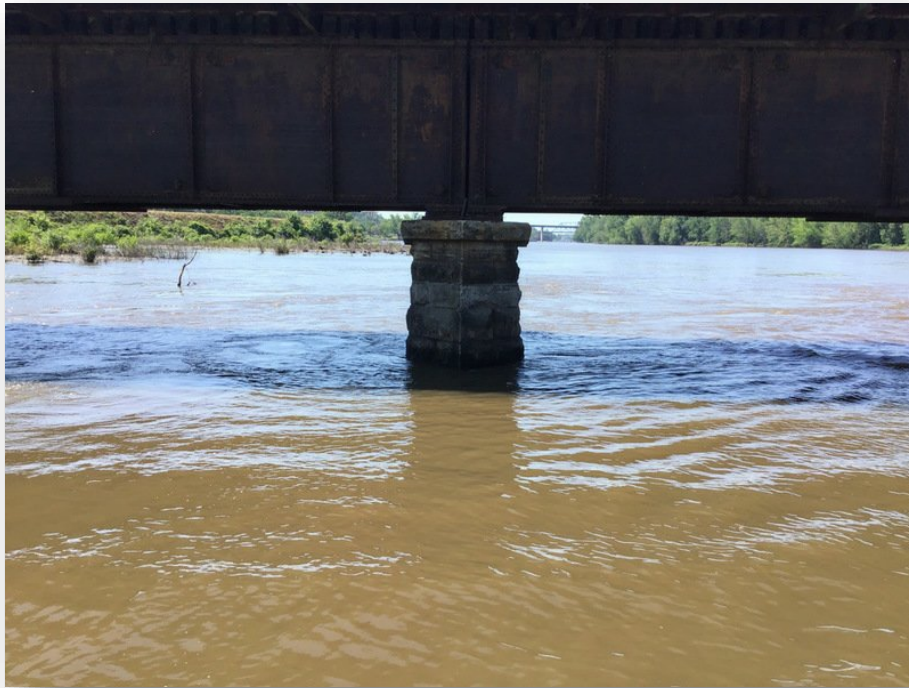
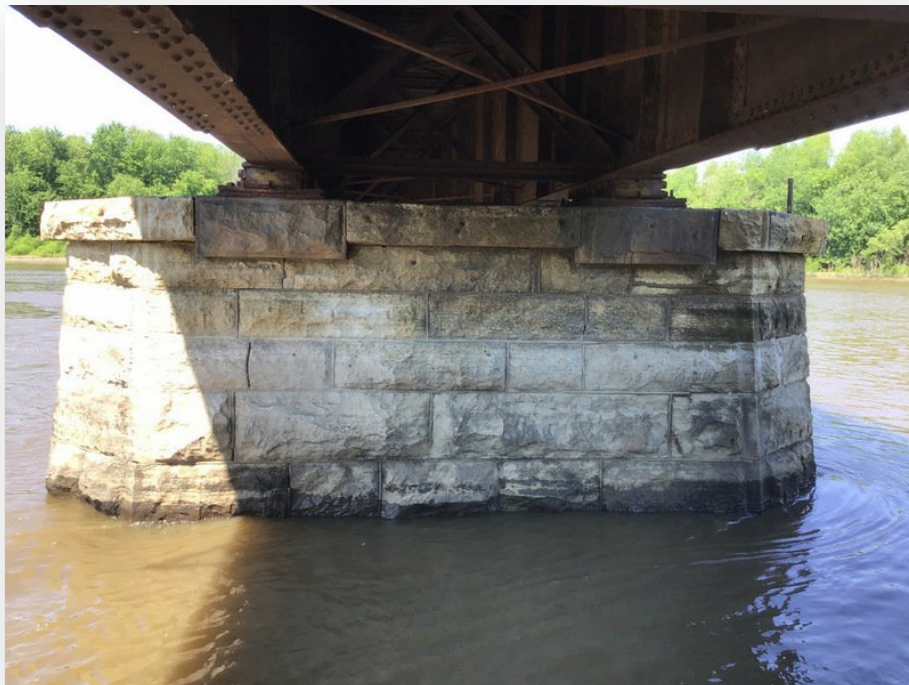
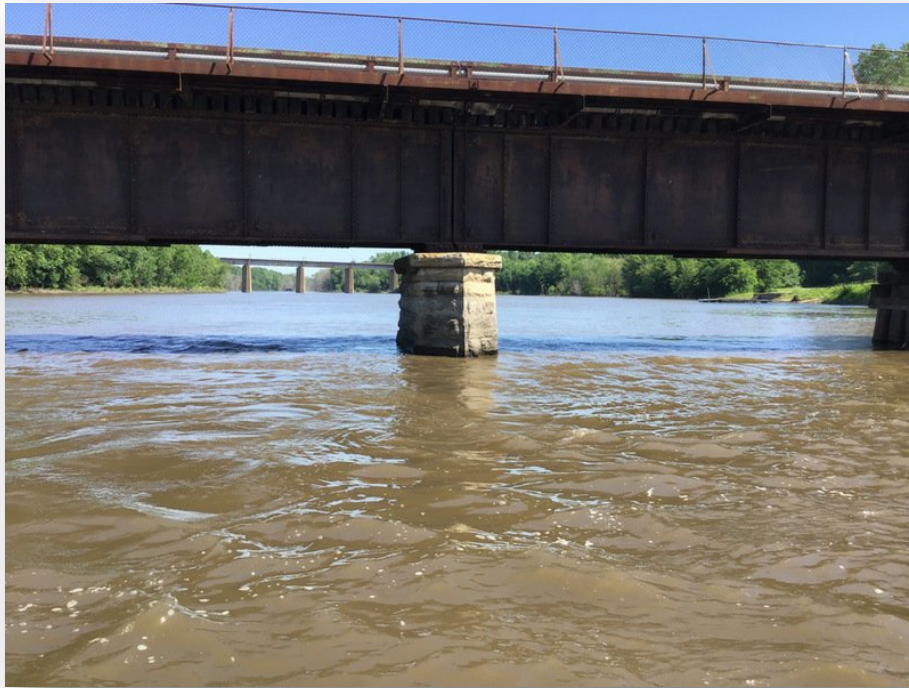
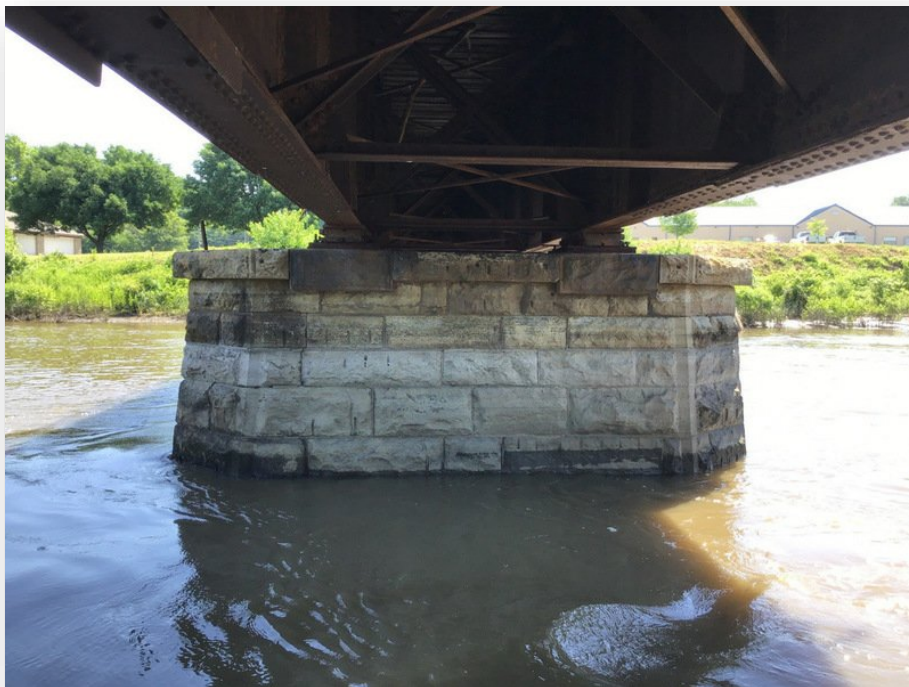
Pier 25 was constructed from masonry stone with mortar fill (See 'Appendix A, A3' and 'Appendix B, Figures 7 - 10').

- Overall, there was minor mortar loss in sporadic areas with minor deterioration along the freeze/thaw zone.
- Upstream Bullnose:
 - Overall, the masonry stone and mortar were in satisfactory condition above and below the waterline.
 - There was a moderate amount of debris stacked up.
- Right Face:
 - Overall, the masonry stone and mortar were in satisfactory condition above and below the waterline.
 - There was a moderate amount of debris stacked up (See 'Appendix B, Figure 28').
- Downstream Bullnose:
 - Overall, the masonry stone and mortar were in satisfactory condition above and below the waterline (See 'Appendix B, Figure 29').
- Left Face:
 - Overall, the masonry stone and mortar were in satisfactory condition above and below the waterline.
- The bottom substrate consisted of riprap and mud.

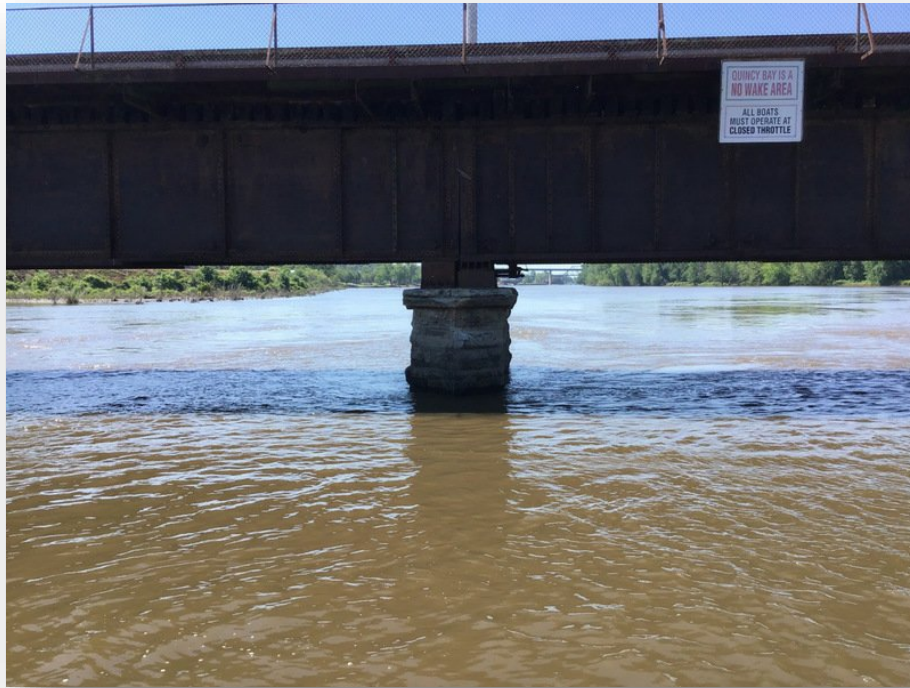
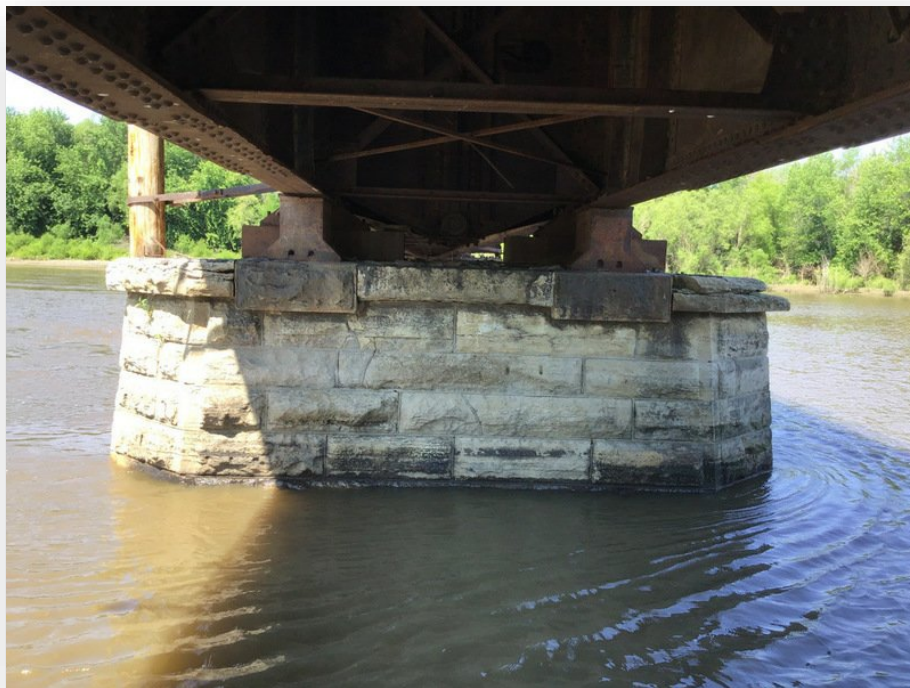
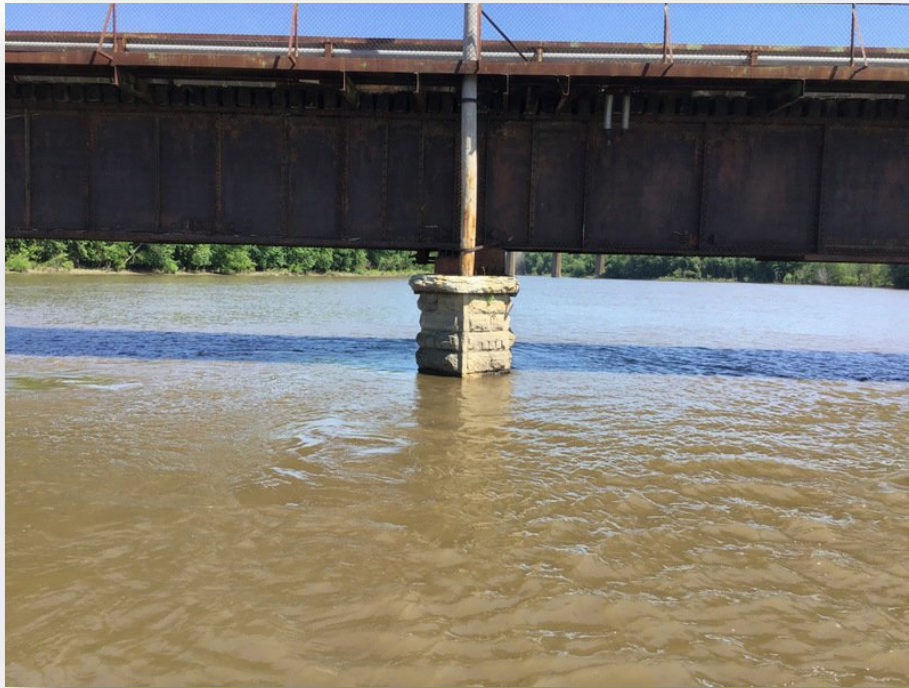
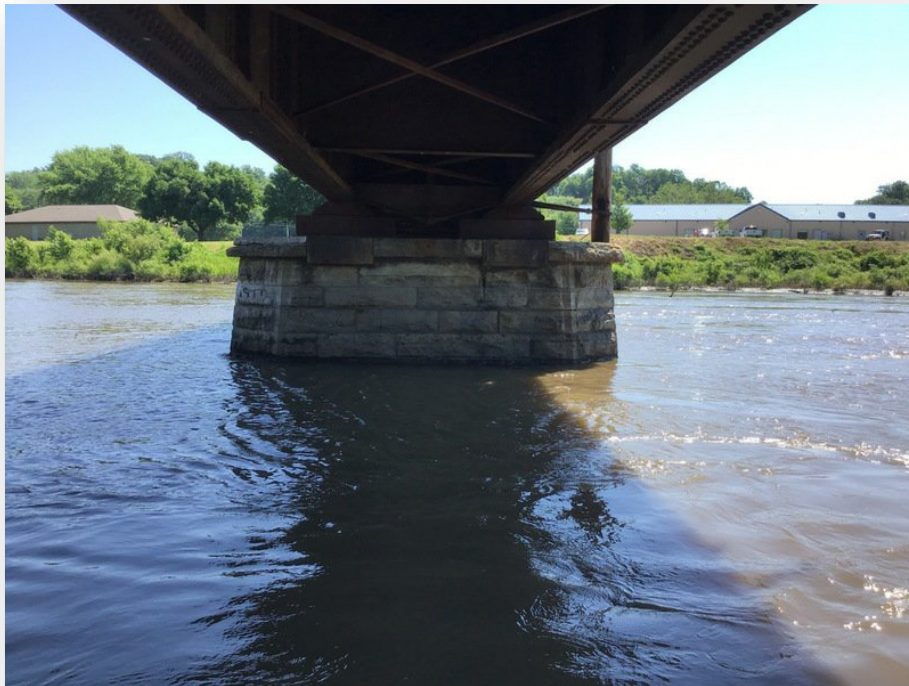
Pier 24 was constructed from masonry stone with mortar fill (See 'Appendix A, A4' and 'Appendix B, Figures 11 - 14').

- Overall, there was minor mortar loss in sporadic areas with minor deterioration along the freeze/thaw zone.
- Upstream Bullnose:
 - Overall, the masonry stone and mortar were in satisfactory condition above and below the waterline.

- Right Face:
 - Overall, the masonry stone and mortar were in satisfactory condition above and below the waterline.
 - The top of the footing was exposed and had a 1½-foot horizontal face. The vertical face was not exposed as it was flush with the riprap mud bottom (See 'Appendix B, Figure 30').

- Downstream Face:
 - Overall, the masonry stone and mortar were in satisfactory condition above and below the waterline.
 - The footing was exposed and had a 2½-foot horizontal face with a vertical face of 1½-feet.

- Undermining was found under the exposed footing and measured 1-foot wide by 10-inches high and had up to 1-foot of loss (See 'Appendix B, Figure 31').

- Left Face:
 - Overall, the masonry stone and mortar were in satisfactory condition above and below the waterline.
- The bottom substrate consisted of riprap and mud.

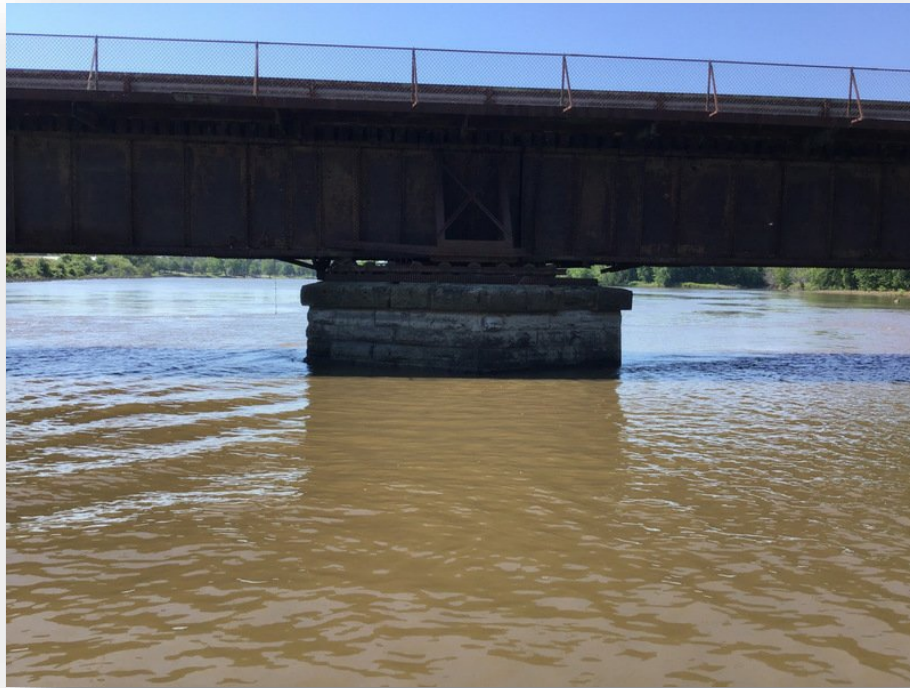
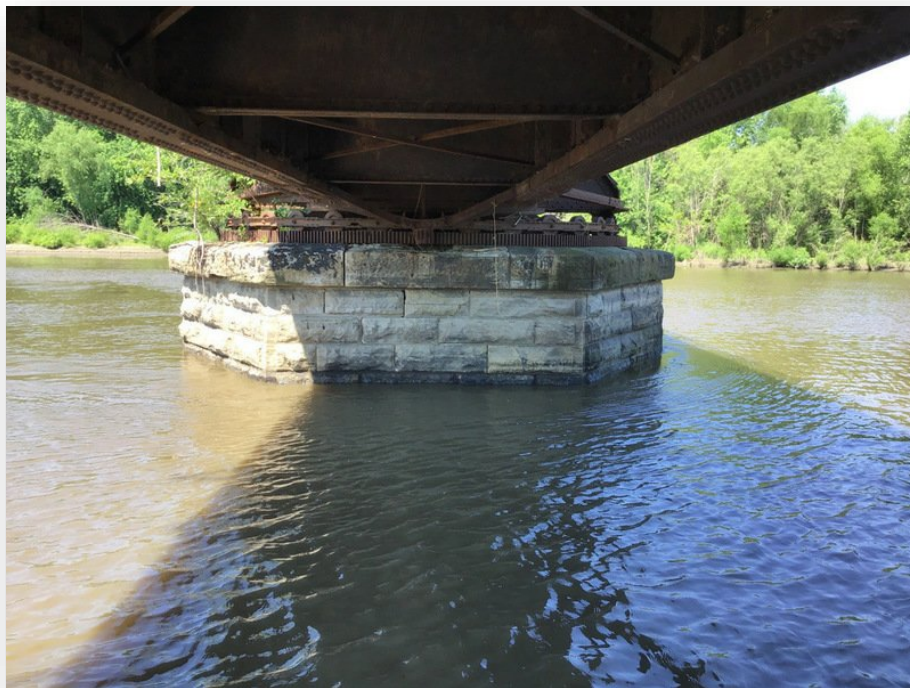
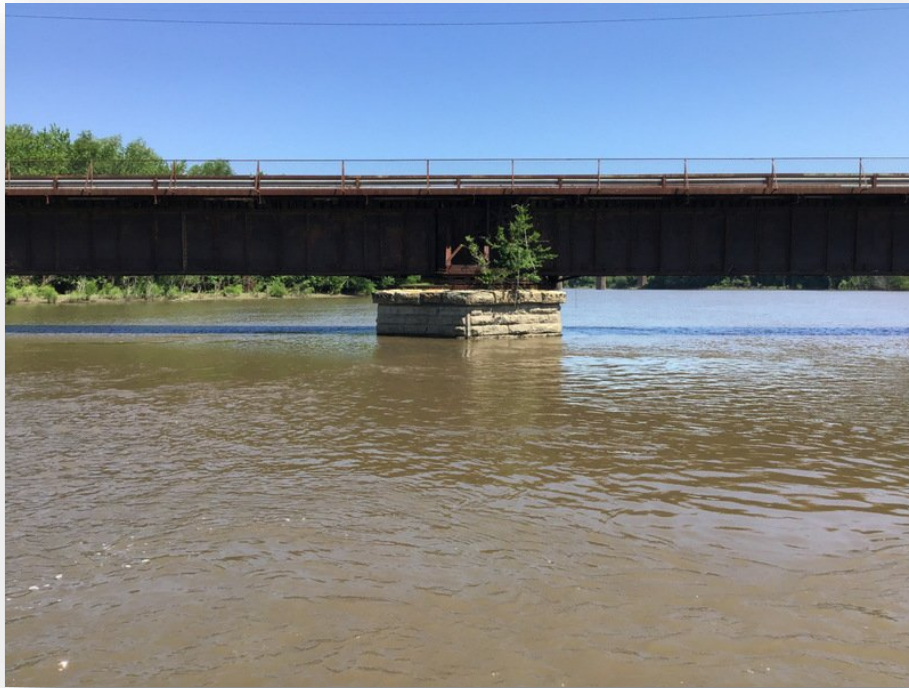
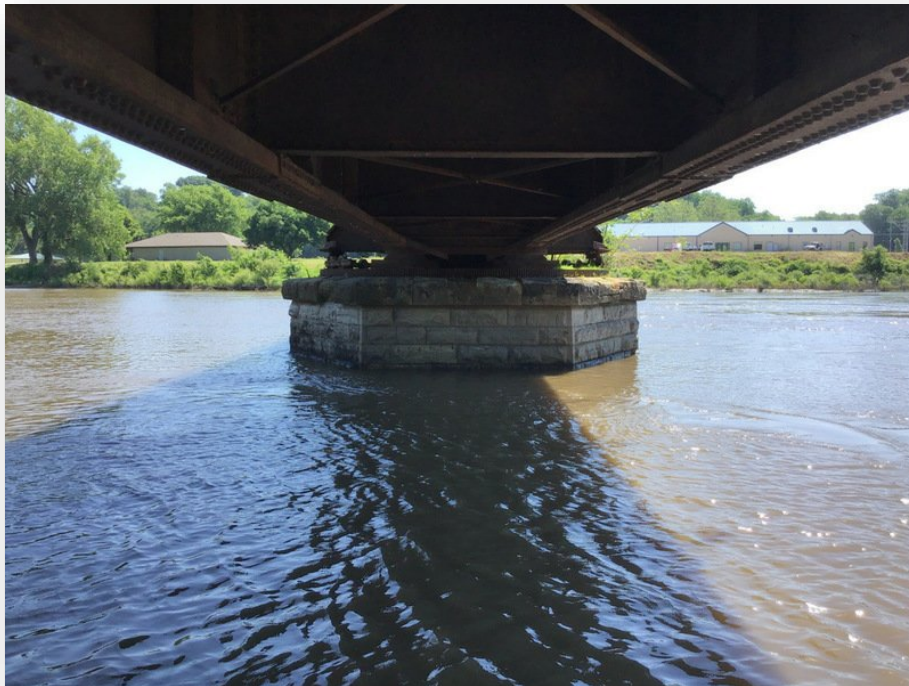
Pier 23 was constructed from masonry stone with mortar fill (See 'Appendix A, A5' and 'Appendix B, Figures 15 - 18').

- Overall, there was minor mortar loss in sporadic areas with minor deterioration along the freeze/thaw zone.
- Upstream Bullnose:
 - Overall, the masonry stone and mortar were in satisfactory condition above and below the waterline.
- Right Face:

- Overall, the masonry stone and mortar were in satisfactory condition above and below the waterline.
- There was a minor amount of debris stacked up (See 'Appendix B, Figure 32').
- Downstream Bullnose:
 - Overall, the masonry stone and mortar were in satisfactory condition above and below the waterline.
- Left Face:
 - Overall, the masonry stone and mortar were in satisfactory condition above and below the waterline.
- The bottom substrate consisted of riprap and mud.
